Geotechnical Report for Proposed Plan Change

Wilfield Subdivision Proposed Southern Extension

Issue Date: **20 November 2020**

Miyamoto Ref: **200509-RP-001[A]**

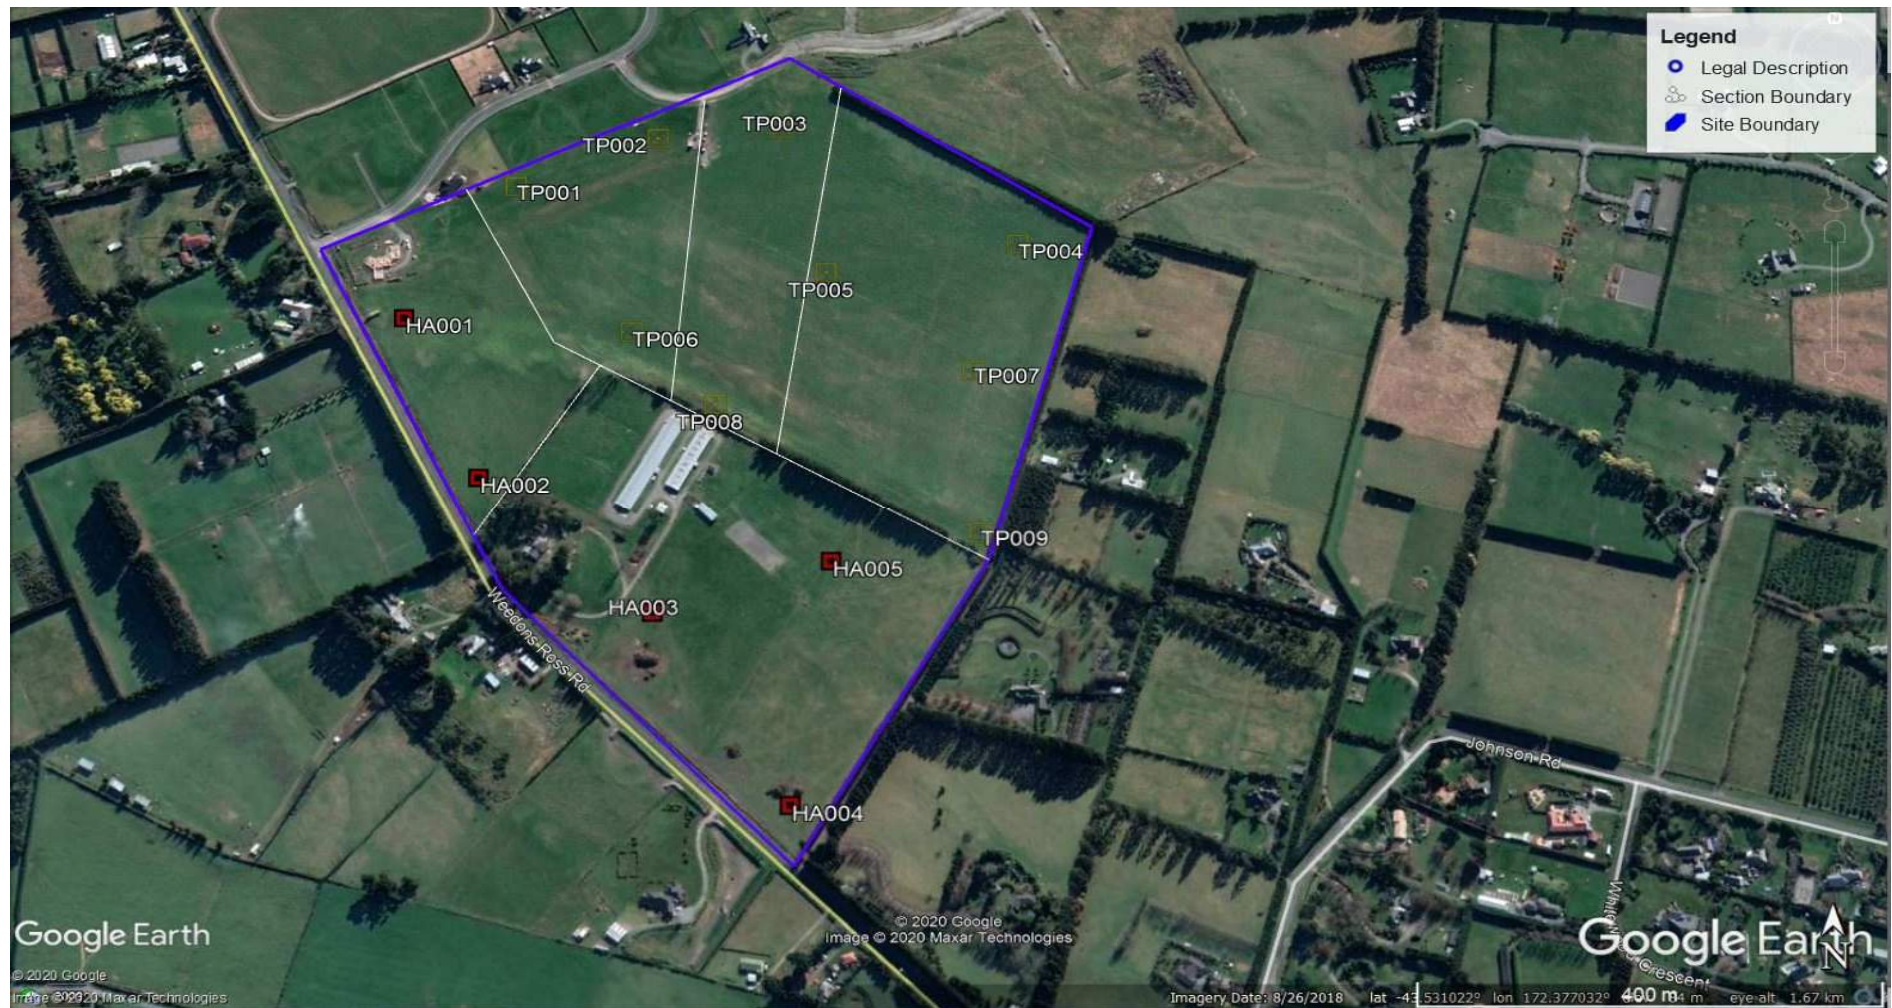
SITE INVESTIGATION PLAN

Wilfield Subdivision, West Melton
