***Soil Contamination Risk  
Stage 4 – Validation Report***

***Homestead Area - Wilfield***

***Weedons Ross Road, West Melton***

*November 2016*

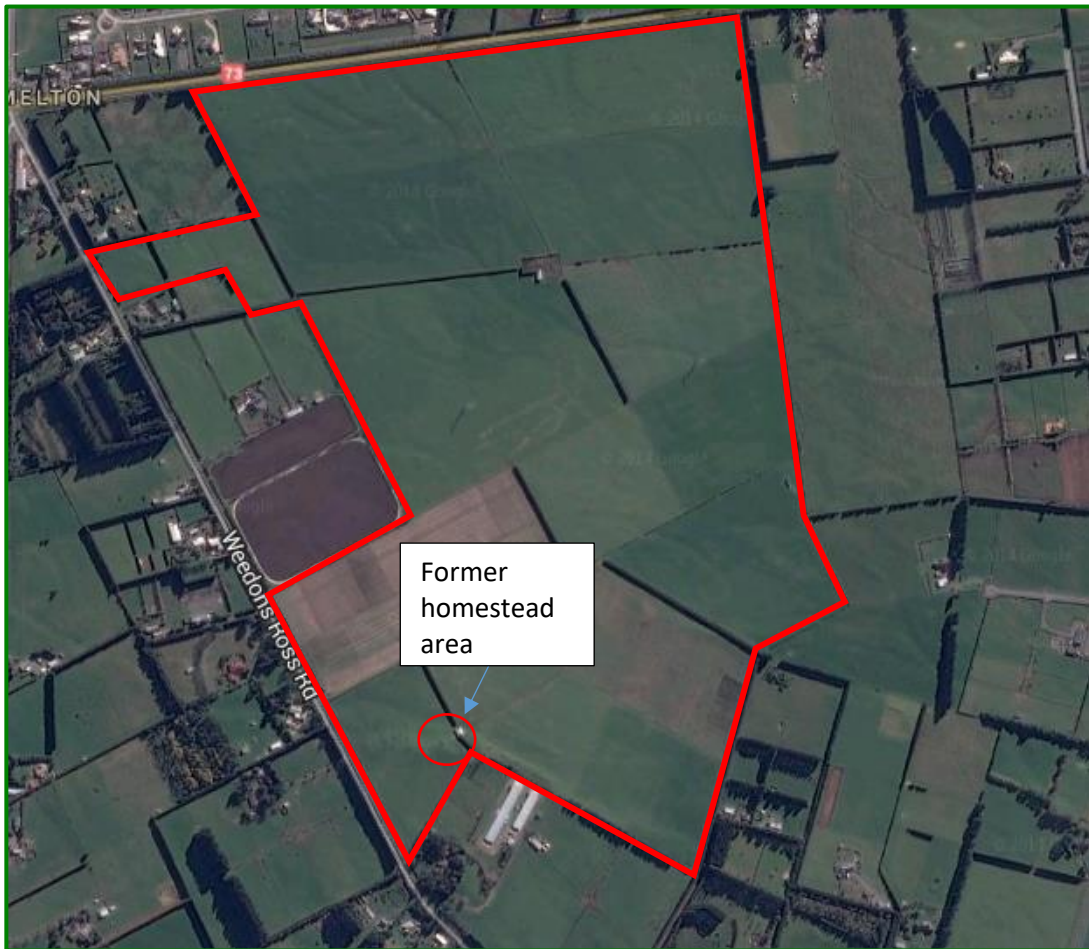
Figure 2 – Homestead Area Location

The area that this validation report covers is the former homestead area near the south-western corner of the site, as shown on the plan in **Figure 2** below:

The former homestead area is in the south-western corner of the site, on an elevated area. There was a barn adjacent to where the original homestead was sited, but has been removed since the DSI was completed.

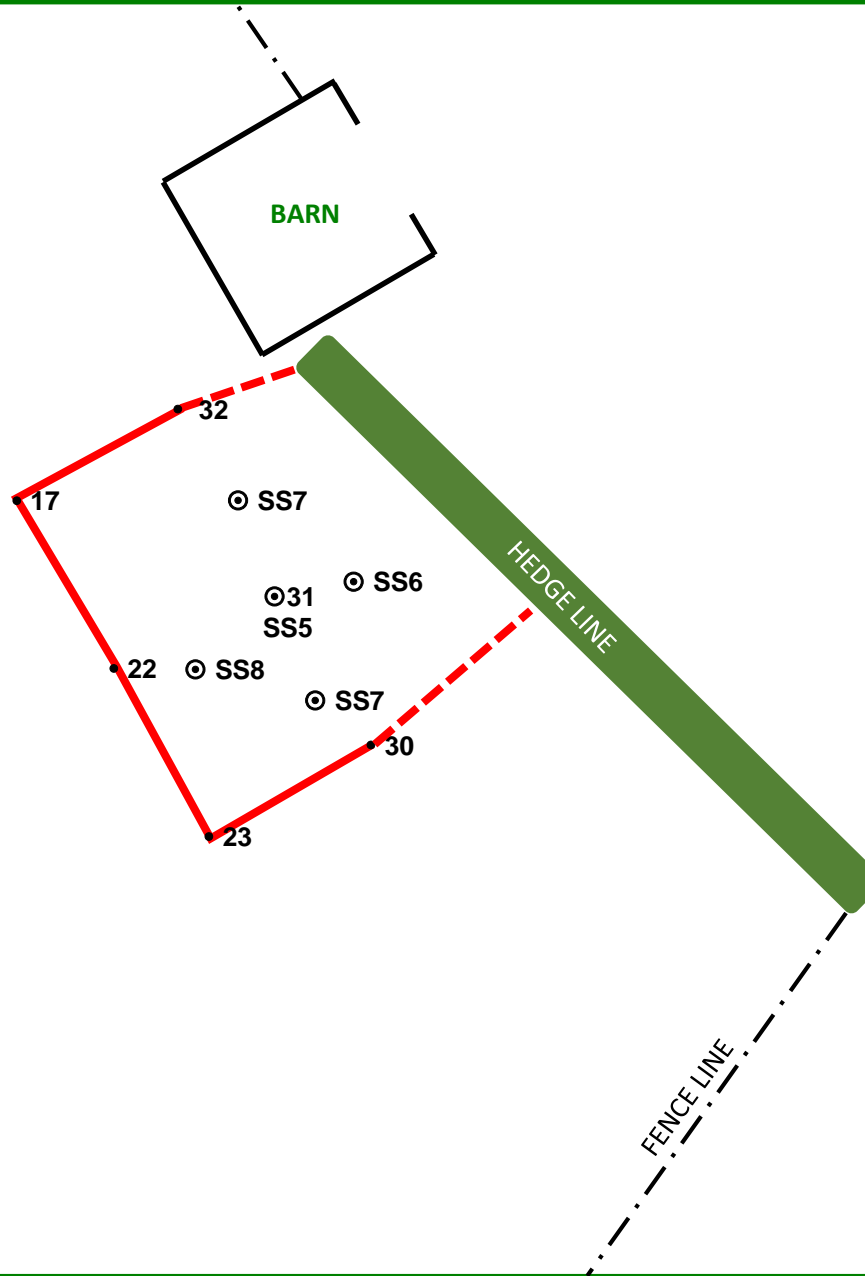
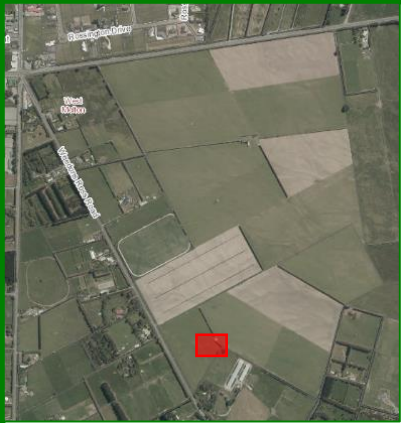
Wilfield Homestead Remediation Plan  
 Cnr West Coast & Weedons Ross Rds, West Melton

The results of the DSI found that the rural/residential 25% produce soil guideline value (SGV) for lead of 160mg/kg, was exceeded in four sample locations. Further testing of deeper samples at SS5 showed that lead levels reduced to below SGV by 450mm. Lead levels at the four locations varied from 178mg/kg to 320mg/kg.

The validation sample plan included in **Appendix A** shows the extent of the contaminated area, and the extent of the mixed area and stockpile.

The remediation option chosen for the homestead area was mixing of the soils. Mixing the soils with clean soils to dilute was considered to be the most viable option for the lead contaminated soils at the former homestead. This was because the contaminant levels are not very high, do not extend very deep and there is adequate area and available clean soil for this option to be successful.

- Strip the affected soils to a depth of approximately 300mm to 400mm using a motor scraper with an elevating paddle, in a pattern of stripes. The scraper will traverse along the contaminated area and then extend out beyond into clean soils for a distance of at least double the contaminated area.

- Soils will be laid down in a linear stockpile in 50mm layers.
- Once validation by XRF confirms the goal contaminant level for lead of 160mg/kg has been met, samples will be taken for lab analysis.

- When lab results have confirmed that all the contaminated material has been removed, the stockpile of mixed soils will be returned to the excavated area, once again using a motor scraper with an elevating paddle to mix the soils again.

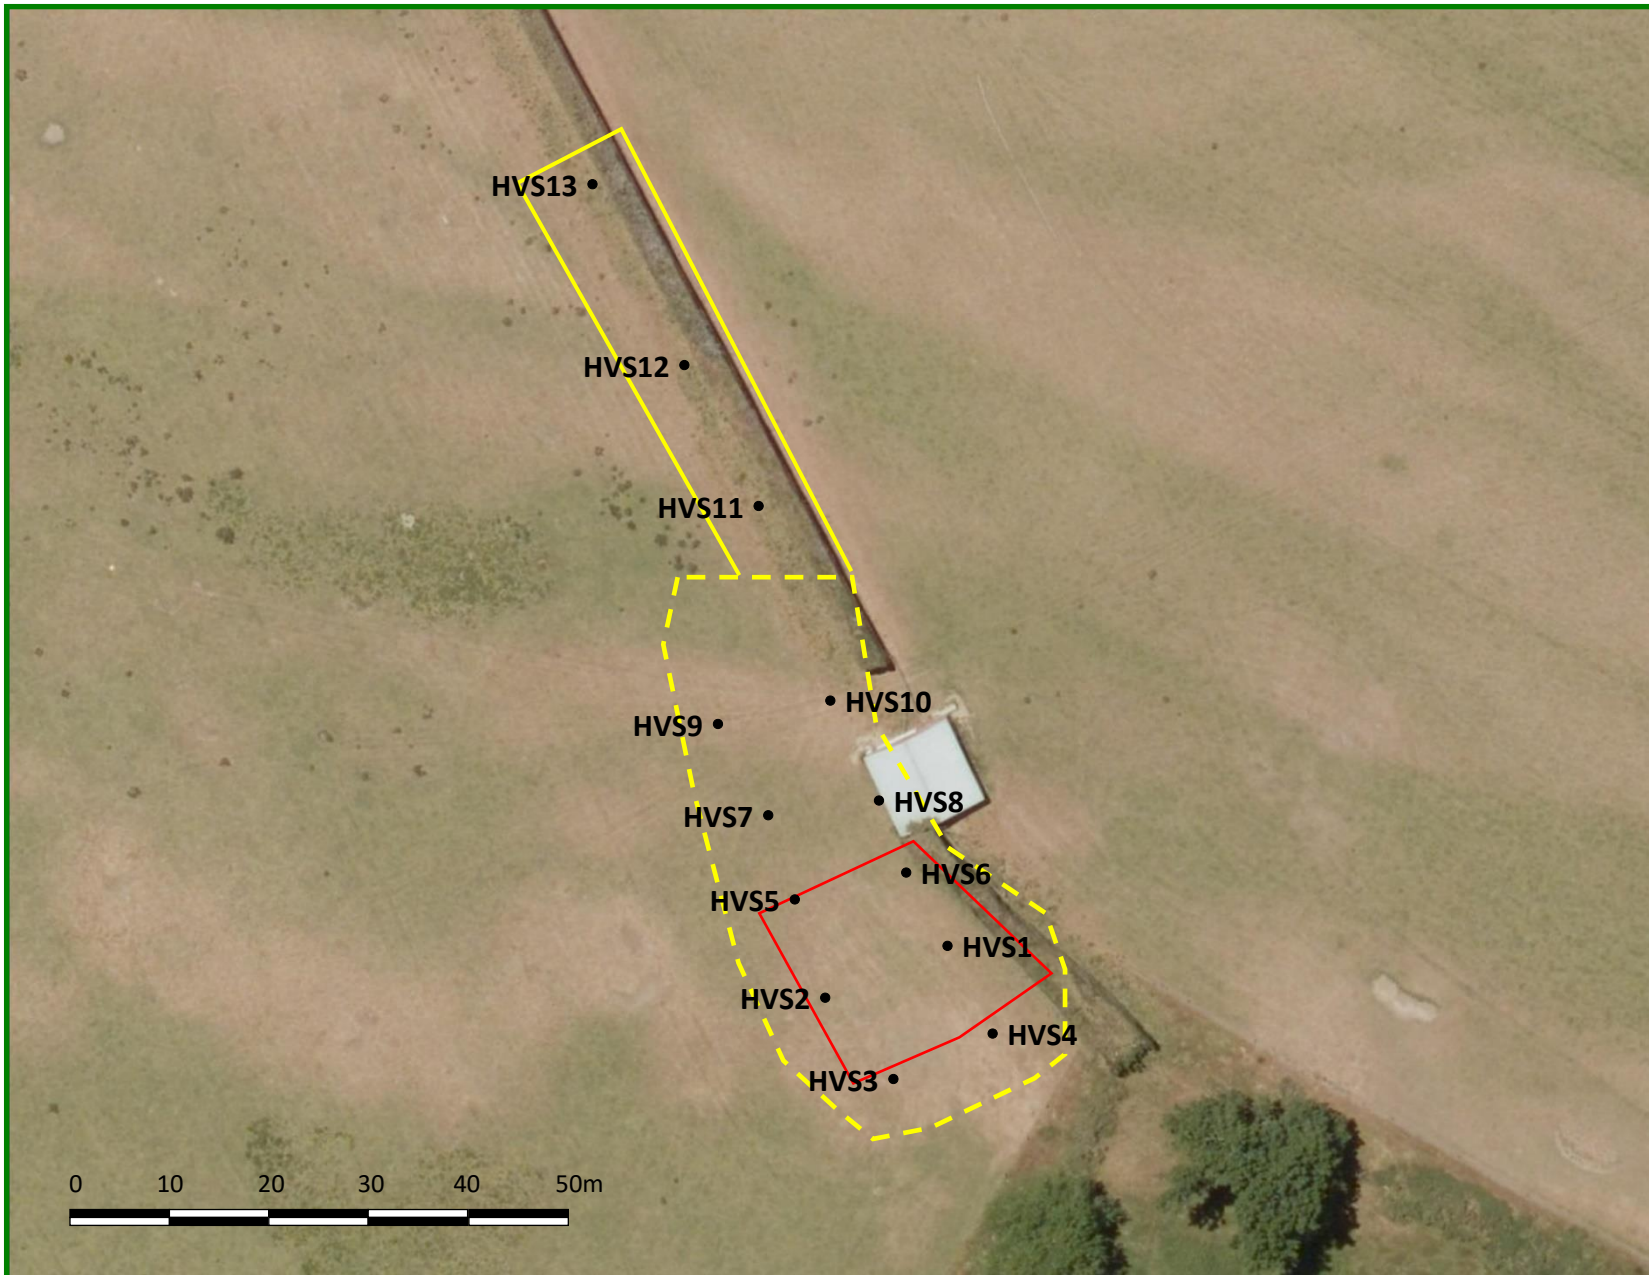
**Validation Sample Location Plan**  
 Wilfield – Homestead Area

the excavated surface was not completed. However, it was evident from the depth of loose mixed soils that a depth of at least 300mm had been involved in the mixing process. The soils had been stripped off an area extending beyond the contaminated extent and at least double the distance of the contaminated area. The soil was excavated in layers, in a series of strips using a motor scraper with an elevating paddle which mixes the soils. The soils were laid out into a longitudinal stockpile. The soils were then replaced in layers in a similar manner.

On the 19<sup>th</sup> October, 2016 a total of ten validation samples were taken from the area of excavation around the contaminated area. The soils were loose and appeared to be well mixed. Samples were taken from a range of depths. An additional three samples were taken from the surface in the area used for stockpiling the mixed soils during remediation. All samples were tested for arsenic and lead at Hill Laboratory.

All thirteen samples taken in the contaminated area, and the area where the soil was stockpiled, returned results below the rural residential SGVs. Results for arsenic were all below expected background levels. Results for lead were consistently around 40-90mg/kg indicating the mixing of soils had been relatively consistent. The highest result of 131 mg/kg was from the base of the stockpiled area. Although the base of the excavation was not tested prior to the mixed soils being replaced, it is considered that due to the relatively low level of contamination found at depth during the DSI, the evident depth of mixing, and the good results for the mixed soils, that no further actions or investigations are necessary.

The remediation actions in the former homestead area were considered to be successful with all validation samples of the mixed soils returning results below the rural residential 25%

produce SGVs for arsenic and lead. The area is now deemed to be suitable for rural residential use, with no further actions or investigations required.
