Geotechnical Completion Report

**Stages 1 to 6, Falcons View Subdivision, 153 Lincoln Rolleston Road,
Rolleston**

Issue Date: **28 November 2023**

Miyamoto Ref: **2003576-RP-001[A]**

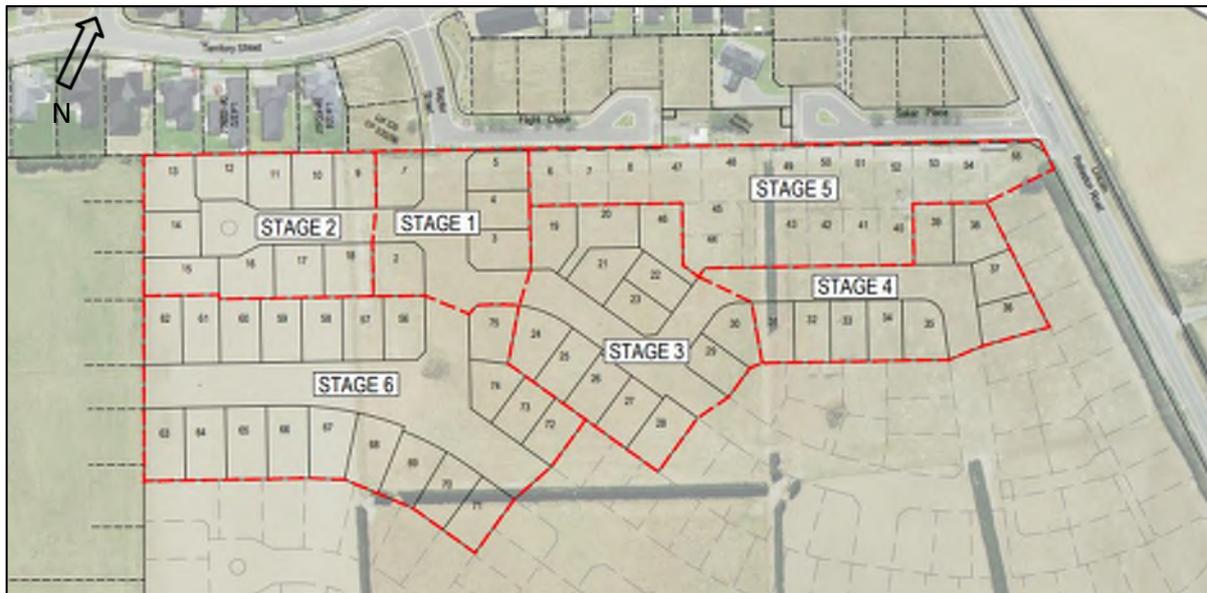
Figure 1: Site location and layout (BASE co, 15/04/23)

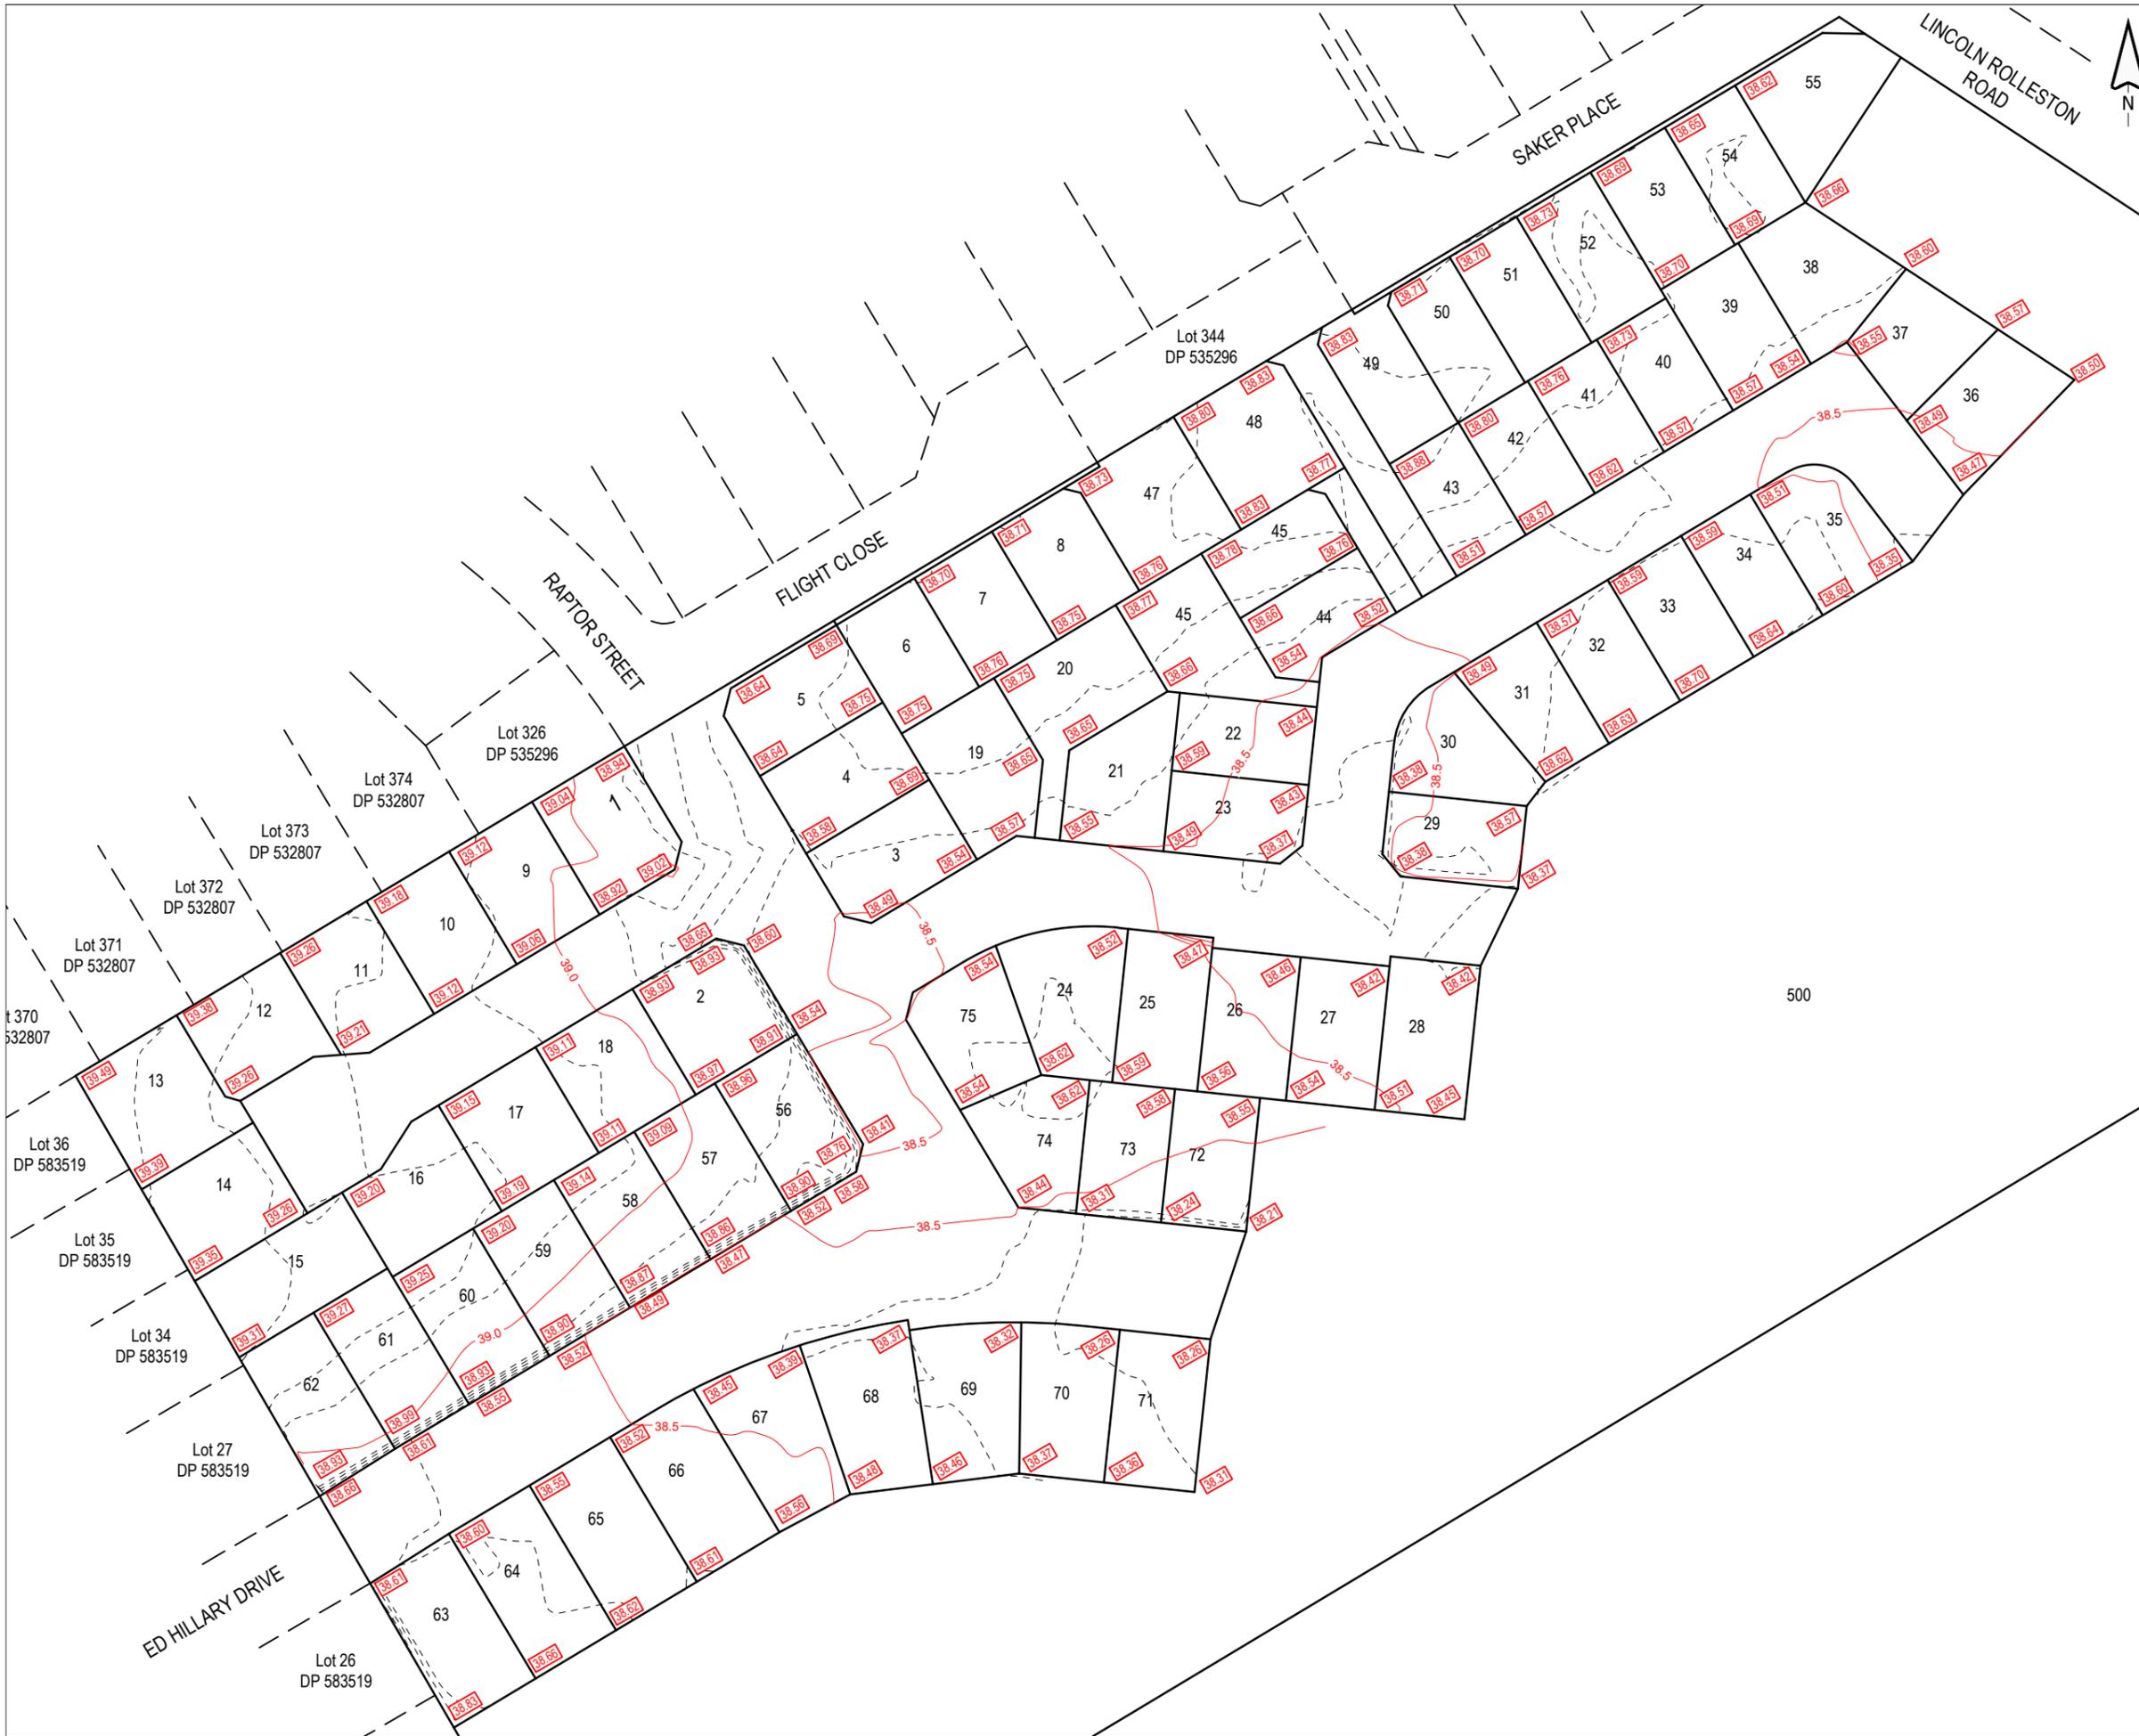
CLIENT		
YOURSECTION FV LTD		
PROJECT		
FALCONS VIEW - STAGE 1-6		
DRAWING TITLE		
ASBUILT PLAN EARTHWORKS FINISHED LEVELS AND CONTOURS		
STATUS	SCALE	SIZE
FOR INFORMATION	1:1250	A3
PROJECT	DRAWING NO	REVISION
1041-1	AB-01	A

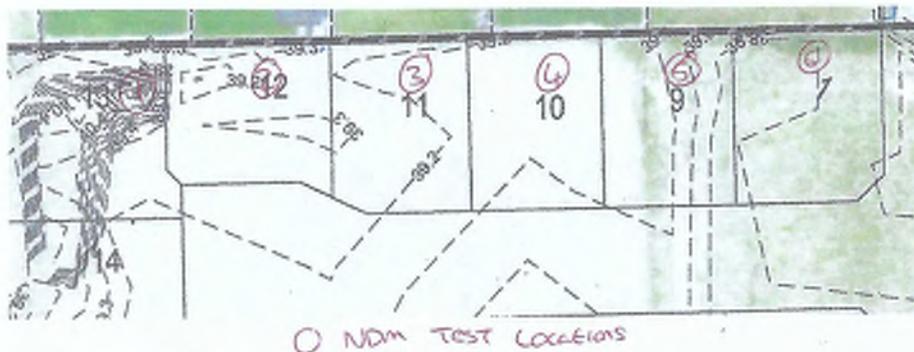
Ndm test Locations
 not to scale

Site No	Depth (mm)	Moisture (%)	Wet Density (t/m ³)	Dry Density (t/m ³)	Relative Compaction (%)
1	200	15.5	2.17	1.88	107
2	200	15.5	2.03	1.74	100
3	200	16.1	2.12	1.82	104
4	200	19.2	2.10	1.76	100
5	200	12.4	2.16	1.92	109
6	200	11.7	2.15	1.92	109

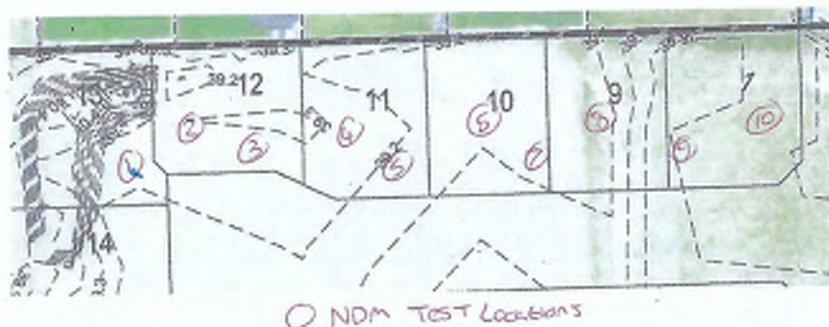
Ndm test Locations
 not to scale

Testing Details		Compaction Target Details	
Site Tested: Fill Lot 1, 9 to 13 Final layer		Material Sample ID: External	
Date: 23/08/2023	Time: 16.00	Max. Dry Density: 1.76 (t/m ³) @ 16.0 %	
Material: Silt		Min. Dry Density (t/m ³): 1.67	
Field methods: NZS 4407:2015 Test 4.2		Solid density: Assumed	
Moisture Content Determined by Ndm

Site No	Depth (mm)	Moisture (%)	Wet Density (t/m ³)	Dry Density (t/m ³)	Relative Compaction (%)
1	200	12.2	2.04	1.81	102
2	200	13.9	2.22	1.95	110
3	200	10.3	2.07	1.88	105
4	200	20.8	2.11	1.75	98
5	200	20.1	2.11	1.76	99
6	200	17.4	2.11	1.80	101
7	200	11.6	2.08	1.82	102
8	200	18.0	2.11	1.79	100
9	200	14.4	2.05	1.79	101
10	200	13.5	2.18	1.92	108

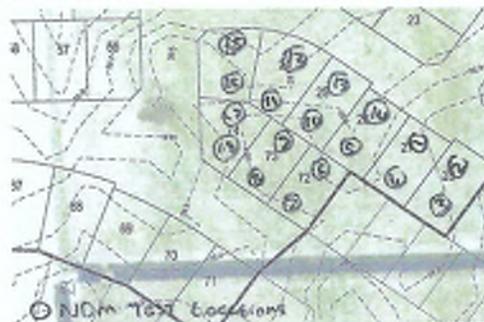
Ndm test Locations
 not to scale

Site No	Depth (mm)	Moisture (%)	Wet Density (t/m ³)	Dry Density (t/m ³)	Relative Compaction (%)
1	200	19.0	2.14	1.80	102
2	200	17.4	2.02	1.72	98
3	200	17.9	2.06	1.75	100
4	200	14.8	2.06	1.79	102
5	200	14.5	2.11	1.84	105
6	200	15.9	2.07	1.79	102
7	200	17.3	2.06	1.75	100
8	200	15.5	2.06	1.79	101
9	200	14.8	2.12	1.85	105
10	200	13.9	2.05	1.80	102
11	200	20.5	2.06	1.71	97
12	200	18.9	2.10	1.76	100
13	200	19.4	2.05	1.72	98
14	200	19.5	2.13	1.78	101
15	200	19.1	2.08	1.75	99
16	200	18.7	2.09	1.76	100
17	200	18.2	2.09	1.77	101
18	200	18.6	2.09	1.76	100

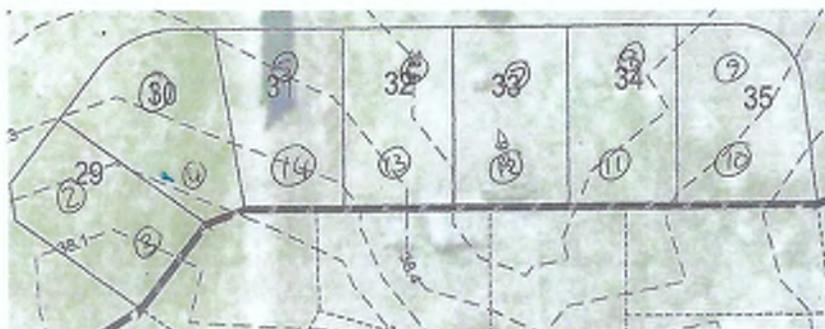
Ndm test Locations
 not to scale

Site No	Depth (mm)	Moisture (%)	Wet Density (t/m ³)	Dry Density (t/m ³)	Relative Compaction (%)
1	200	17.5	2.09	1.78	101
2	200	15.9	2.10	1.81	103
3	200	14.1	2.18	1.91	109
4	200	14.9	2.14	1.86	106
5	200	18.5	2.10	1.77	101
6	200	16.3	1.99	1.71	97
7	200	11.0	2.13	1.87	106
8	200	13.1	2.15	1.70	108
9	200	14.8	2.08	1.81	103
10	200	18.3	2.07	1.75	100
11	200	16.0	2.08	1.78	101
12	200	16.6	2.09	1.79	102
13	200	14.1	2.15	1.88	106
14	200	15.2	2.13	1.85	105

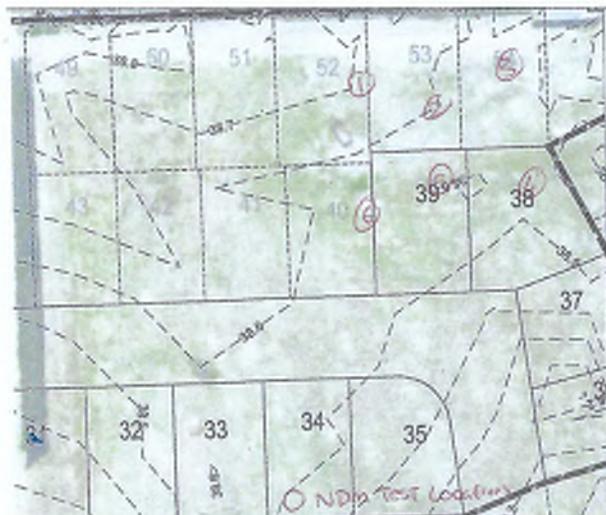
Ndm test Locations
 not to scale

Site No	Depth (mm)	Moisture (%)	Wet Density (t/m ³)	Dry Density (t/m ³)	Relative Compaction (%)
1	200	16.3	1.97	1.70	96
2	200	13.6	1.97	1.73	98
3	200	12.1	1.99	1.78	101
4	200	14.0	1.99	1.75	99
5	200	12.7	2.00	1.78	101
6	200	12.8	1.99	1.76	100

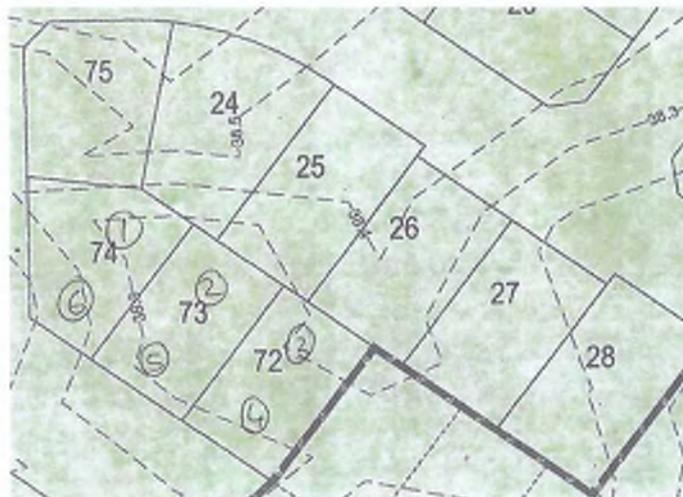
Ndm test Locations
 not to scale

Site No	Depth (mm)	Moisture (%)	Wet Density (t/m^3)	Dry Density (t/m^3)	Relative Compaction (%)
1	200	13.5	2.09	1.84	105
2	200	11.5	1.97	1.72	98
3	200	13.5	1.94	1.71	97
4	200	11.5	2.19	1.92	108
5	200	15.9	2.14	1.85	105
6	200	14.7	1.95	1.70	97

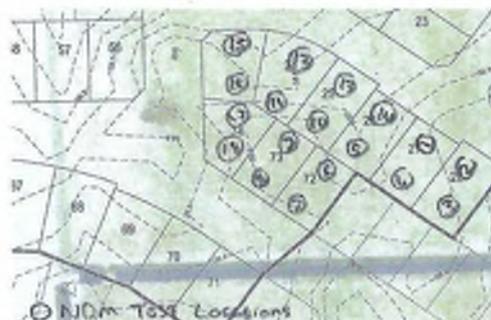
Ndm test Locations
 not to scale

Site No	Depth (mm)	Moisture (%)	Wet Density (t/m ³)	Dry Density (t/m ³)	Relative Compaction (%)
1	200	19.0	2.14	1.80	102
2	200	17.4	2.02	1.72	98
3	200	17.9	2.06	1.75	100
4	200	14.8	2.06	1.79	102
5	200	14.5	2.11	1.84	105
6	200	15.9	2.07	1.79	102
7	200	17.3	2.06	1.75	100
8	200	15.5	2.06	1.79	101
9	200	14.8	2.12	1.85	105
10	200	13.9	2.05	1.80	102
11	200	20.5	2.06	1.71	97
12	200	18.9	2.10	1.76	100
13	200	19.4	2.05	1.72	98
14	200	19.5	2.13	1.78	101
15	200	19.1	2.08	1.75	99
16	200	18.7	2.09	1.76	100
17	200	18.2	2.09	1.77	101
18	200	18.6	2.09	1.76	100

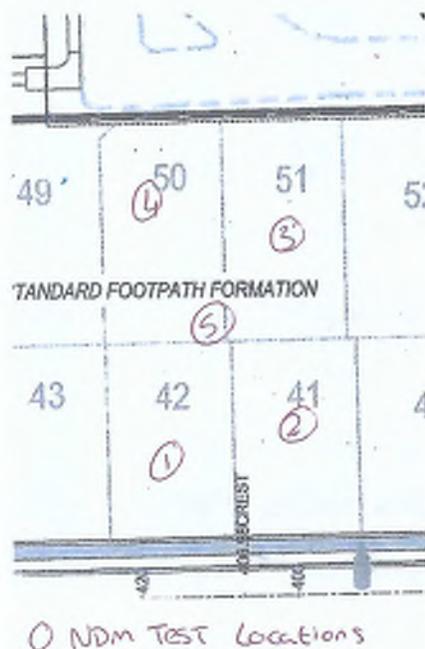
Ndm test Locations
 not to scale

Testing Details		Compaction Target Details	
Site Tested: Lot 41,42,50,51 Old rubbish Tip Backfill Final Layer	Material Sample ID: External		
Date: 30/08/2023	Time: 11.46	Max. Dry Density: 1.76 (t/m ³) @ 16.0 %	
Material: Silt	Min. Dry Density (t/m ³): 1.67		
Field methods: NZS 4407:2015 Test 4.2	Solid density: Assumed		
Moisture Content Determined by Ndm

Site No	Depth (mm)	Moisture (%)	Wet Density (t/m ³)	Dry Density (t/m ³)	Relative Compaction (%)
1	200	17.3	2.09	1.78	101
2	200	18.9	2.09	1.76	100
3	200	13.5	2.18	1.92	109
4	200	15.3	2.04	1.76	101
5	200	13.0	2.05	1.81	103

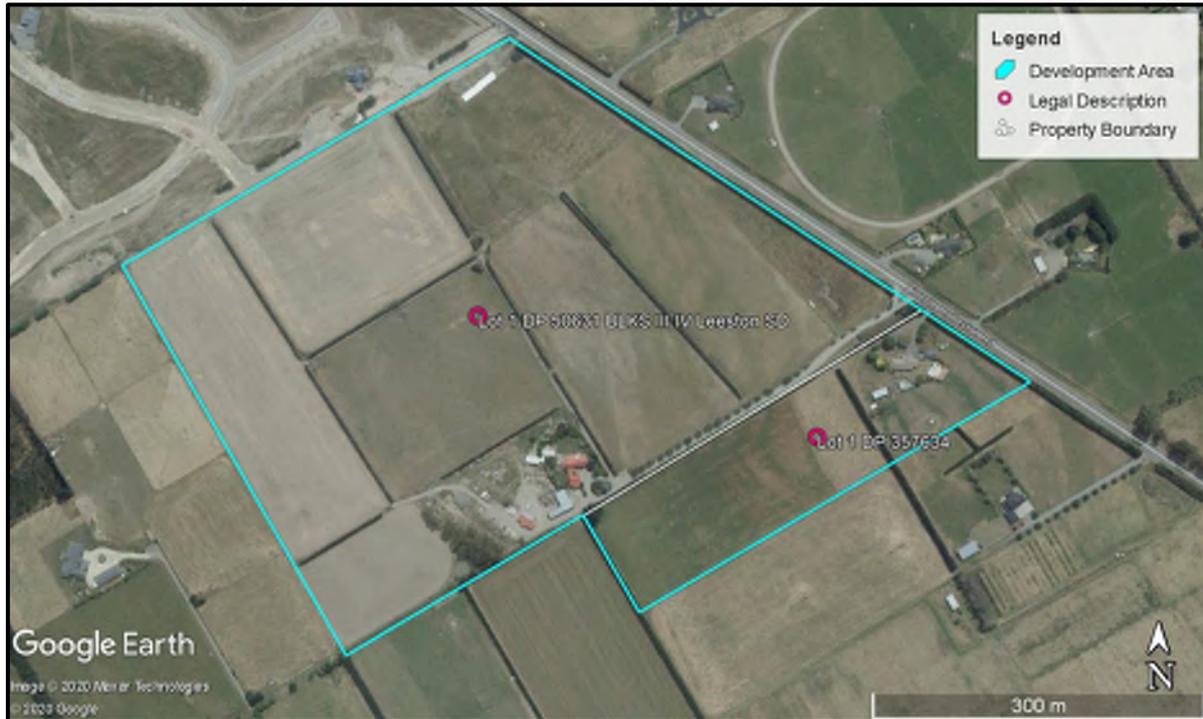
Figure 1: Site Location / Layout Plan

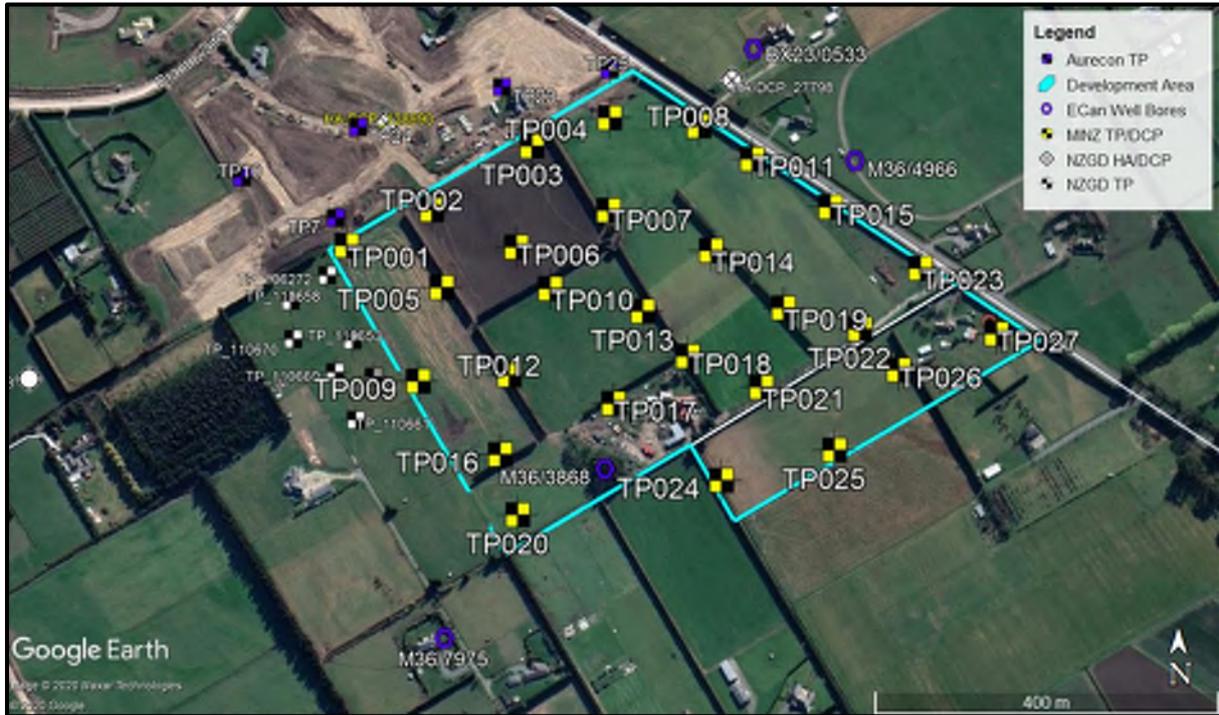
Figure 2: Ground Investigation Location Plan

The test locations are shown in Figure 2, the general details of the ground investigations are summarised in Table 1, and the engineering and well bore logs are presented in Appendix A.

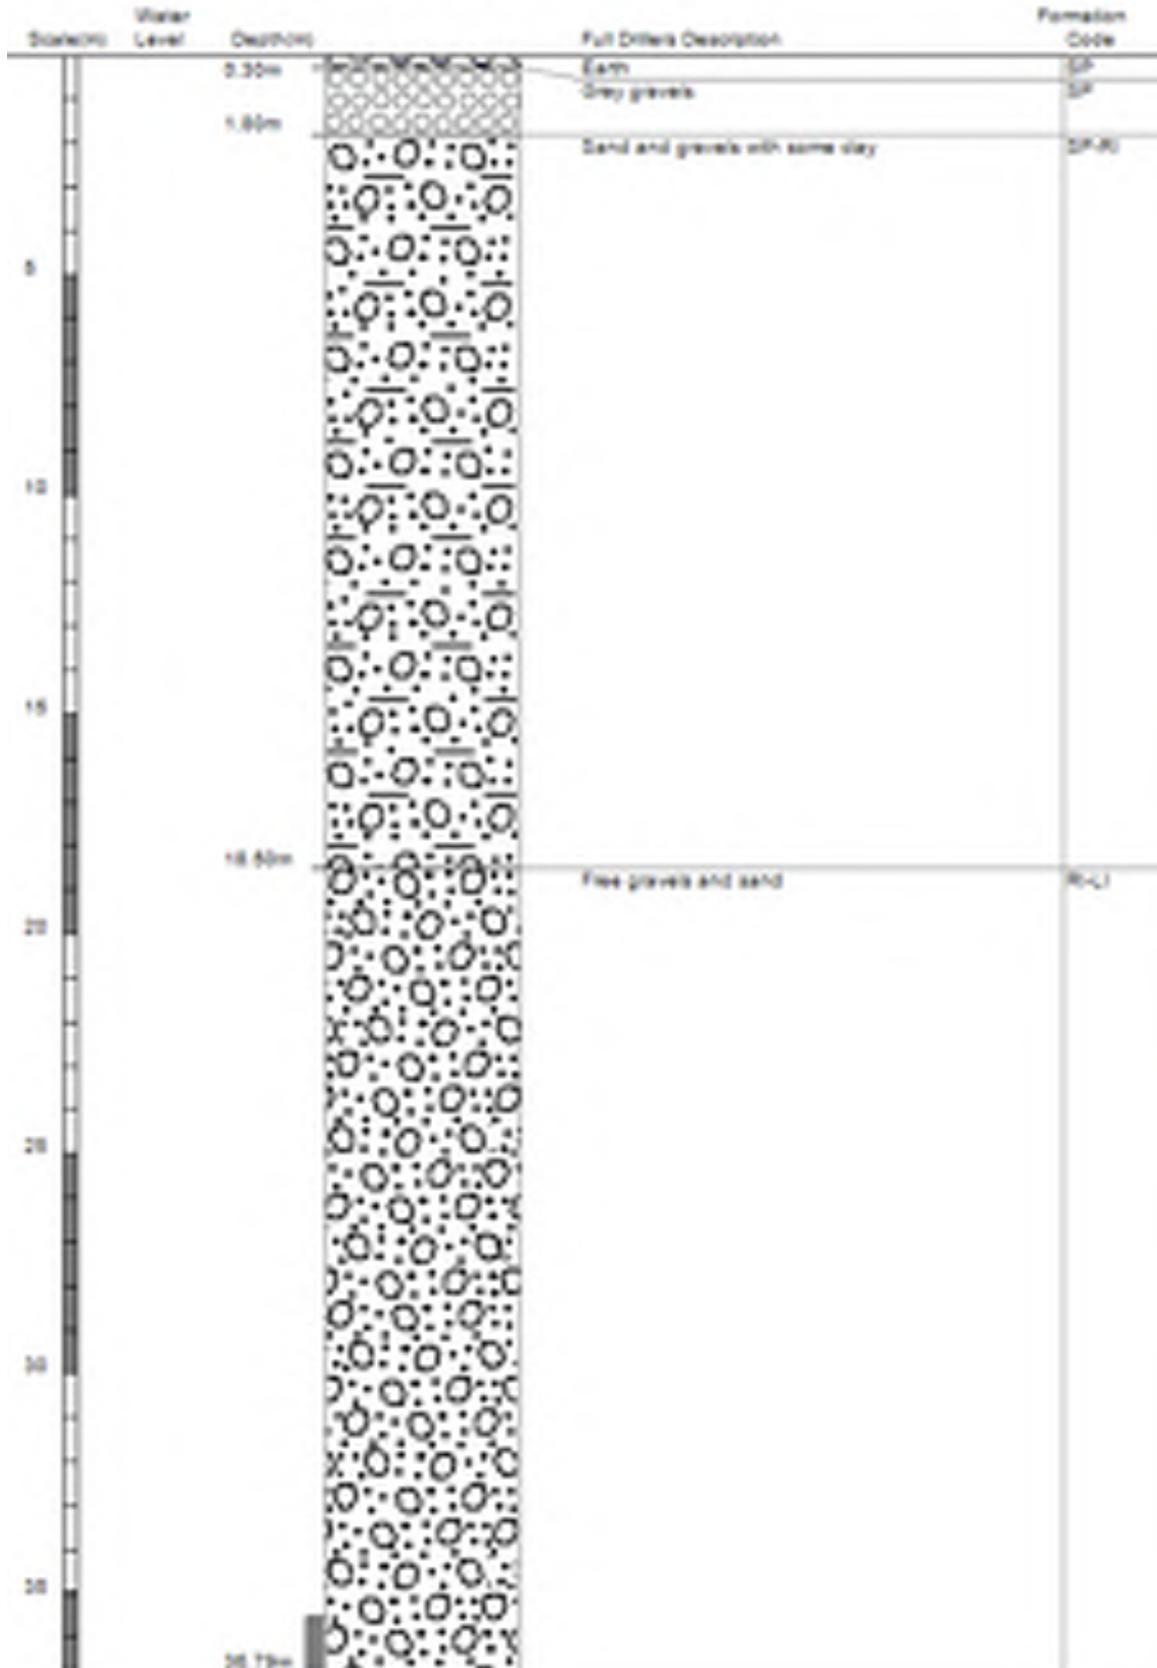
Borelog for well M36/7976

Grid Reference (NZTM): 1552317 mE, 5171001 mN
 Location Accuracy: 50 - 300m
 Ground Level Altitude: 37.7 m +MSD Accuracy: < 2.5 m
 Driller: Dynes Road Drilling
 Drill Method: Cable Tool
 Borelog Depth: 37.5 m Drill Date: 05-Sep-2005

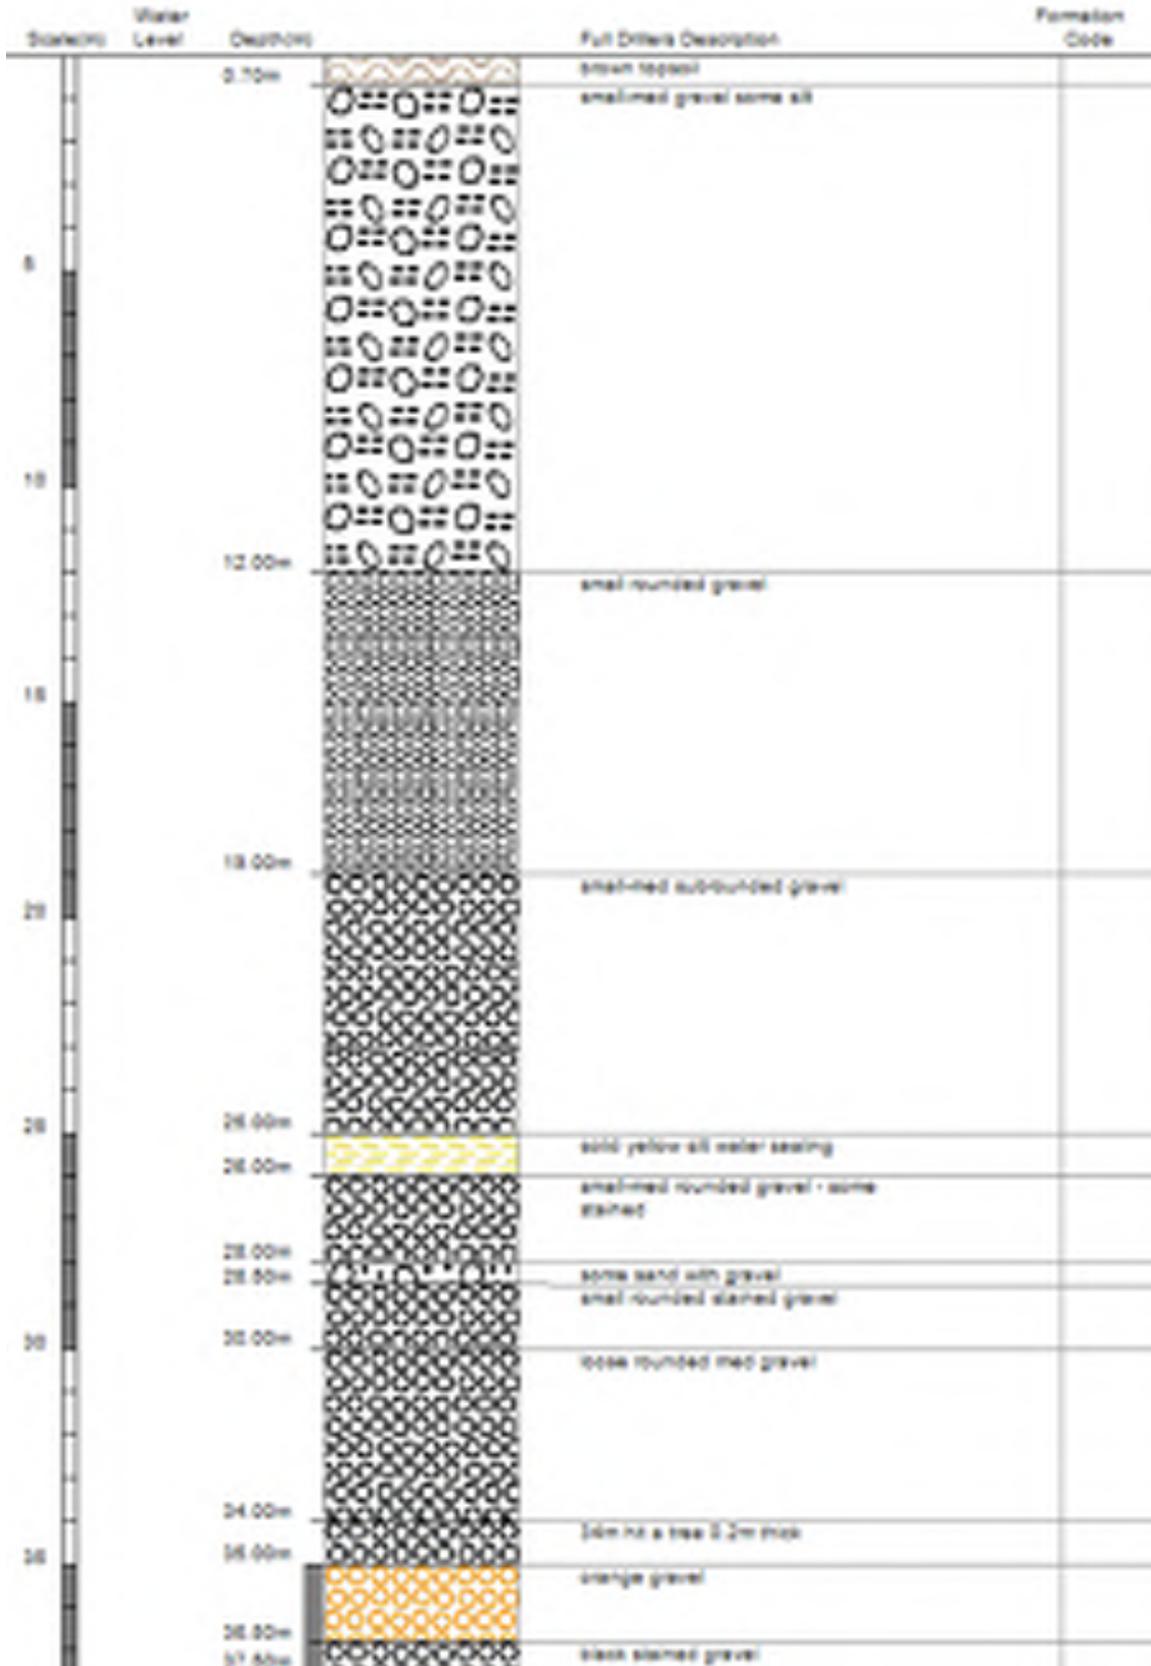
Borelog for well M36/4966

Grid Reference (NZTM): 1552787 mE, 5171568 mN
 Location Accuracy: 50 - 200m
 Ground Level Altitude: 38.8 m +MSD Accuracy: < 2.5 m
 Driller: McMillan Drilling Ltd
 Drill Method: Rotary/Percussion
 Borelog Depth: 48.5 m Drill Date: 18-Aug-1995

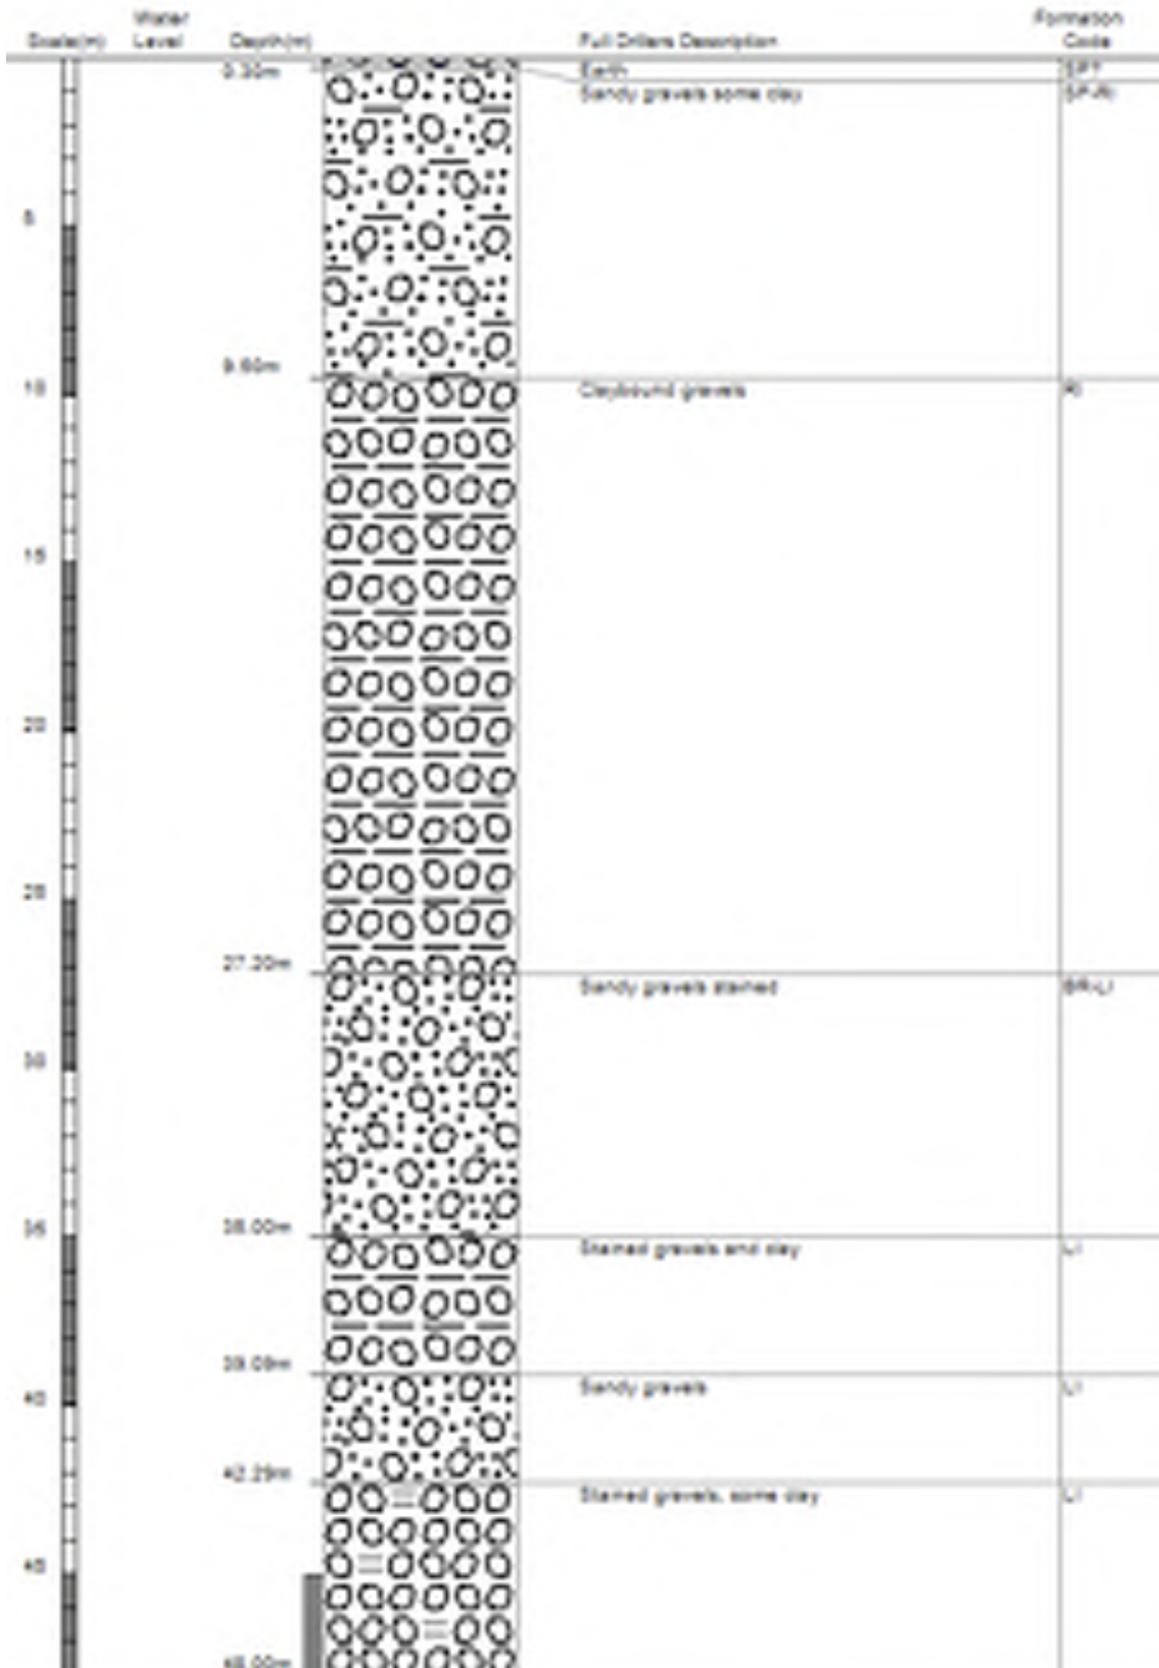
Borelog for well BX23/0533

Grid Reference (NZTM): 1552674 mE, 5171682 mN
 Location Accuracy: 10 - 50m
 Ground Level Altitude: m +MSD Accuracy:
 Driller: East Coast Drilling
 Drill Method: Air Rotary
 Borelog Depth: 48.0 m Drill Date: 20-Nov-2015
