Falcons Landing
Geotechnical Subdivision Report
GW Rolleston Limited

16 February 2017
Revision: 2
Reference: 254246

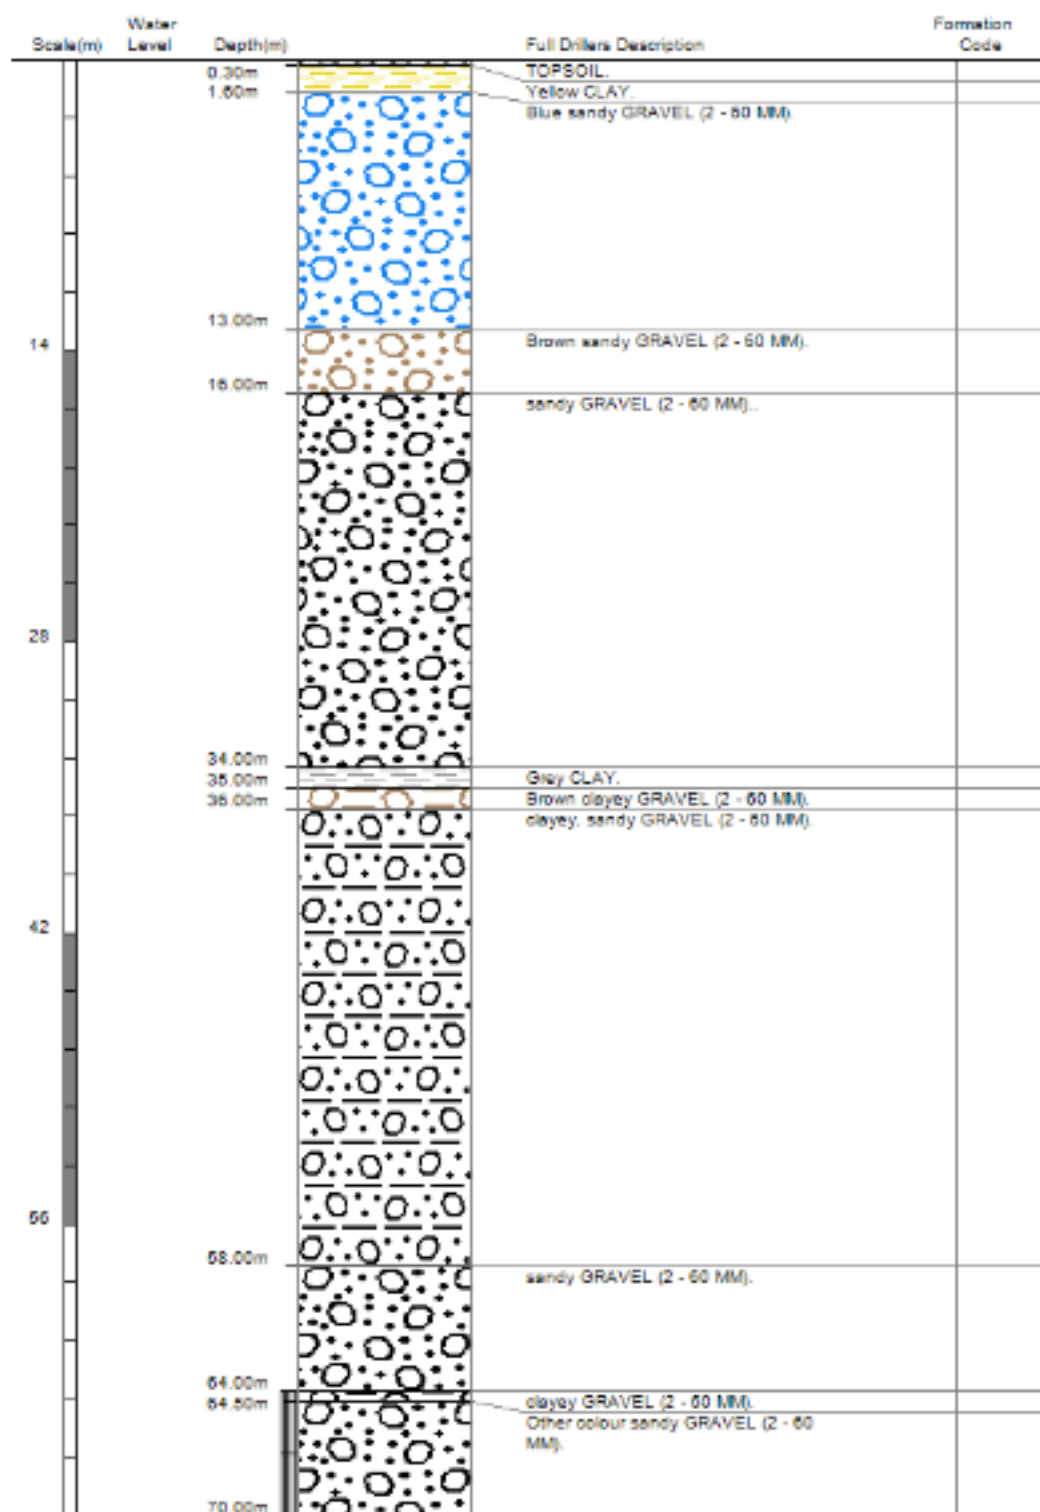
Borelog for well M36/4885

Grid Reference (NZTM): 1540833 mE, 5159272 mN
 Location Accuracy: 10 - 50m
 Ground Level Altitude: 38.2 m +MSD Accuracy: < 2.5 m
 Driller: Smiths Welldrilling
 Drill Method: Rotary/Percussion
 Borelog Depth: 70.0 m Drill Date: 02-Dec-1996

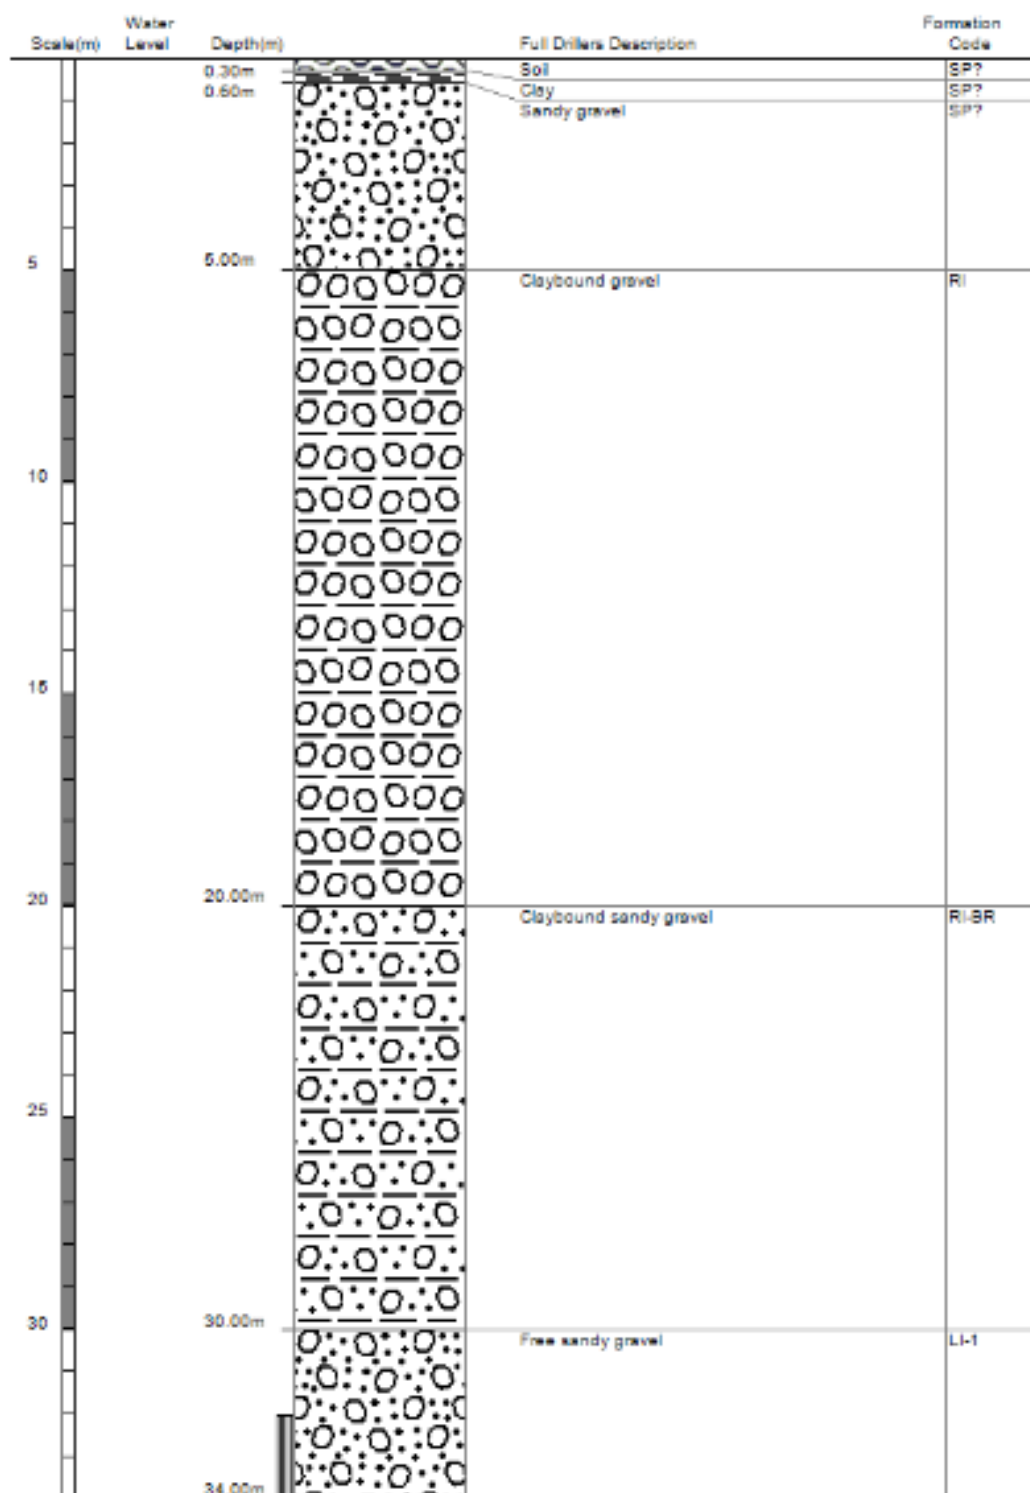
Borelog for well M36/4894

Grid Reference (NZTM): 1552087 mE, 5171830 mN
 Location Accuracy: 50 - 300m
 Ground Level Altitude: 40.5 m +MSD Accuracy: < 2.5 m
 Driller: Smiths Welldrilling
 Drill Method: Rotary Rig
 Borelog Depth: 34.0 m Drill Date: 16-Mar-1995

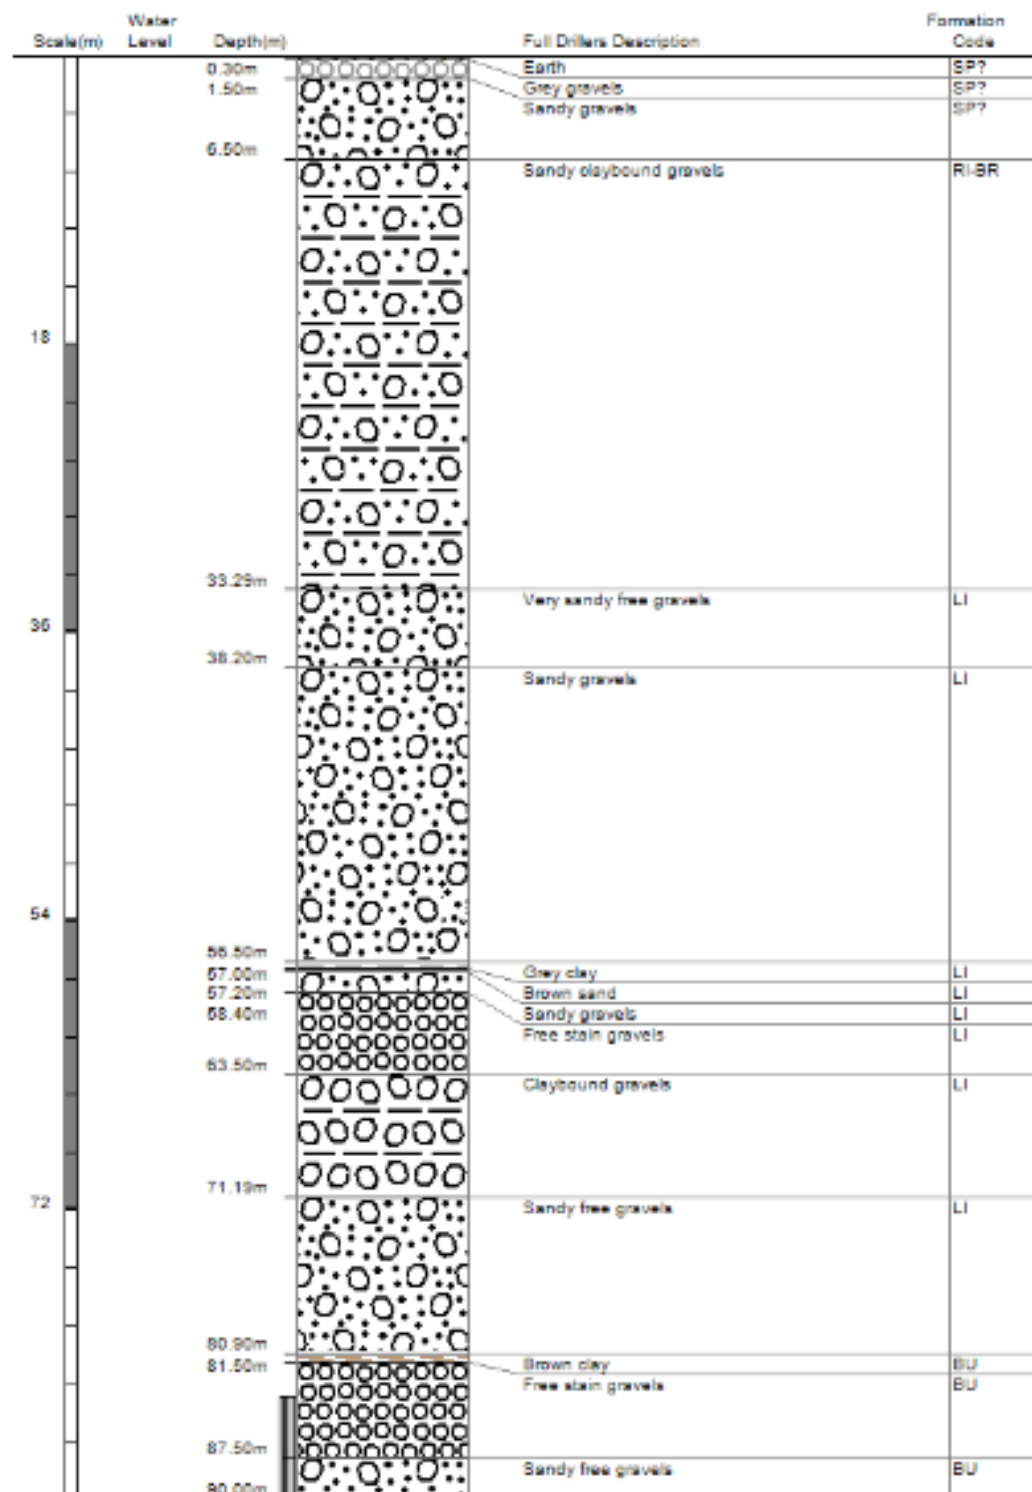
Borelog for well M36/4680

Grid Reference (NZTM): 1552060 mE, 5171738 mN
 Location Accuracy: 1 - 2m
 Ground Level Altitude: 40.3 m +MSD Accuracy: < 2.5 m
 Driller: McMillan Drilling Ltd
 Drill Method: Rotary/Percussion
 Borelog Depth: 90.0 m Drill Date: 11-Mar-1994

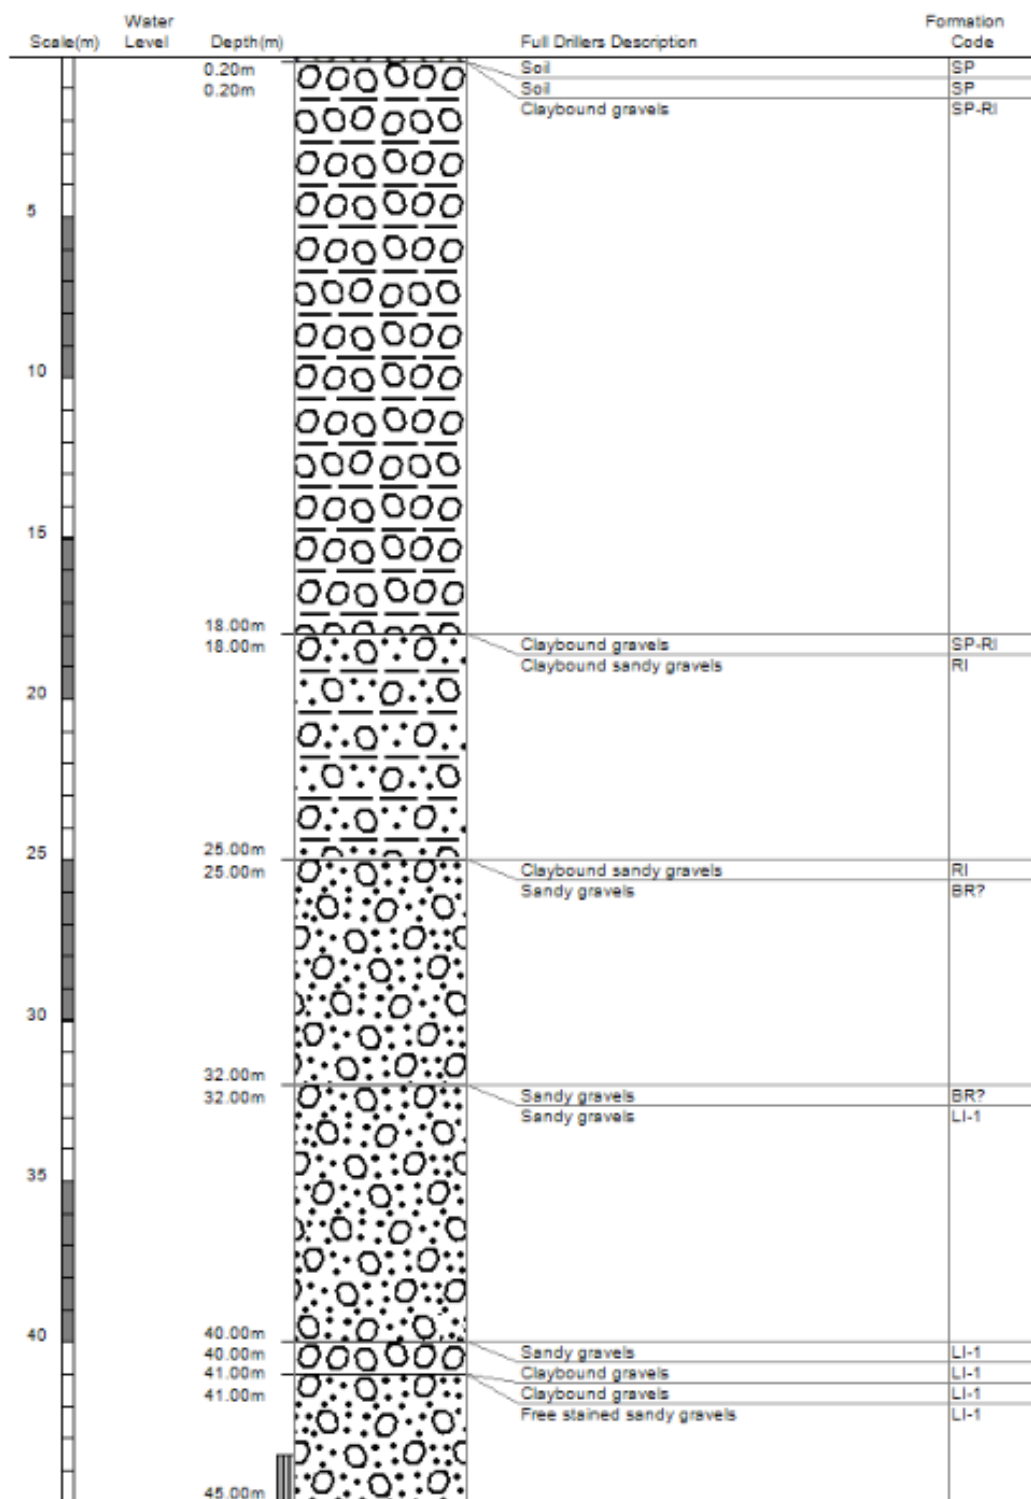
Borelog for well M36/6917

Grid Reference (NZTM): 1553217 mE, 5171820 mN
 Location Accuracy: 10 - 50m
 Ground Level Altitude: 38.1 m +MSD Accuracy: < 0.5 m
 Driller: Smiths Welldrilling
 Drill Method: Rotary Rig
 Borelog Depth: 45.0 m Drill Date: 18-May-2001

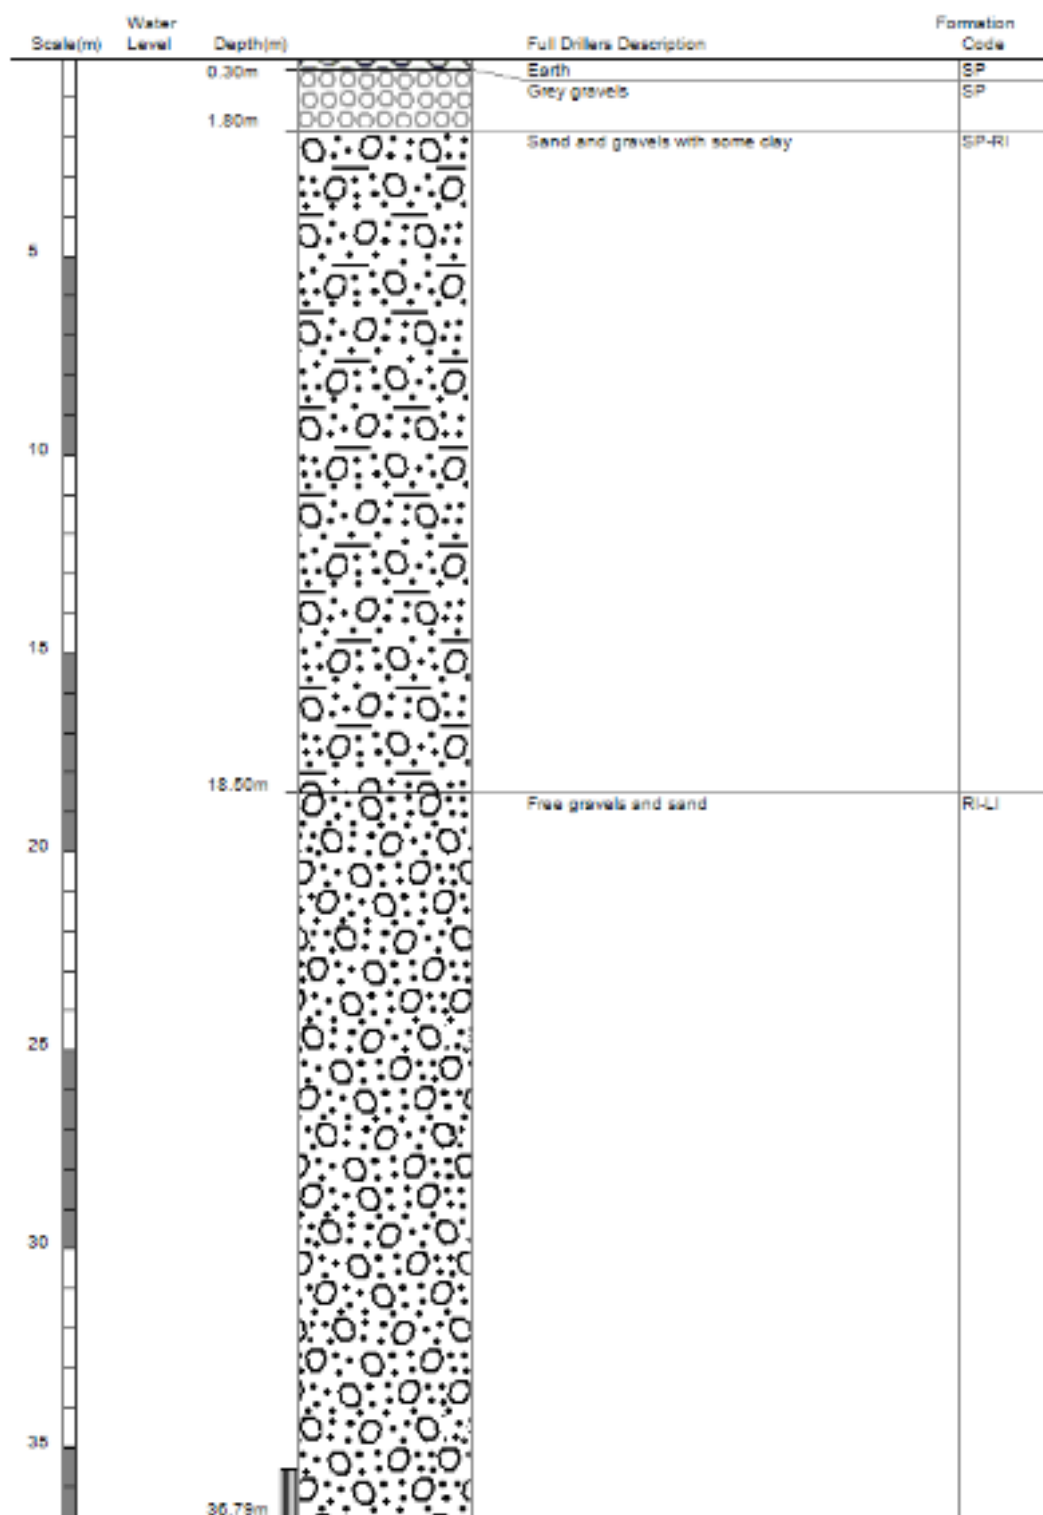
Borelog for well M36/3868

Grid Reference (NZTM): 1552494 mE, 5171203 mN
 Location Accuracy: 10 - 50m
 Ground Level Altitude: 38.4 m +MSD Accuracy: < 2.5 m
 Driller: McMillan Drilling Ltd
 Drill Method: Rotary/Percussion
 Borelog Depth: 36.8 m Drill Date: 18-Jan-1988

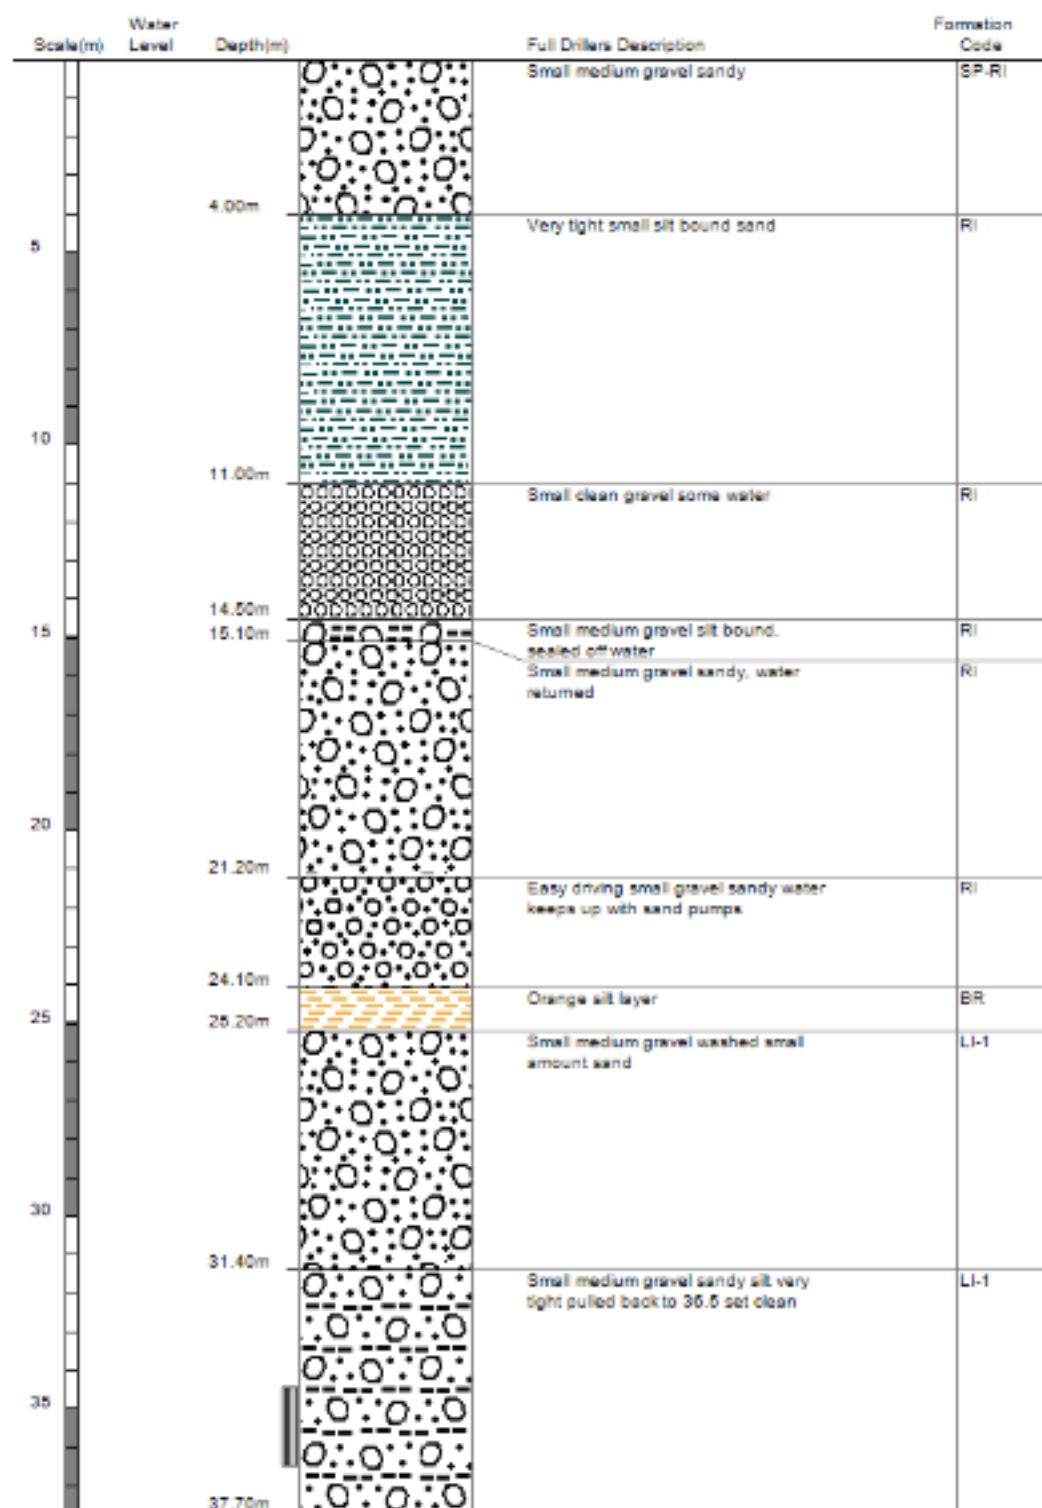
Borelog for well M36/6802

Grid Reference (NZTM): 1551451 mE, 5171282 mN
 Location Accuracy: 2 - 15m
 Ground Level Altitude: 41.1 m +MSD Accuracy: < 2.5 m
 Driller: Dynes Road Drilling
 Drill Method: Cable Tool
 Borelog Depth: 37.7 m Drill Date: 01-Sep-1994

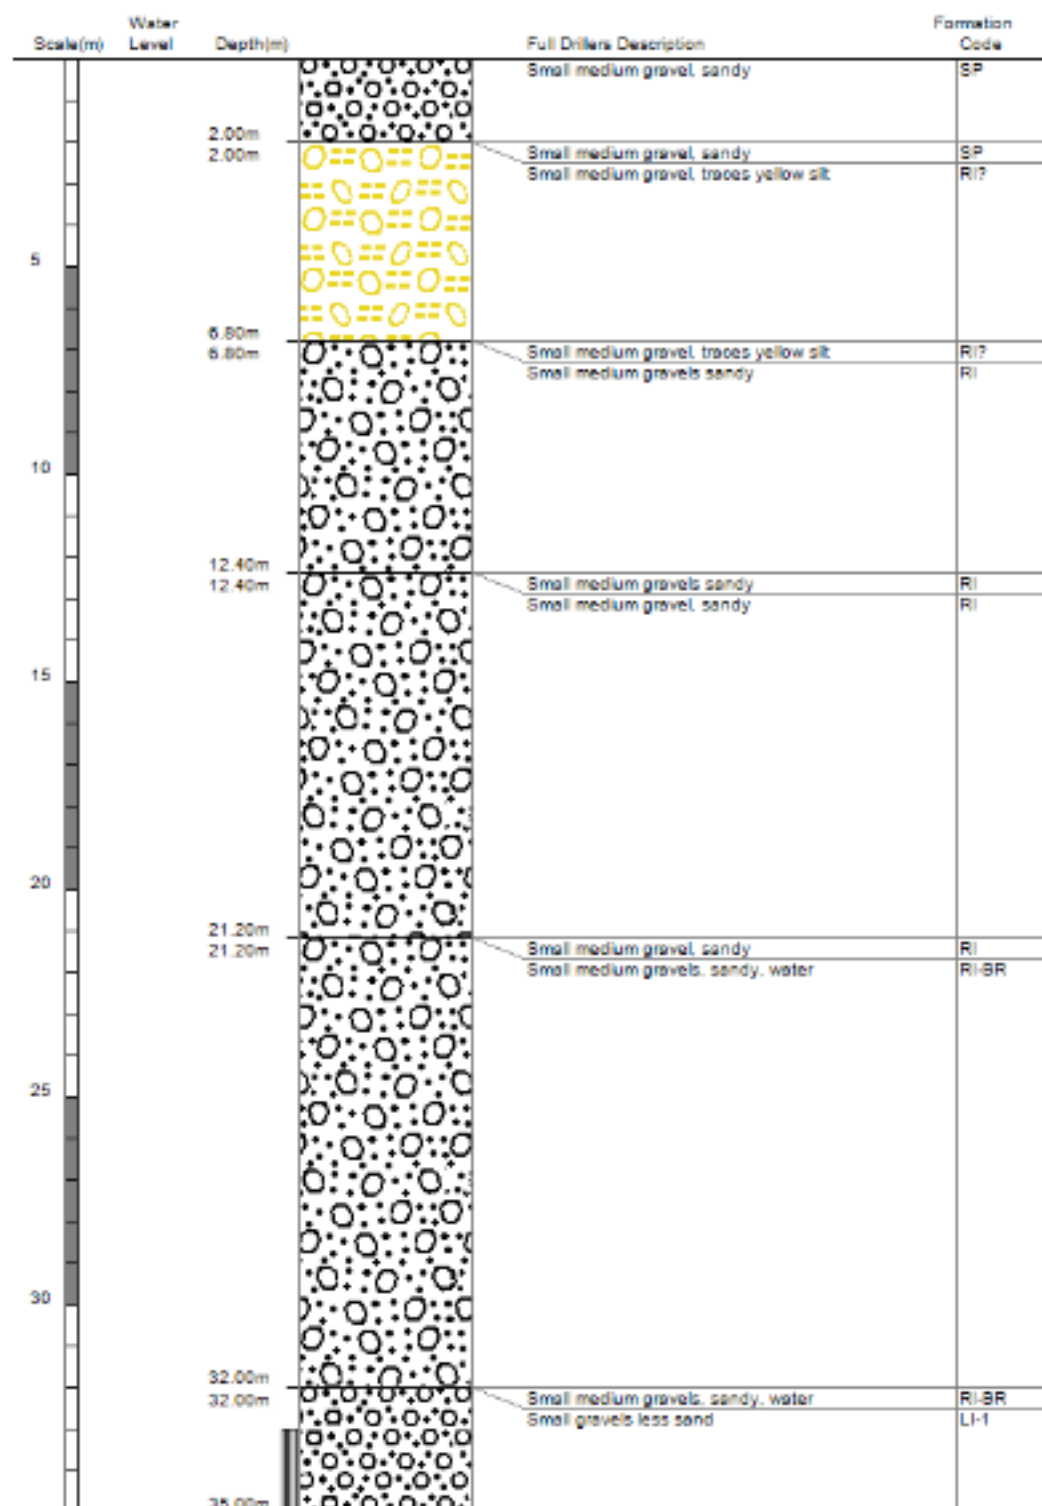
Borelog for well M36/7565

Grid Reference (NZTM): 1551067 mE, 5171240 mN
 Location Accuracy: 50 - 300m
 Ground Level Altitude: 42.2 m +MSD Accuracy: < 0.5 m
 Driller: Dynes Road Drilling
 Drill Method: Cable Tool
 Borelog Depth: 35.0 m Drill Date: 01-Jan-2004

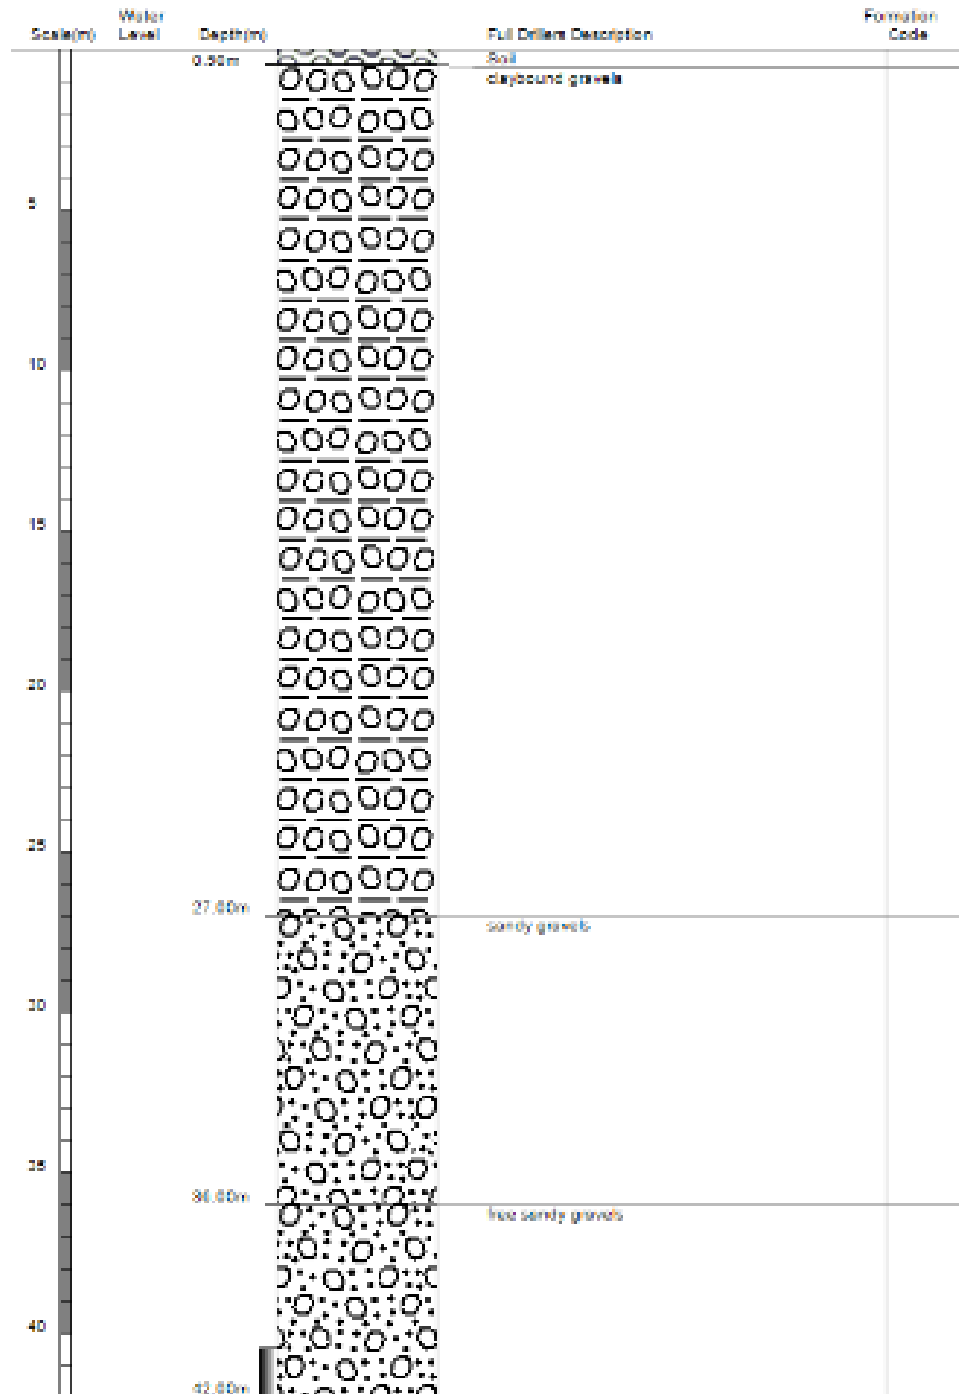
Borelog for well M36/7860

Grid Reference (NZTM): 1550977 mE, 5171720 mN
 Location Accuracy: 50 - 300m
 Ground Level Altitude: 44.7 m +MSD Accuracy: < 2.5 m
 Driller: Smiths Well Drilling
 Drill Method: Rotary Rig
 Borelog Depth: 42.0 m Drill Date: 22-Apr-2005

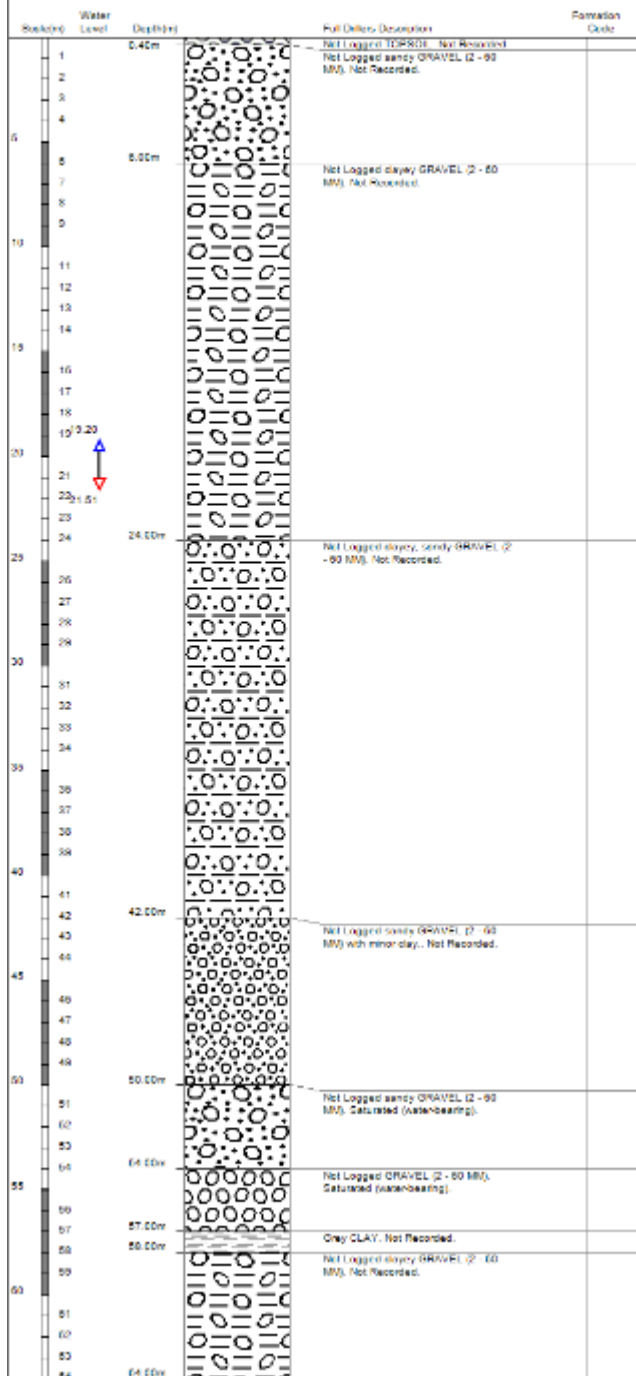
Borelog for well BX23/0508

Grid Reference (NZTM): 1551041 mE, 5172151 mN
 Location Accuracy: 10 - 50m
 Ground Level Altitude: m +MSD Accuracy:
 Driller: McMillan Drilling Ltd
 Drill Method: Rotary Percussion
 Borelog Depth: 211.5 m Drill Date: 02-May-2016
