# Geotechnical Report for Proposed Plan Change

148, 156 & 178 Lincoln Rolleston Road & 487 Weedens Road

Miyamoto Ref: **200357-01-RP-001[B]**

Prepared for: **Yoursection Ltd**

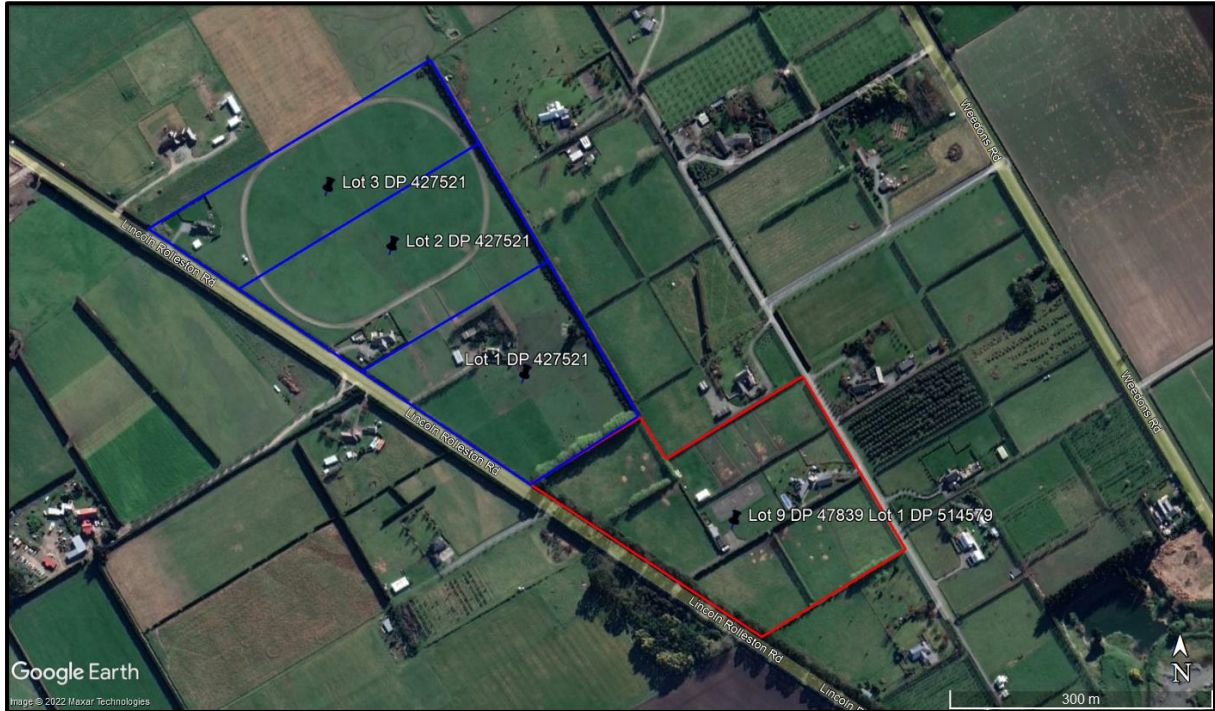
Figure 1: Site Location / Layout Plan

The site (approximately 19 hectares in area) is located in a rural setting in Rolleston, Selwyn, and encompasses the following land parcels (as shown in Figure 1):

The site is predominantly flat with a global elevation difference of ~ 3.0 m (increasing to the north-west). The land is predominantly grass covered farmland with residential dwellings, and auxiliary structures currently occupying three relatively small areas of the proposed development area.
