# Land Information Memorandum

511 Halswell Road

**Christchurch City Council**

**Project: MINZ 19066.01 - Geotechnical Subdivision Evaluation and Assessment**

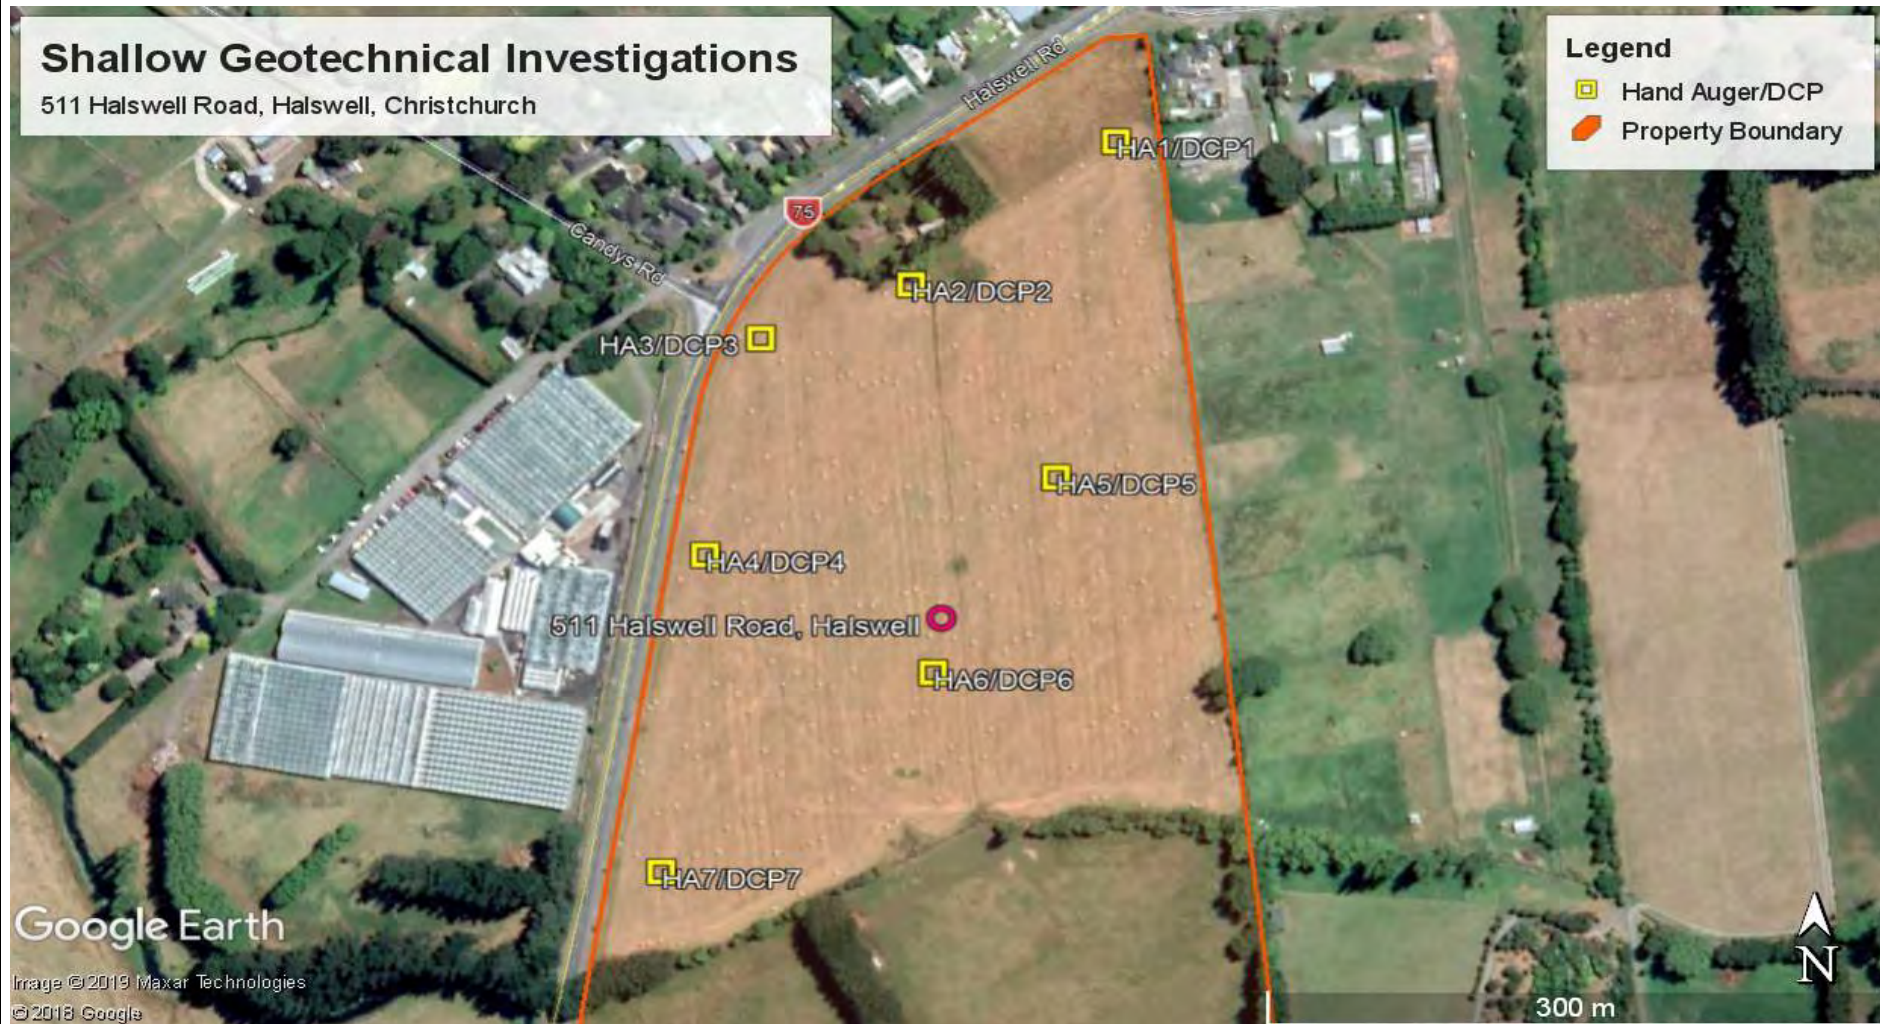
**Legend**

- Hand Auger/DCP
- Property Boundary

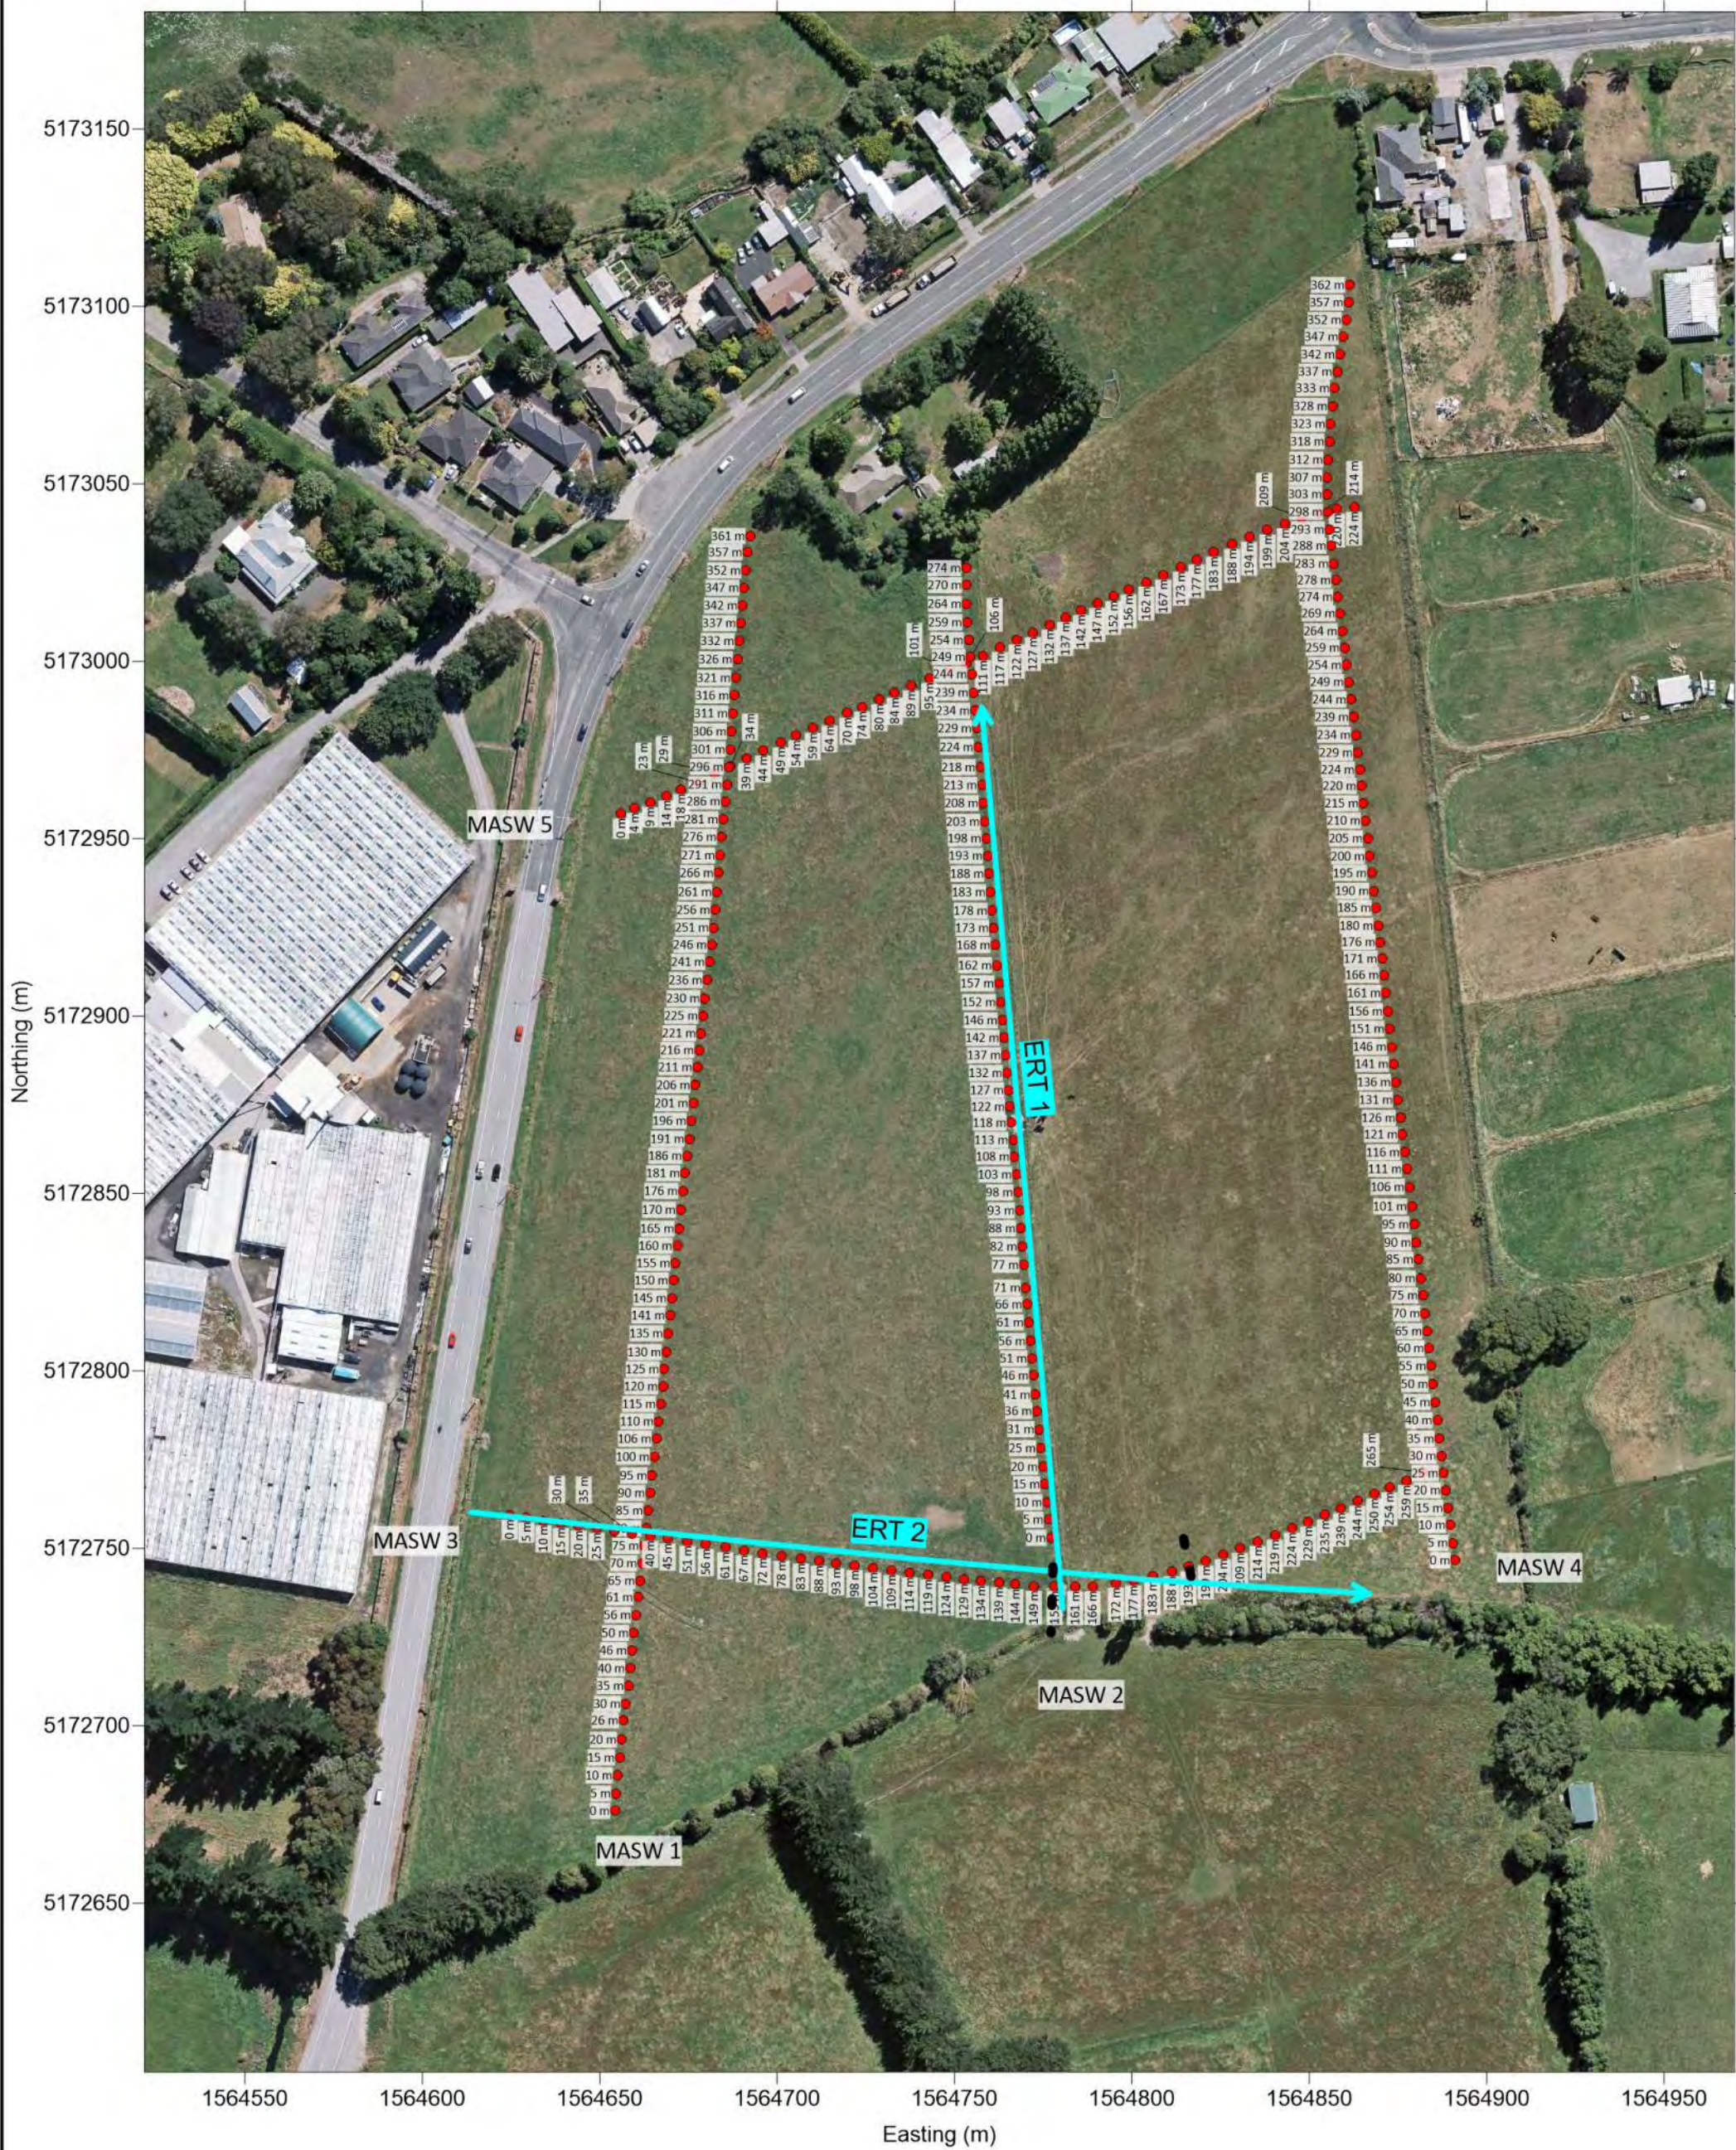
**Figure 1: Geophysical Site Investigations**

The ERT lines primarily show a contrast between low resistivity and high resistivity soils at around 4 m depth. The marked increase in resistivity is likely related to the boundary between shear-wave velocity units 1 and 2. Confirmation of the site geology would require correlation of the shear-wave velocities with intrusive tests.

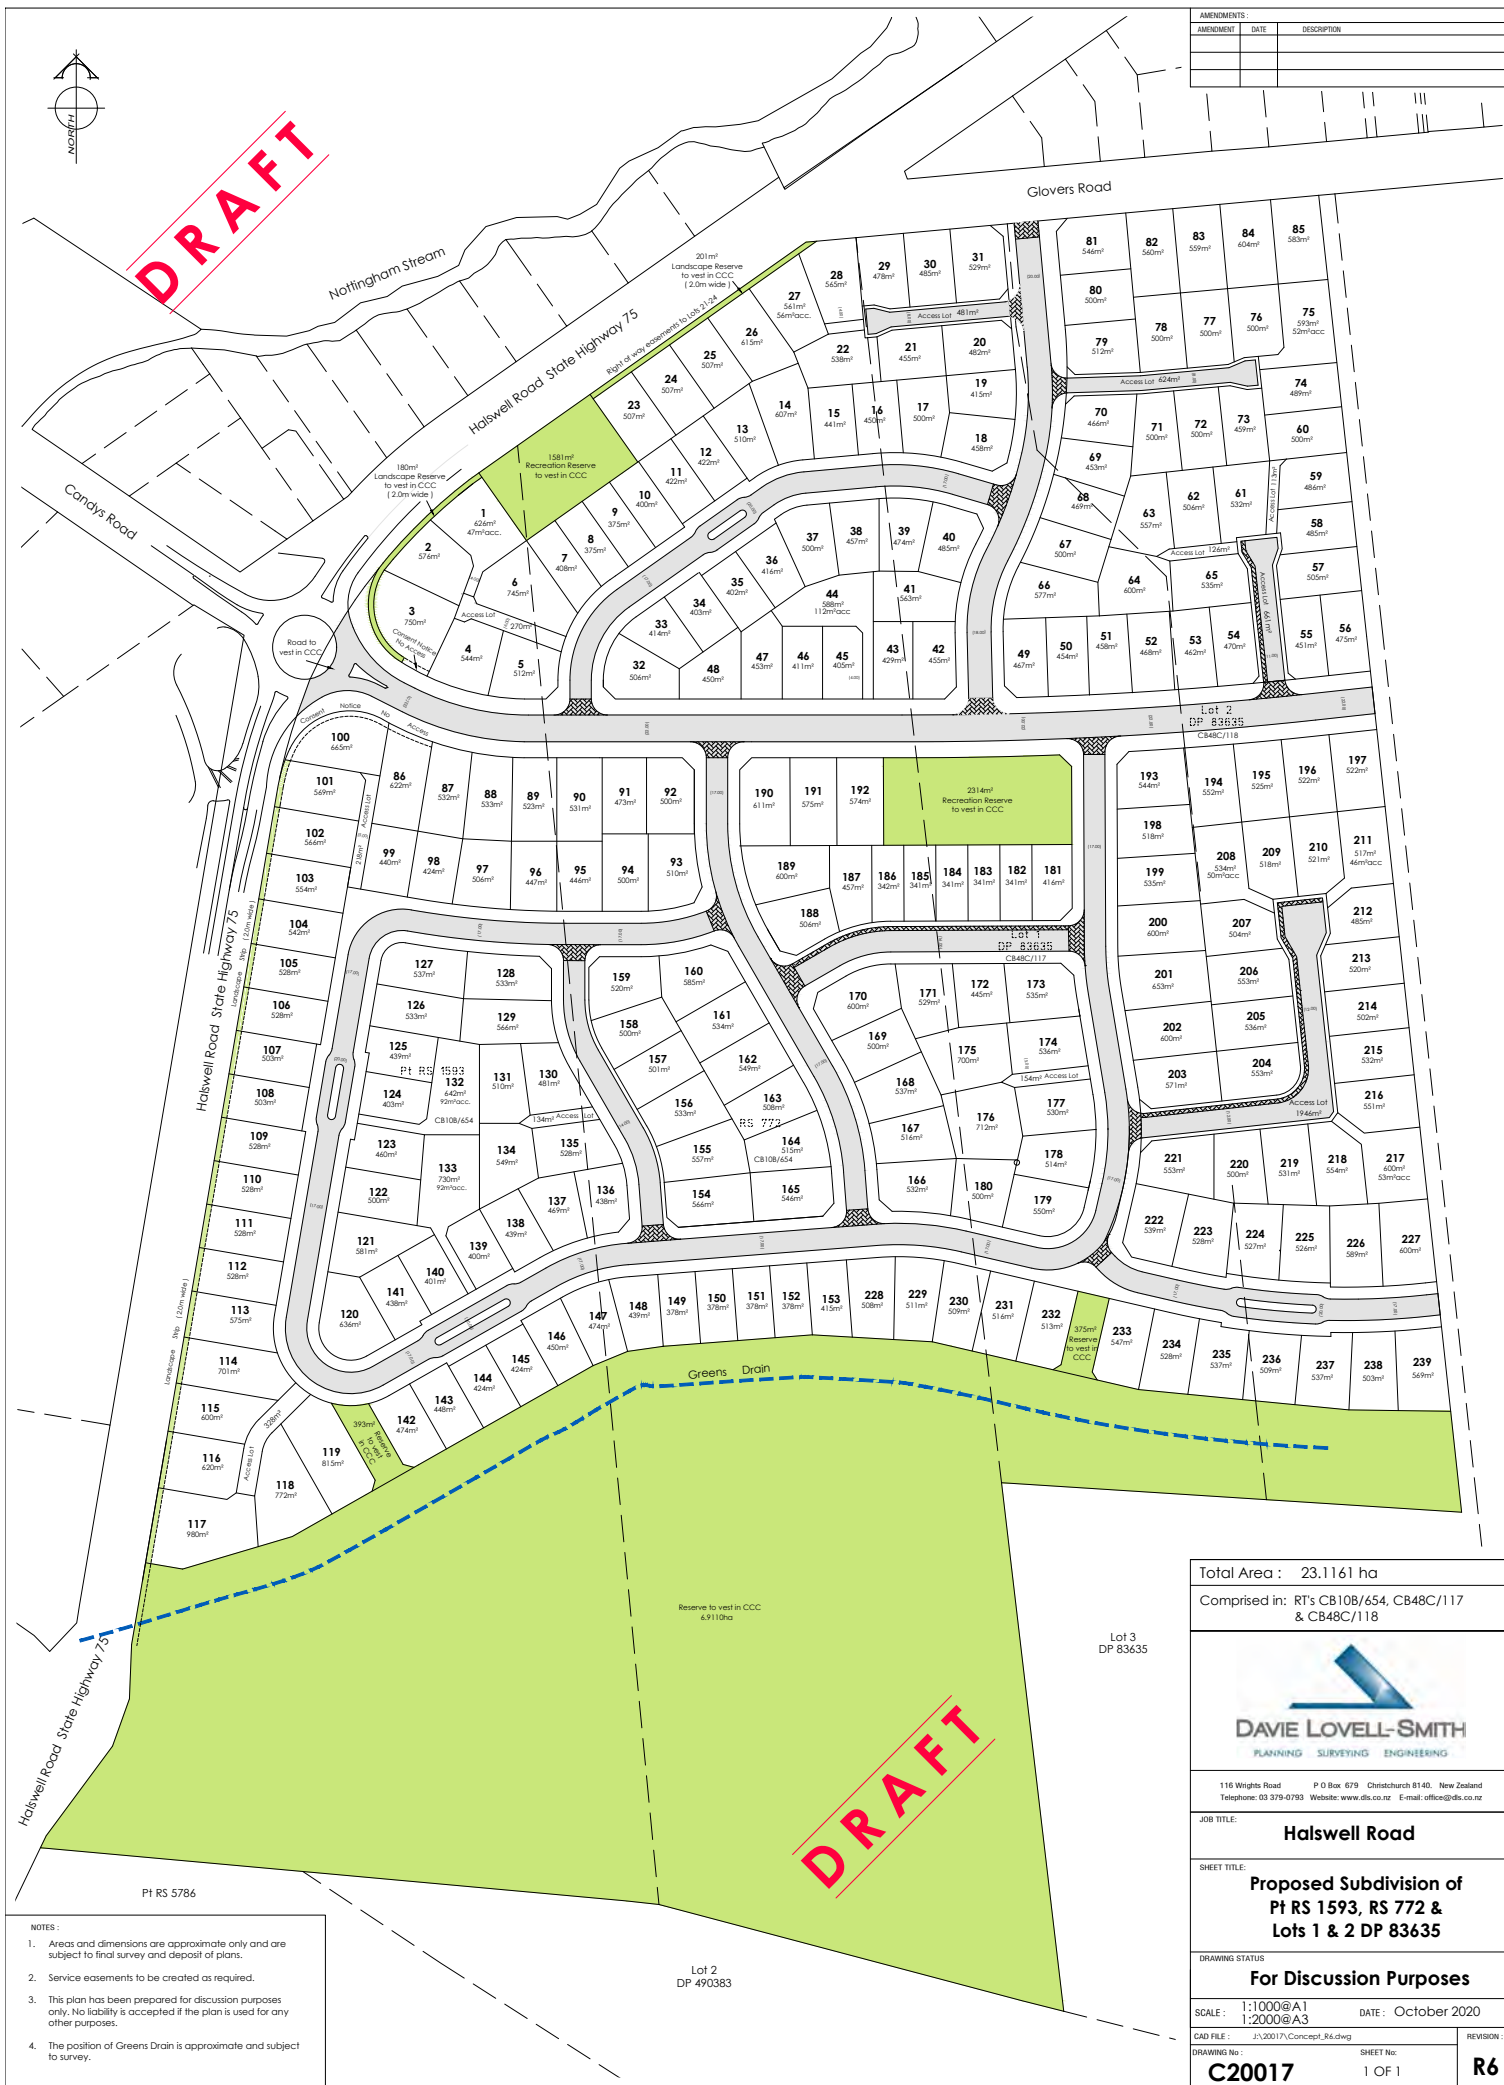
- NOTES:
1. Areas and dimensions are approximate only and are subject to final survey and deposit of plans.
  2. Service easements to be created as required.
  3. This plan has been prepared for discussion purposes only. No liability is accepted if the plan is used for any other purposes.
  4. The position of Greens Drain is approximate and subject to survey.

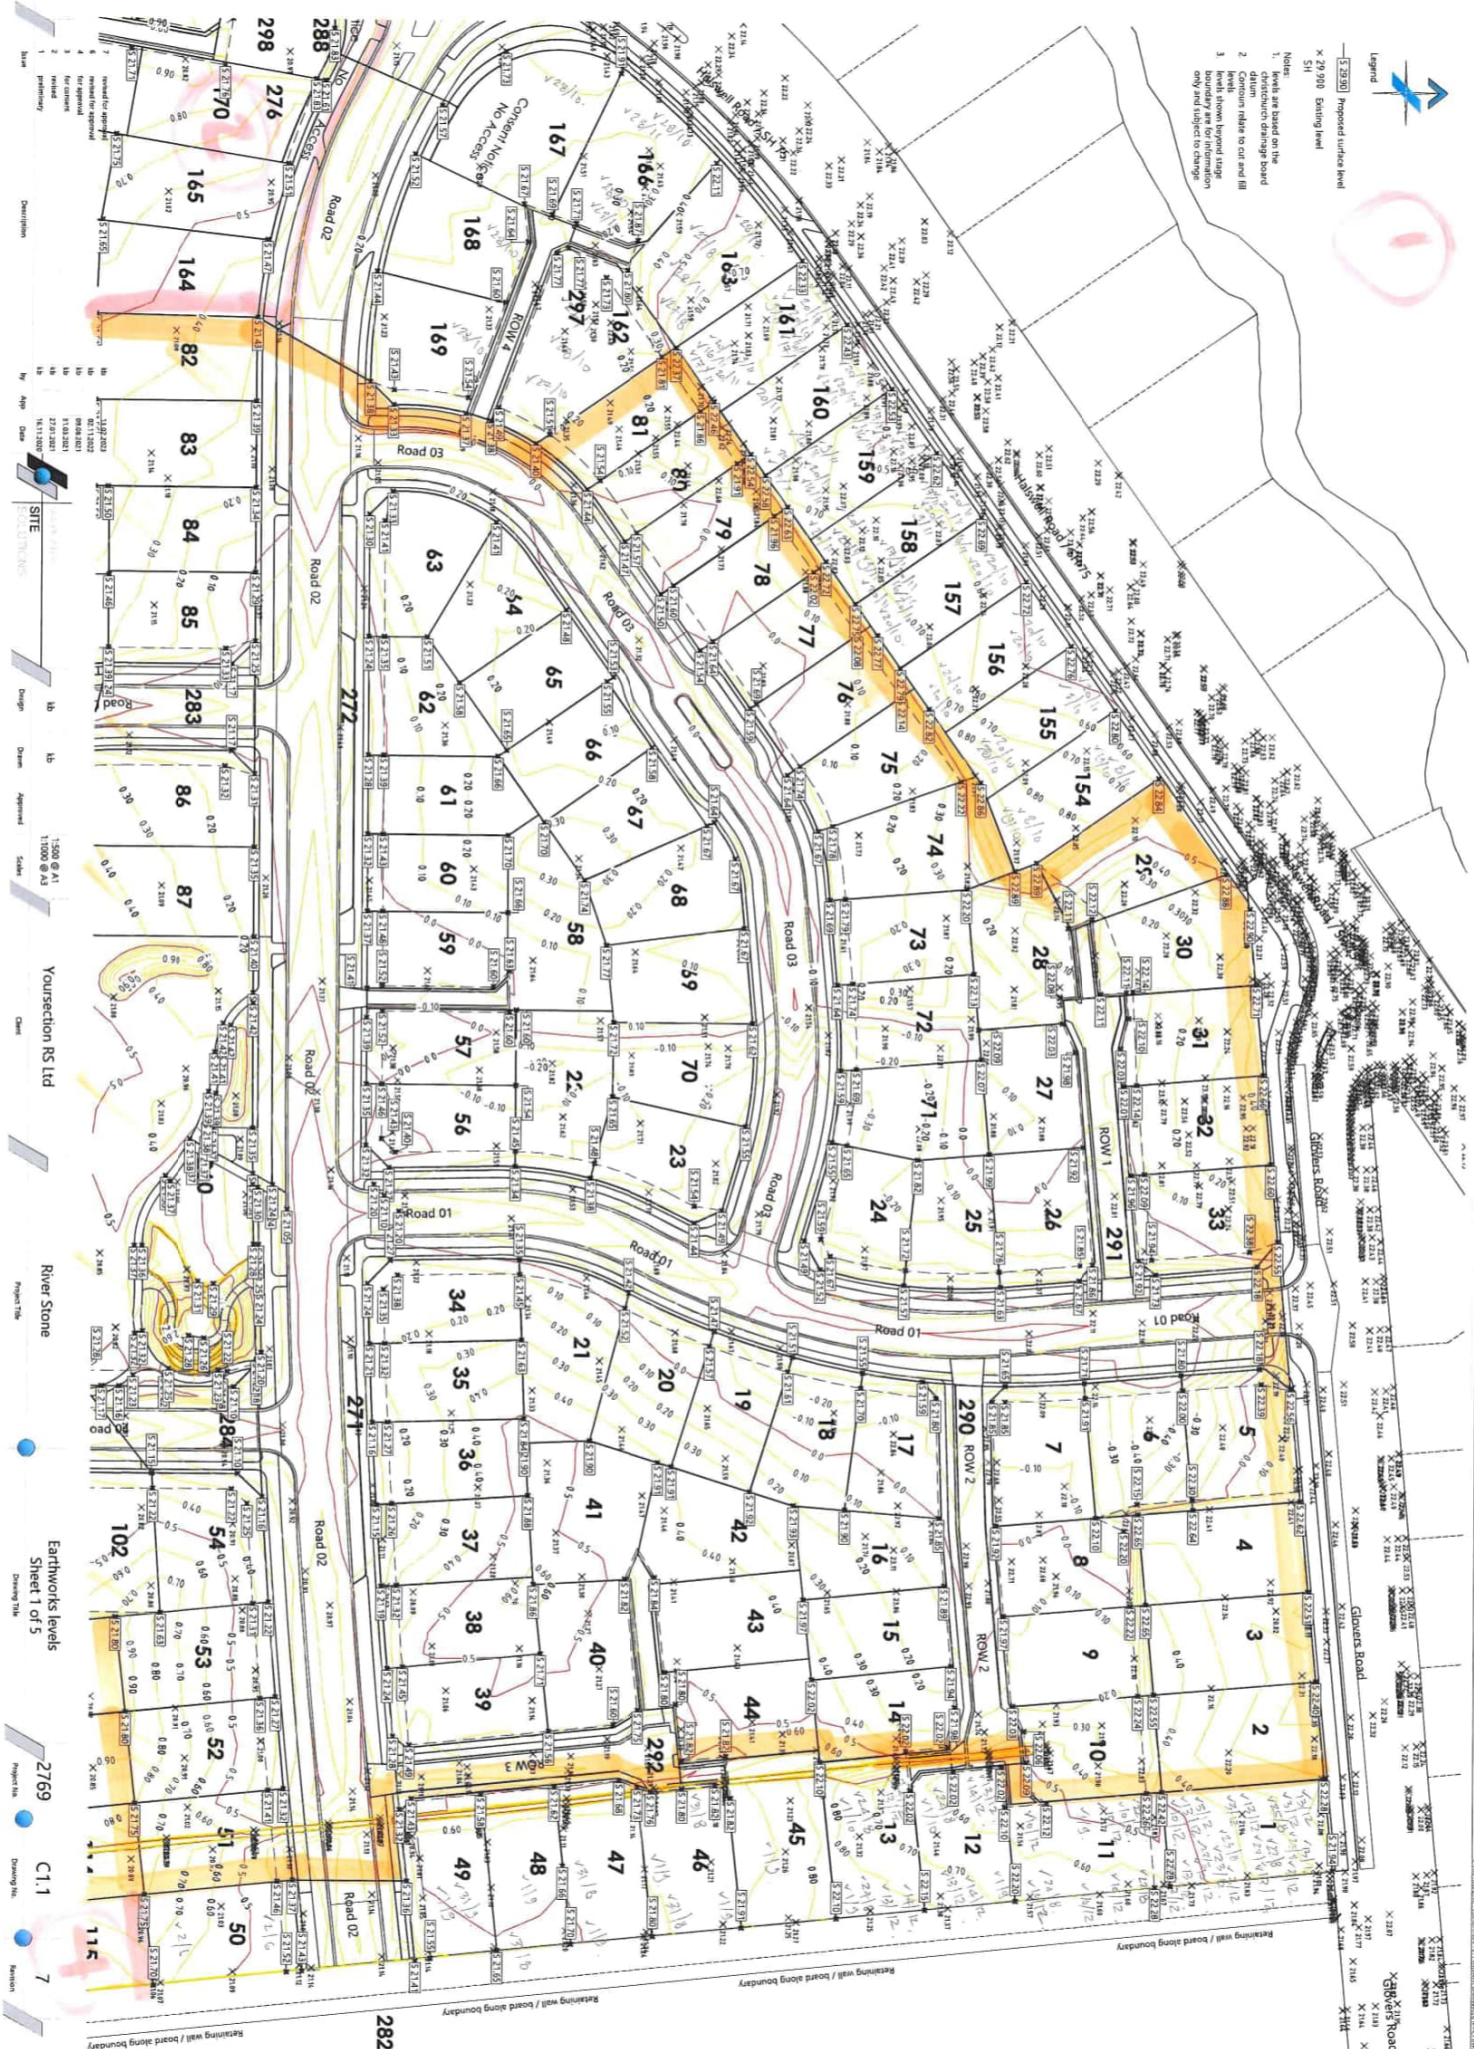
1. levels are based on the Christchurch drainage board datum
2. Contours relate to cut and fill levels
3. levels shown beyond stage boundary are for information only and subject to change

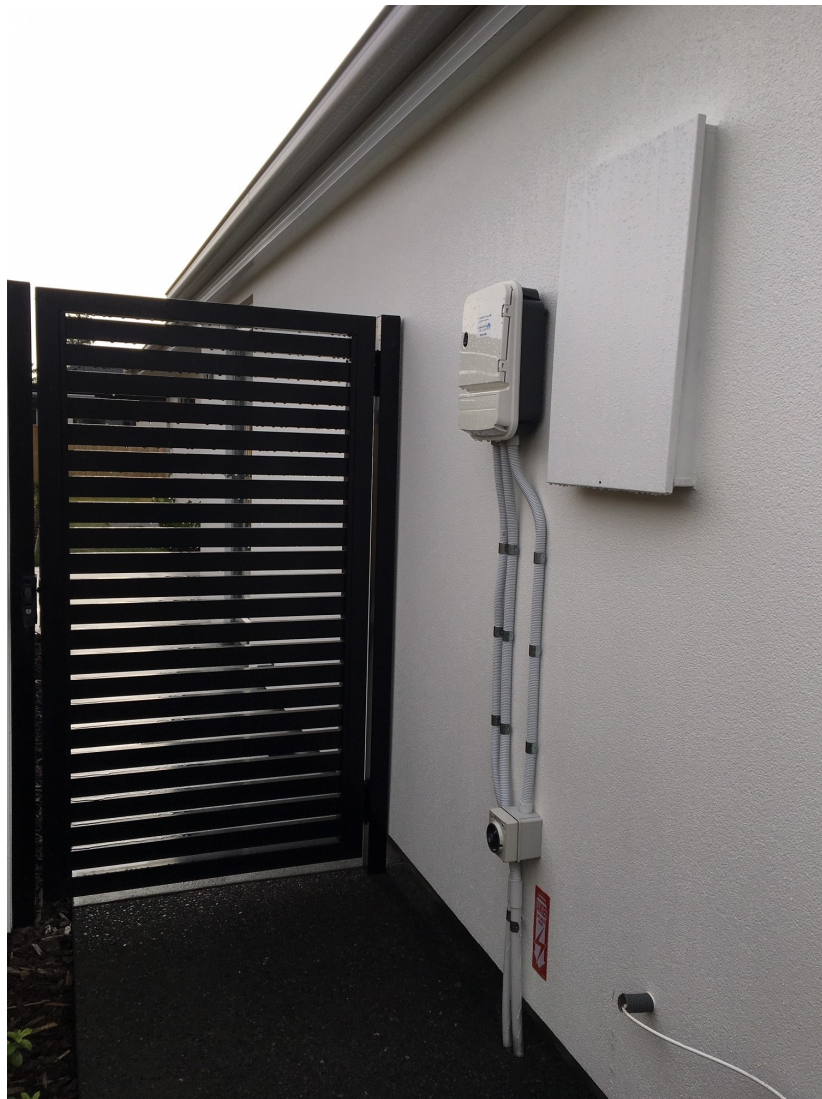
Visible from the driveway, street, or right-of-way.

Power must always be on, and is supplied via dwelling's power.

Accessible for maintenance.

**IOTA OneBox may not be fenced off.**
