# Site Validation Report

## **Soil Contamination Risk Site Validation Report**

**148 Lincoln Rolleston Road & 6/487 Weedons Road,  
Rolleston, Canterbury**

October 2025

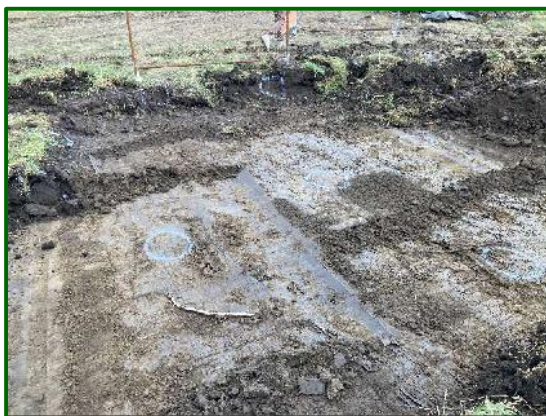
The photos below show the final excavated remediation areas with XRF test locations marked with a 'O' to indicate readings below 'residential 10% produce' SGVs. Any readings above 'residential 10% produce' SGVs were marked with an 'X' and further excavation undertaken.

Photo 1 – Excavated & XRF tested burn area BP1

The excavation of the two contaminated areas was undertaken in accordance with the approved RAP on 29 July 2025. Each remediation area was excavated until XRF testing indicated that heavy metal concentrations were below 'residential 10% produce' SGVs. The excavation at burn area BP1 measures approximately 5x6m and extends to a depth of 100-200mm deep. The excavation of the burn/mound area extended further than anticipated with a final area of approximately 410m<sup>2</sup> excavated to 100-350mm depth.

Validation samples were taken from the walls and base of each area and submitted to Hill Laboratories for heavy metal analysis to confirm the XRF readings. The validation sample results were all below 'residential 10% produce' SGVs indicating the two contaminated areas have been successfully remediated and no further remediation works were required.

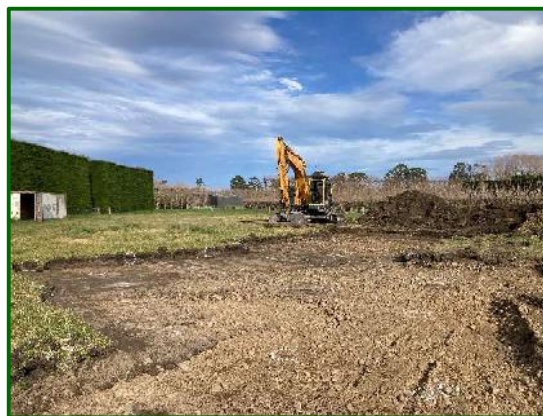
Photo 2 – Excavated & XRF tested burn area/mound on 6/487 Weedons Rd

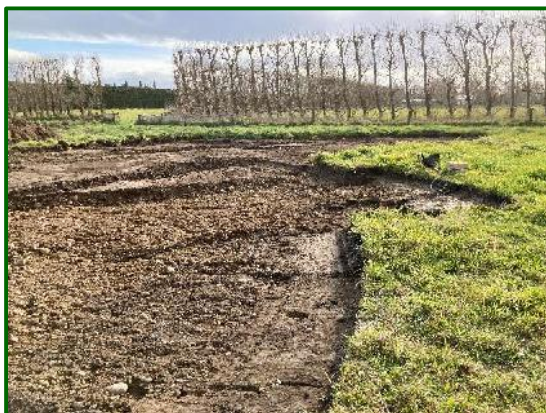
Photo 3 – Excavated & XRF tested burn area/mound on 6/487 Weedons Rd

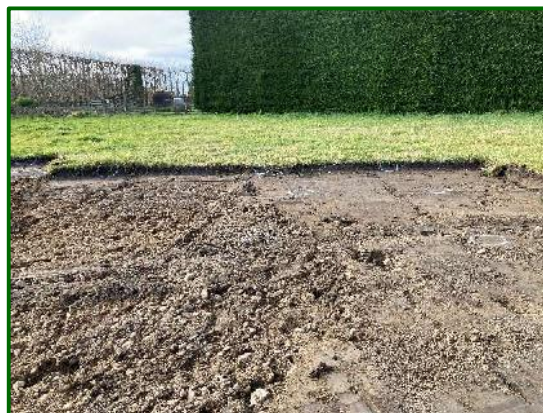
Photo 4 – Excavated & XRF tested burn area/mound on 6/487 Weedons Rd

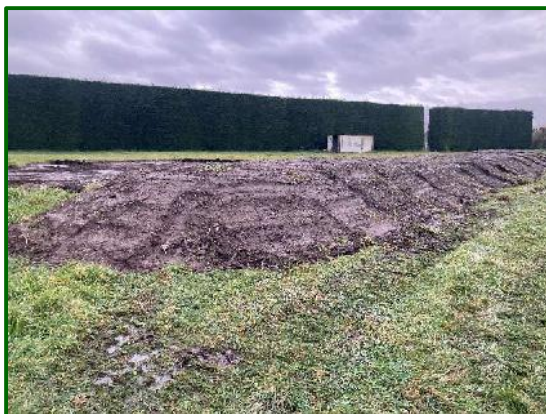
The excavated soils were stockpiled next to the 6/487 Weedons Road burn/mound remediation area. The soils were mixed as the excavation progressed and then thoroughly mixed again once the excavation was complete. The final stockpile volume was approximately 150m<sup>3</sup>. The soils were a mixture of topsoil and silty gravel subsoil with some waste materials including plastic, balage wrap, timber, metal and ash. Twelve field composite samples (samples SP1 – SP12) were taken from the stockpile on 30 July 2025 and submitted to the Hill Laboratories for seven heavy metal analysis. The samples were collected by a Suitably Qualified and Experienced Practitioner (SQEP) in accordance with the Contaminated Land Management Guidelines (MfE, 2020) and the Technical Guidelines: Characterising Surplus Soil for Disposal, (WasteMinz, September 2024).

Photo 5 – Stockpiled excavated soils

The stockpile sample results confirmed the soils meet Burwood Landfill waste acceptance criteria. These results are included in the tables of laboratory results in **Appendix D** with a copy of the laboratory report in **Appendix E**. The stockpiled soils and approximately 150-200mm depth of underlying soils were then transported to Burwood Landfill for disposal. A total of 314.14 tonnes of soil were disposed of at Burwood Landfill under waste manifest 660983. Disposal Documentation is included in **Appendix A**.

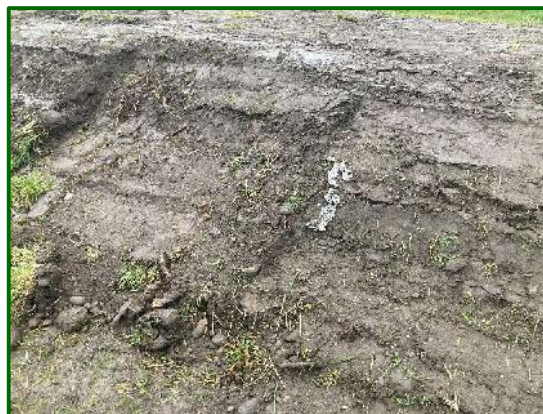
Photo 6 – Material within stockpile

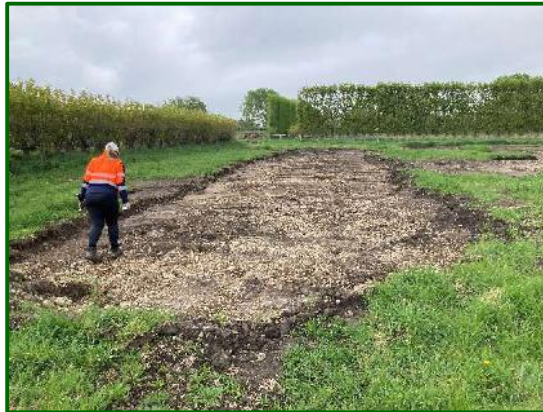
Following the removal of the stockpiled soils, on 07 October 2025, the excavated underlying area was XRF tested to confirm no contaminated soils remained and three validation samples were taken to confirm the XRF readings.

Photo 7 – XRF testing after stockpile removed from site

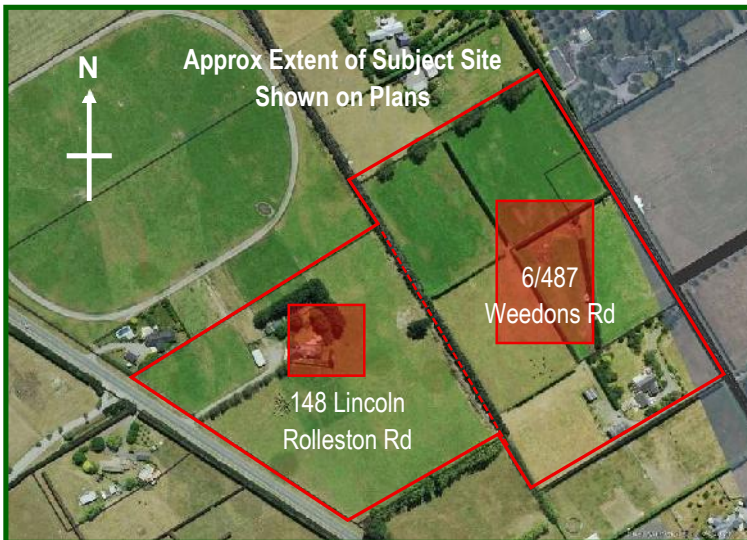
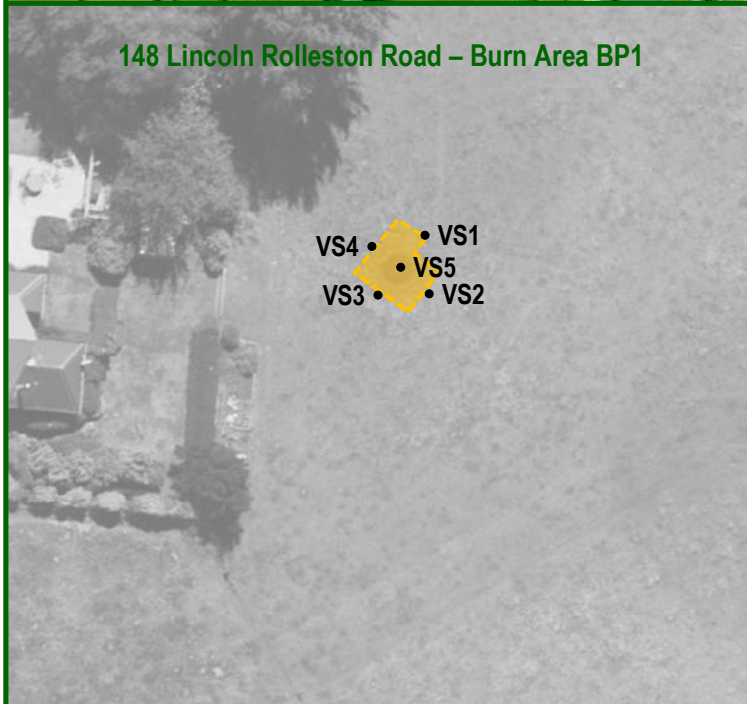
Drawing No: 678/8

A Validation Sampling Plan is included in **Appendix B**.

### Validation Sample Location Plan
