Soil Contamination Risk Site Validation Report

***511 Halswell Road,
Halswell, Christchurch***

April 2020

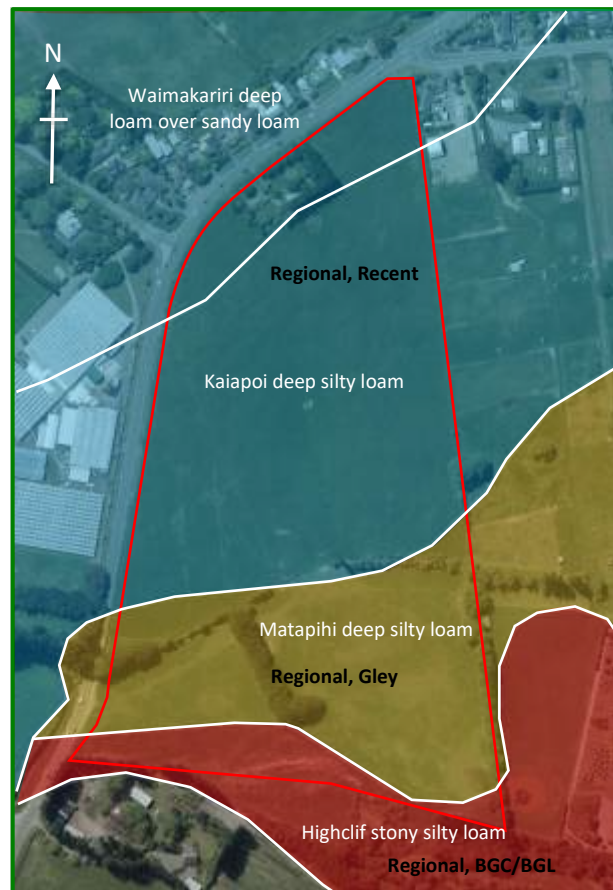
Figure 2 – Soil Type Plan

The ECan GIS describes the soils as a combination of Waimakariri deep loam, Kaiapoi deep silty loam, Matapihi deep silty loam and Highclif stony silty loam. Trace elements are a combination of 'Regional, Recent', 'Regional, Gley' and 'Regional, BGC/BGL'. The soil types and trace elements are shown on the plan in **Figure 2** below. White lines indicate the soil type boundaries, coloured shading indicates the three different trace element areas. Wells in the area indicate that topsoils are underlain by layers of clay, peat with clay, sand, sandy gravels and gravels.

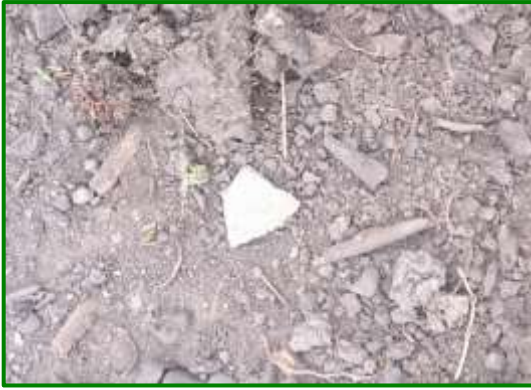
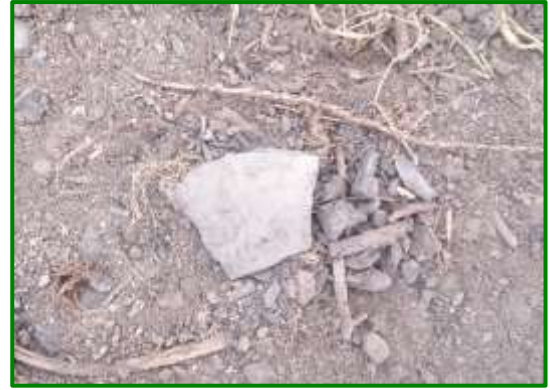
17th February 2020: Following the removal of the waste material from the burn pile area, MEL visited the site to XRF the underlying soils. The XRF readings indicated that arsenic and lead over the 'residential 10% produce' SGV was present but levels were likely below Burwood Landfill acceptance criteria. However, broken pieces of suspected asbestos containing cement board (ACM) were also noted on the southern half of the burn pile area. As Burwood cannot accept any asbestos it was recommended that the top 100mm of soils from the visible extent of the burn pile be excavated and sent to Kate Valley for disposal.

Examples of the ACM pieces noted on the southern half of the burn pile after waste material was removed

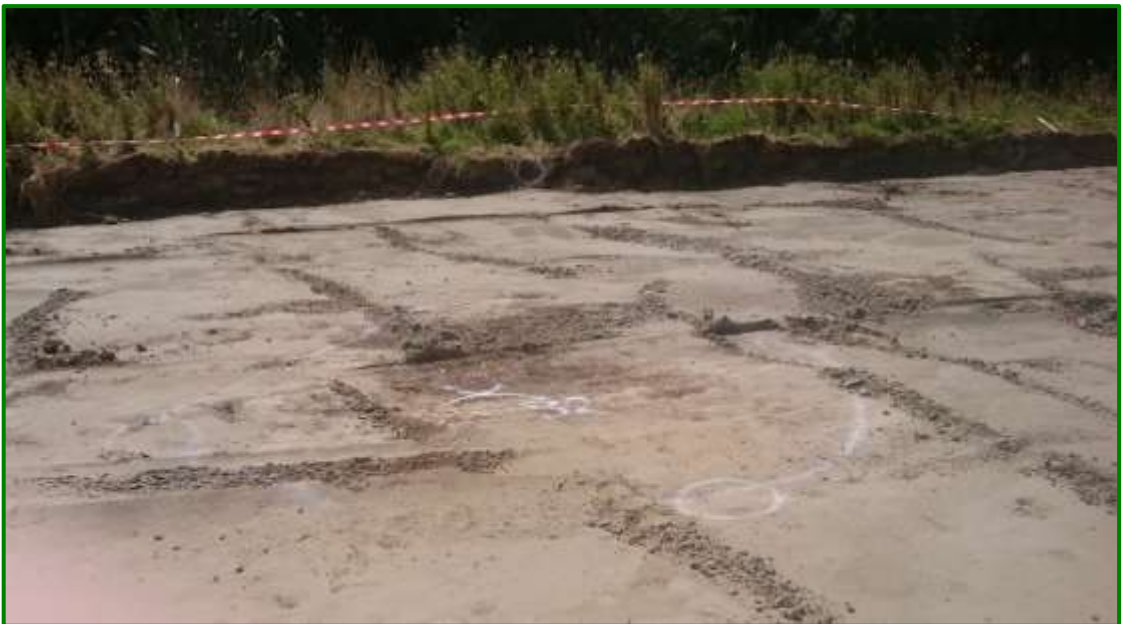
26th February 2020: The area around SS13 had been excavated to a depth of 200-400mm. XRF testing indicated the area was successfully remediated except for a small area approximately at SS13 where arsenic was measured as 32mg/kg. The soils in this area were a darker, reddish colour which has been seen at other nearby sites with potentially natural elevated arsenic. The area was marked out for additional 100mm depth excavation or until visually different soils were removed.

Area at SS13 with arsenic contaminated soils above 20mg/kg

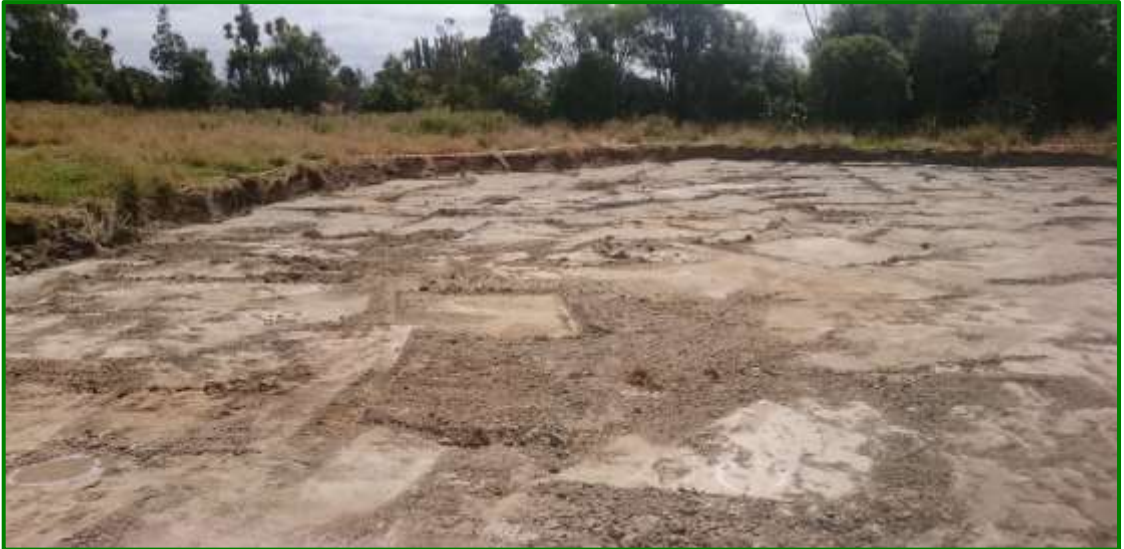
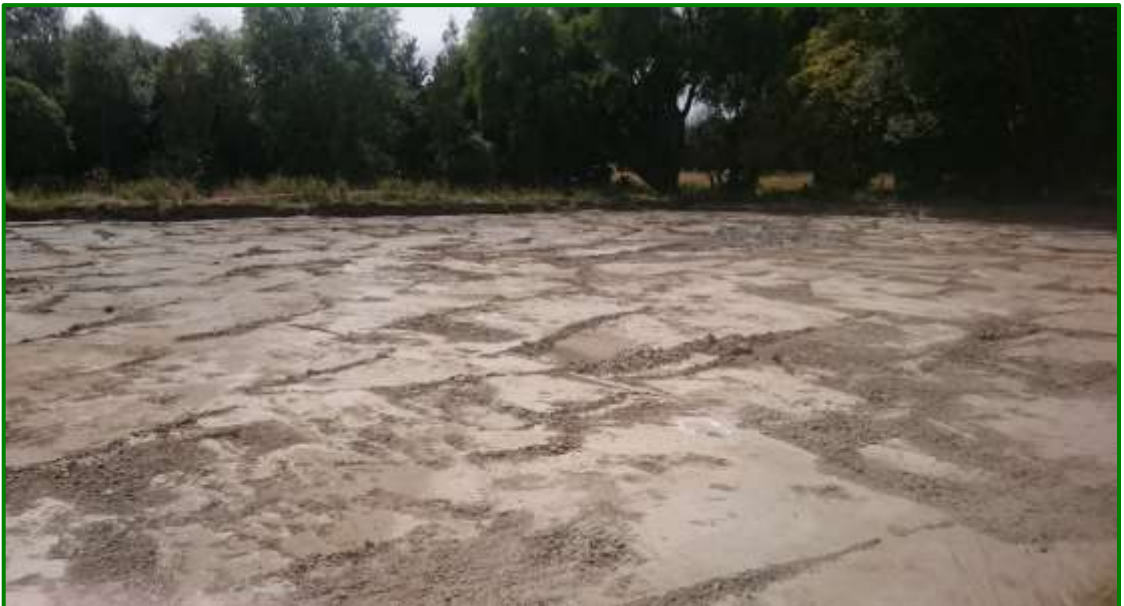
A 3-4m grid of XRF tests showed arsenic well below the SGV across the rest of the excavation.

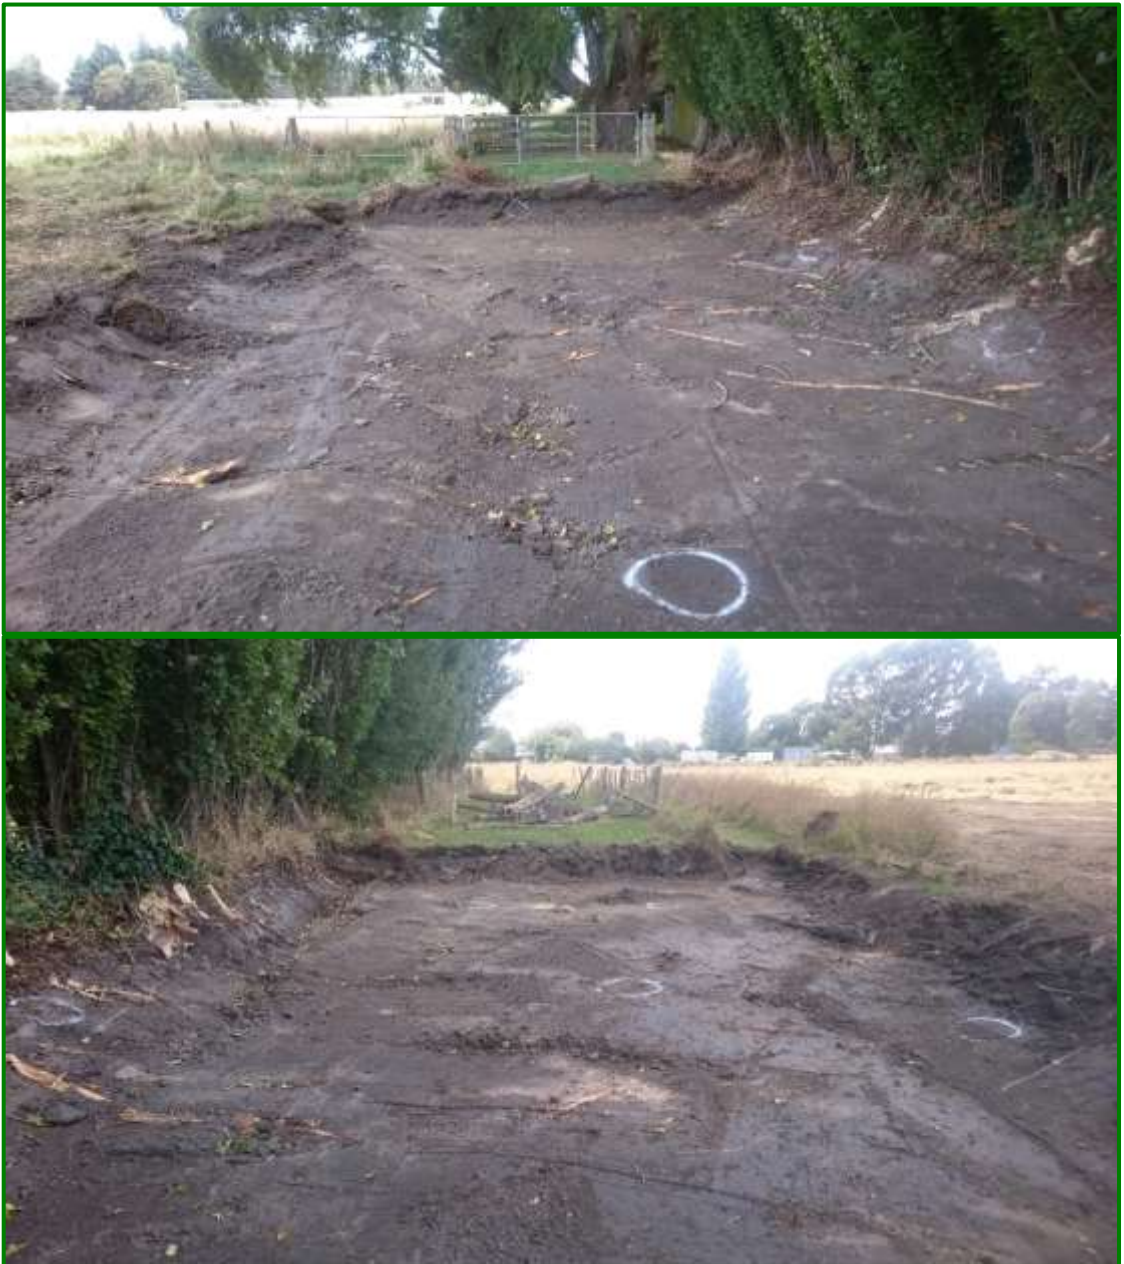
The sheep drafting yard had been excavated to approximately 200-300mm depth. XRF testing indicated the area had successfully been remediated with readings either below the instrument limit of detection or below expected background levels.

Excavated sheep drafting yard area, 'O' marks XRF test locations with arsenic below SGV

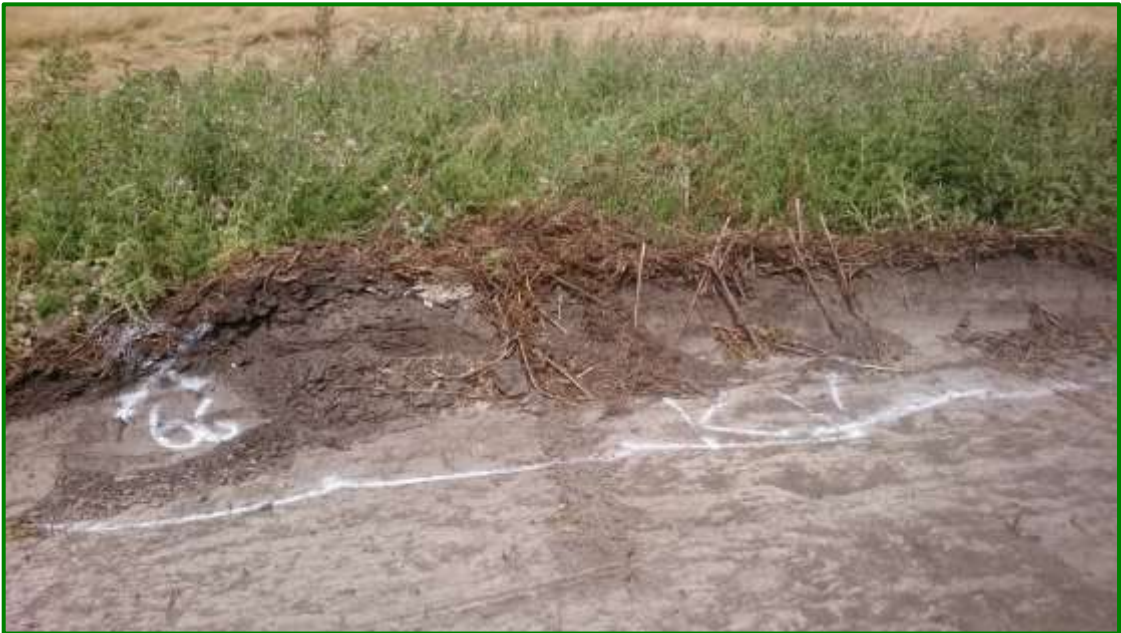
Pieces of ACM and high arsenic levels were still present along the southern wall of the burn pile excavation. It was recommended the excavation should be extended until all visible ash and ACM is removed with disposal at Kate Valley Landfill.

Southern wall of burn pile excavation, 'X' marks high arsenic

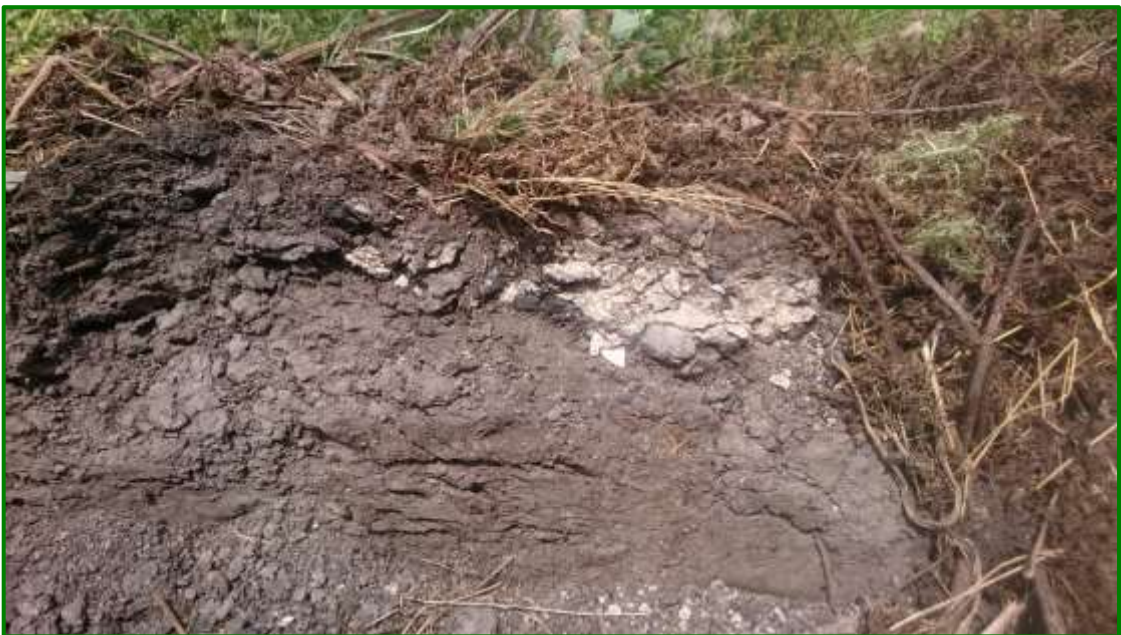
Southern wall of burn pile excavation, pale area includes ACM pieces

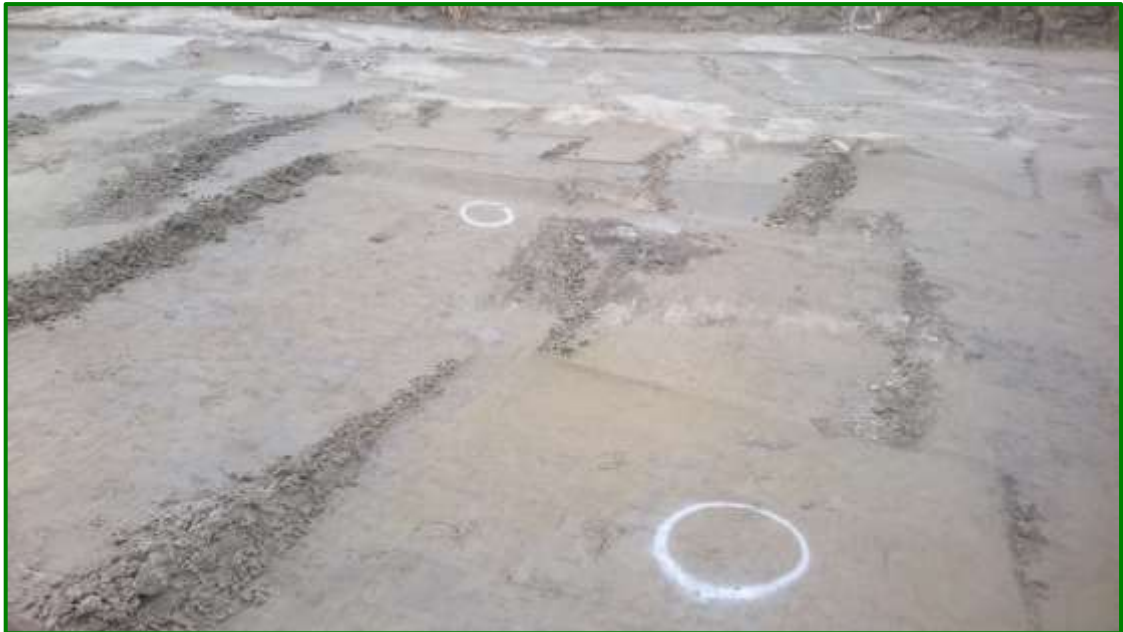
9th March 2020: The additional excavation around SS13 had been completed and XRF testing indicated the area was successfully remediated. Six validation samples were taken and submitted to Analytica Laboratories for arsenic analysis.

Arsenic below SGV at SS13 following extra excavation

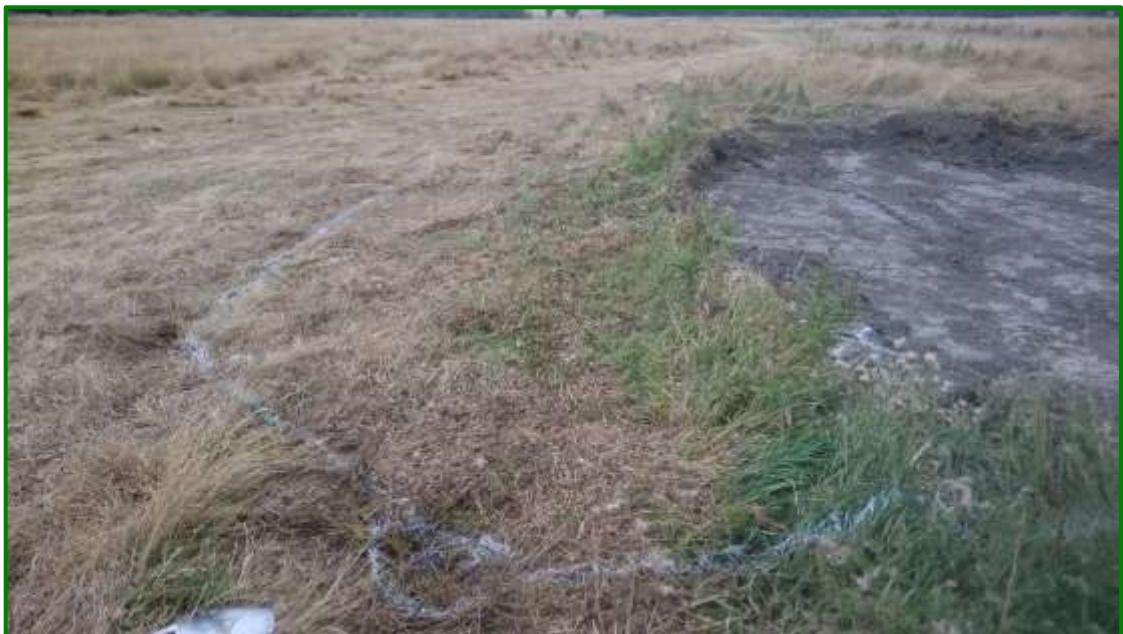
XRF testing of the burn pile excavation indicated arsenic above the 'residential 10% produce' SGV was still present. The XRF was used to delineate the additional area requiring excavation. No remaining pieces of ACM were seen. Two field composite samples, one from locations on the wall and one from locations on the base of the excavation, were collected and submitted to Analytica Laboratories for asbestos presence analysis. Asbestos was not detected in either sample. Therefore, the remaining arsenic contaminated soils qualified for disposal at Burwood Landfill.

Delineation of elevated arsenic at burn pile, 'O' is below SGV

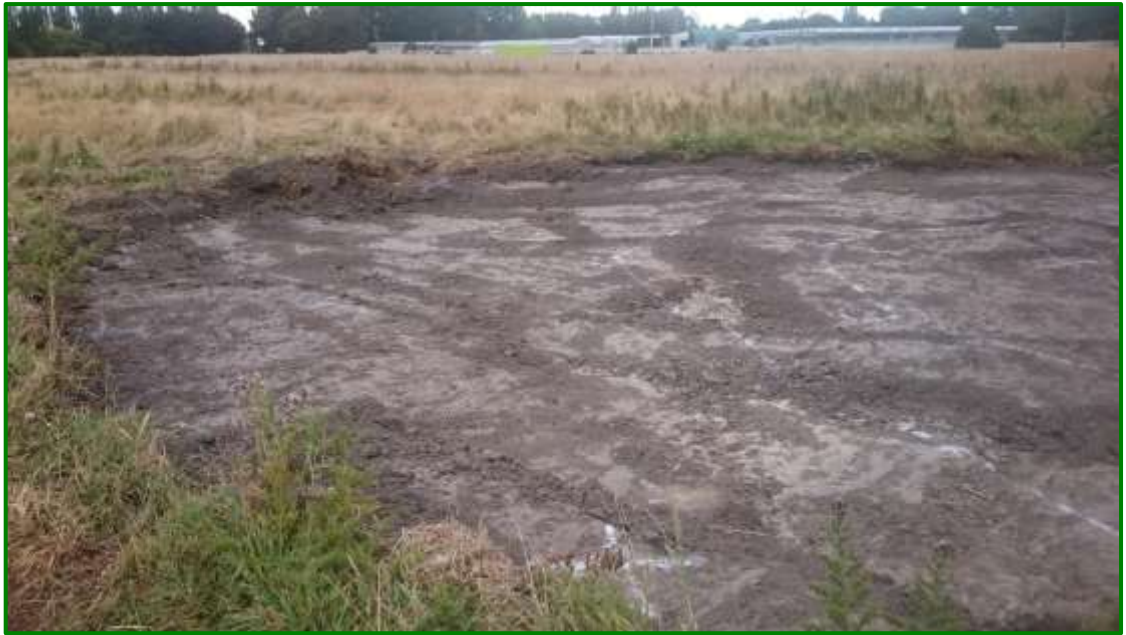
Delineation of elevated arsenic at burn pile, 'X' indicates arsenic above SGV

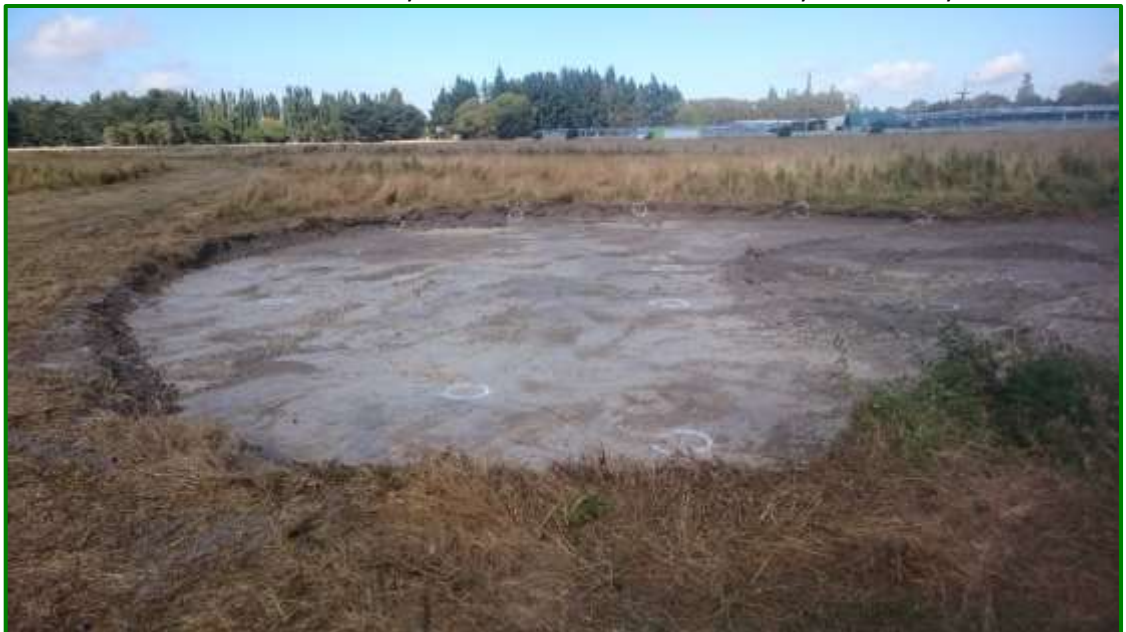
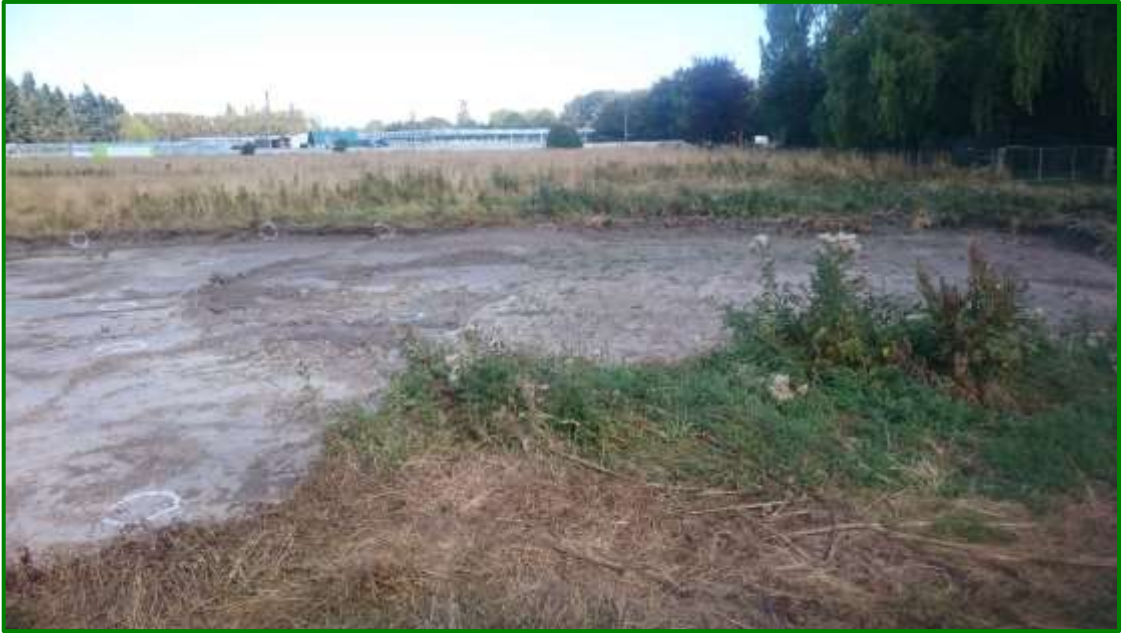
16th March 2020: This was the final validation visit to the site. The extended burn pile area had been excavated to a depth of 200mm. XRF testing indicated the burn pile area was now successfully remediated. Five validation samples were taken from the base and walls of the excavation and submitted to Analytica Laboratories for seven heavy metal analysis.

Final extent of excavation in burn pile area, 'O' marks XRF readings below SGV

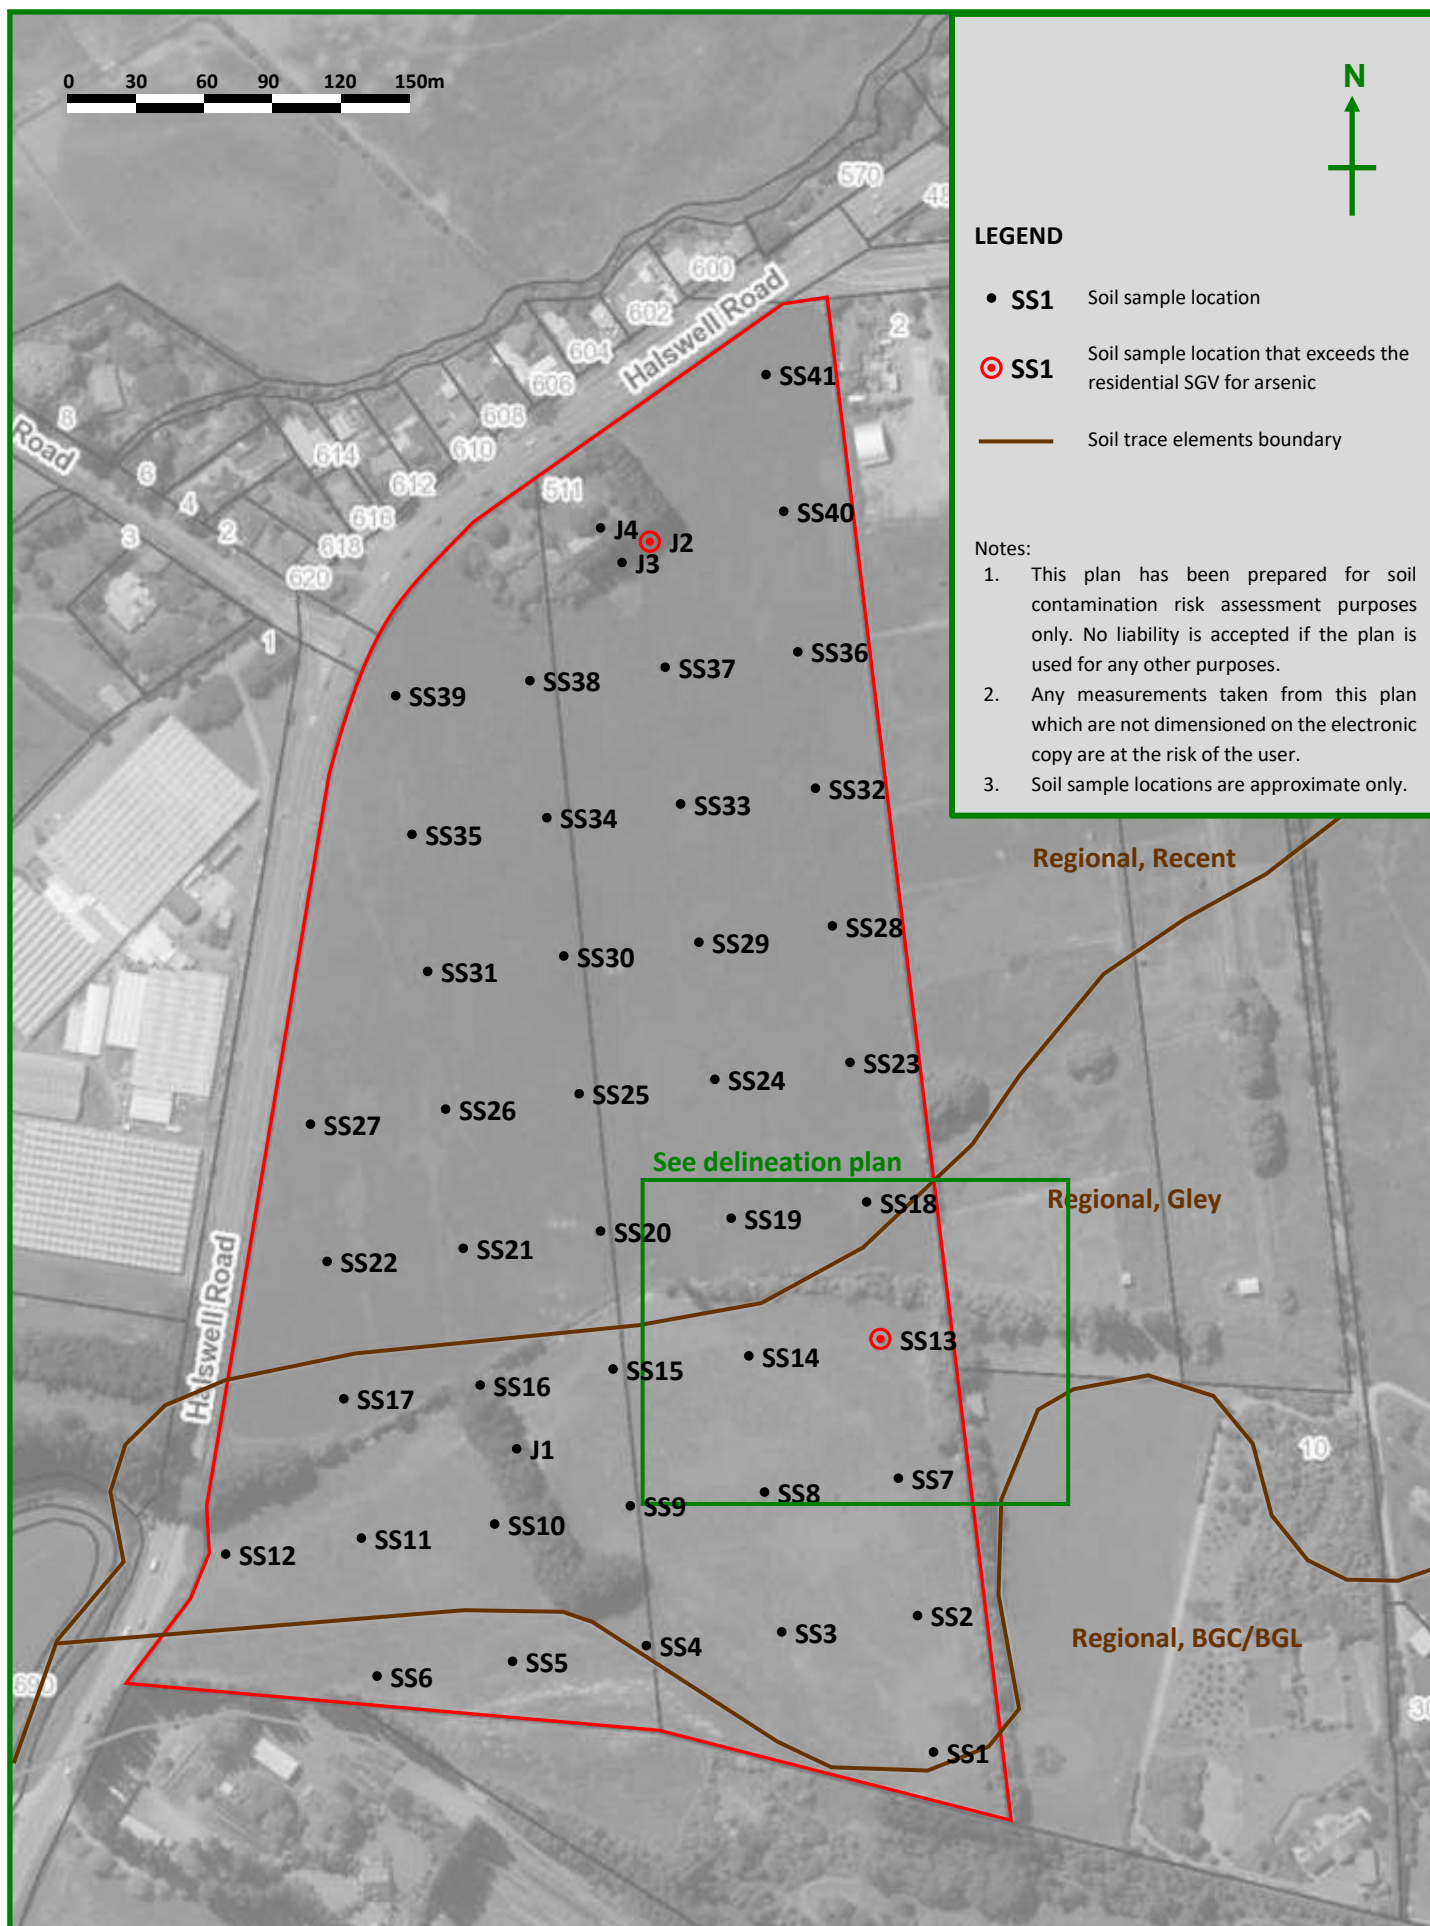
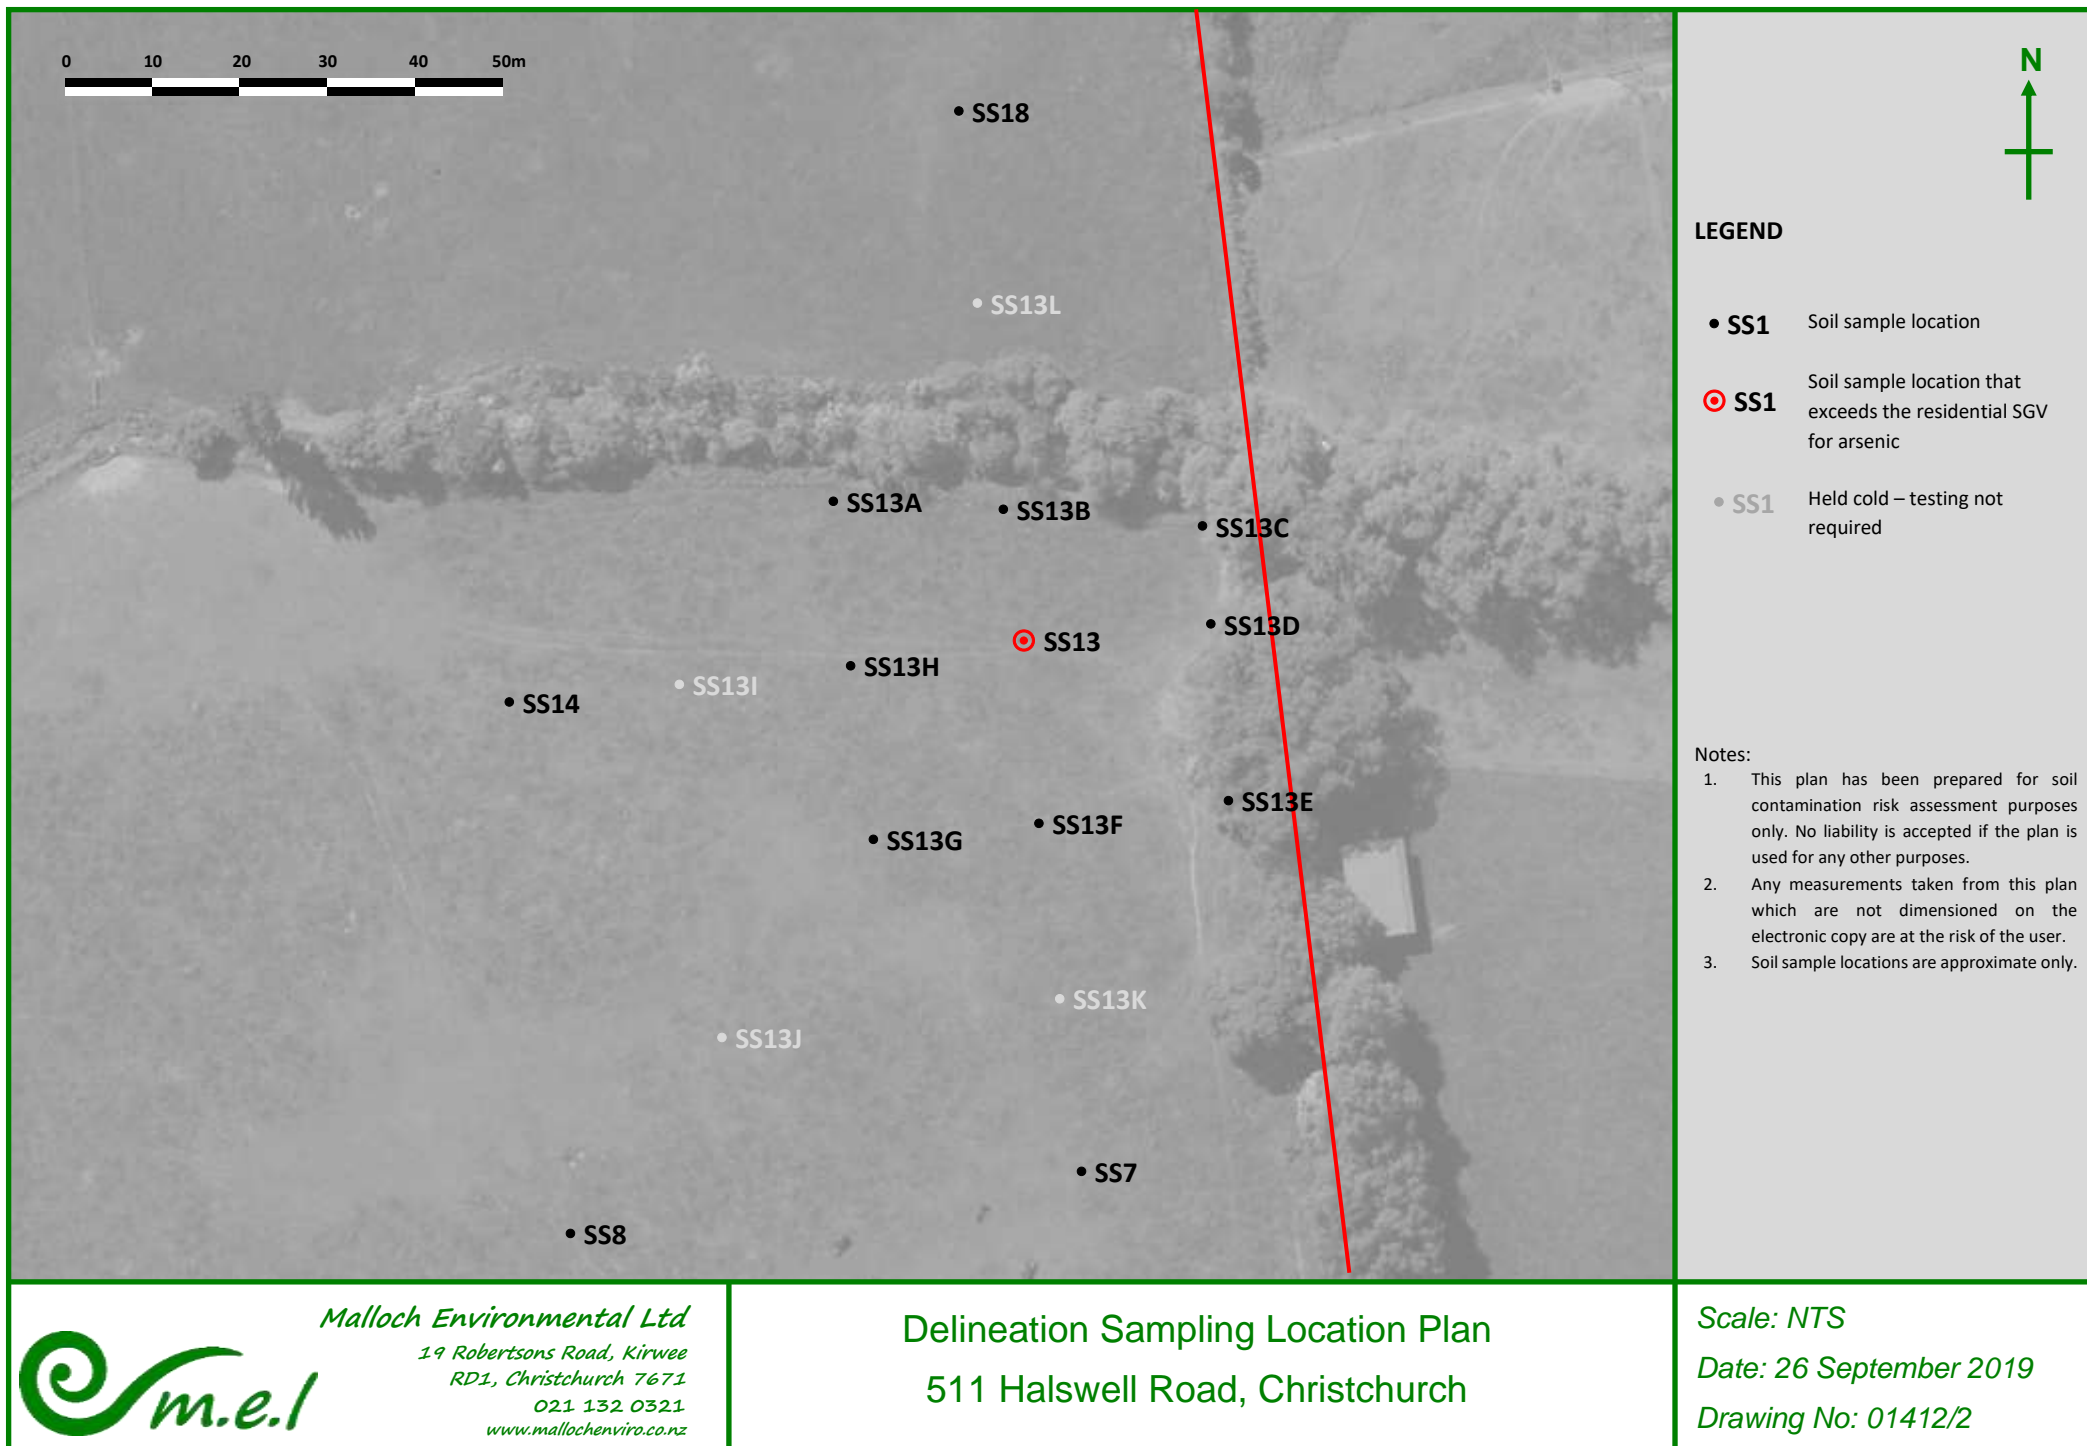
Drawing No: 01412/2

Delineation Sampling Location Plan 511 Halswell Road, Christchurch

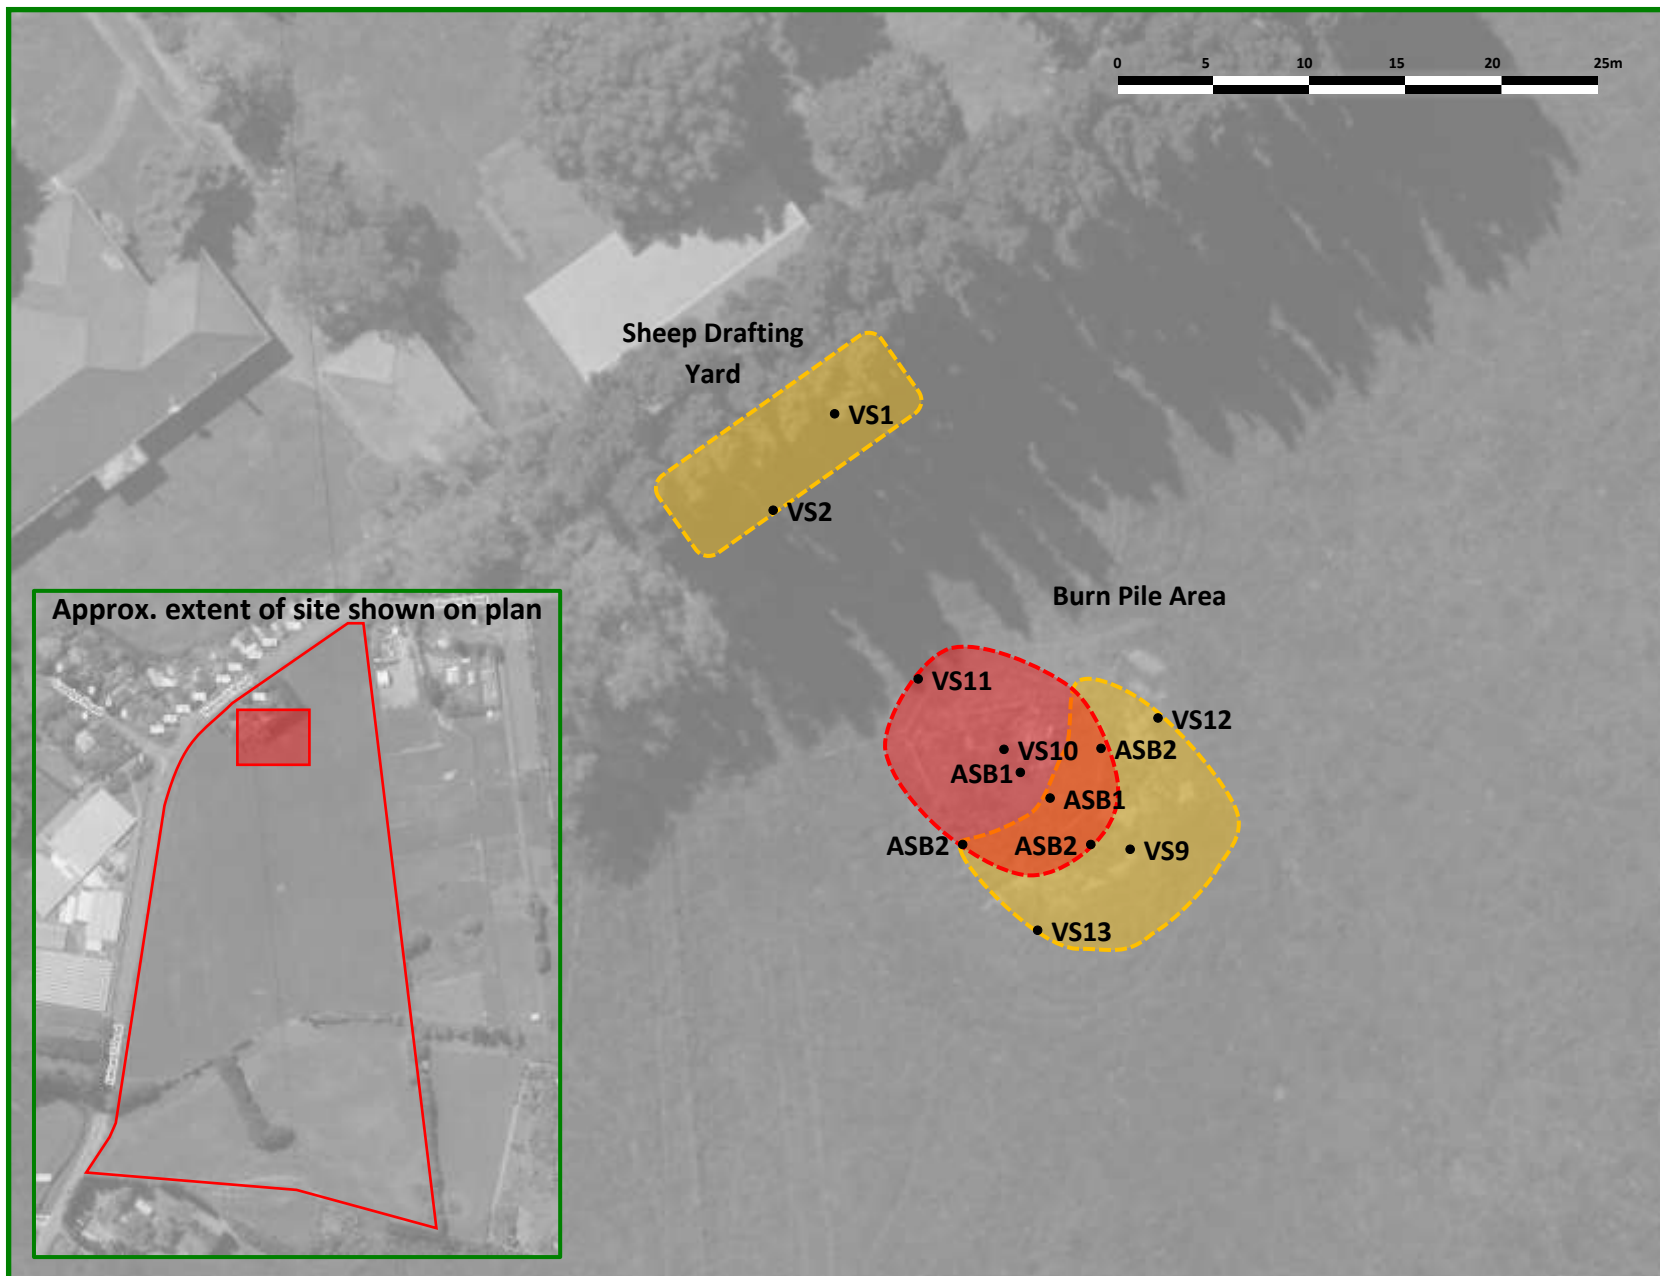
Drawing No: 01412/3

**Validation Sample Location Plan - Burn Pile & Sheep
 Drafting Yard**
 511 Halswell Road, Christchurch

The validation sample plans included in **Appendix B** show the extent of the remediated areas and the validation sample locations. A table of XRF results is included in **Appendix C**. A table of laboratory results is included in **Appendix D**, with the full laboratory report in **Appendix E**.
