Soil Contamination Risk Site Validation Report

39 Branthwaite Drive, Rolleston

June 2023

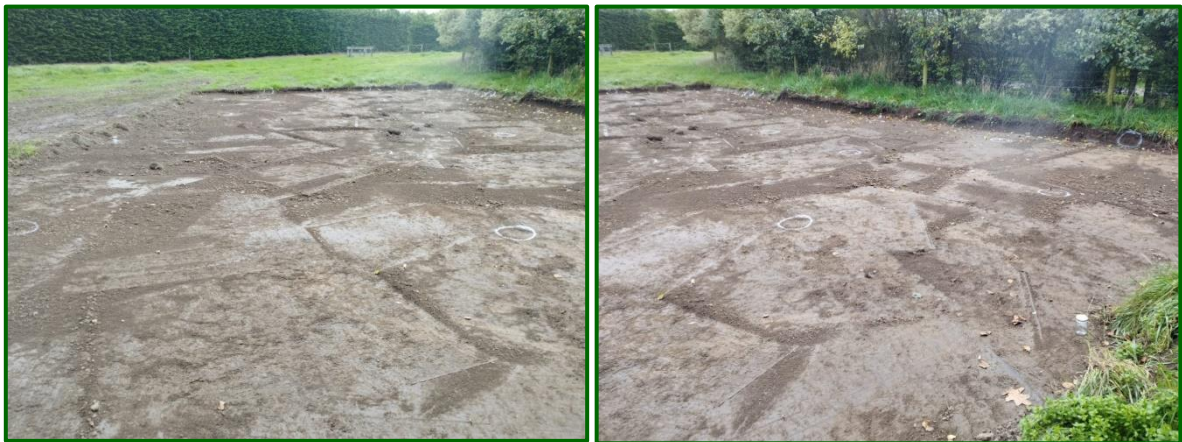
Photo 1 & 2 – Remediated burn area

XRF test locations marked with an 'O' indicate soils with contaminant concentrations below the 'residential 10% produce' SGVs.

The client advised that they wanted to remediate to achieve results of below expected background. Accordingly, the contractors were instructed to undertake an excavation with extra depth and lateral extent beyond visually affected soils. Remediation of the site was completed on 25 May 2023. MEL attended site on 29 May 2023 following the excavation of the burn area to approximately 0.15m. The soils at the base of the excavated area were brown silty topsoils with no evidence of ashy material. XRF testing completed on the walls and the base of the excavated area showed concentrations of arsenic and lead below the device limit of detection. A total of five soil samples were collected from the walls and base of the excavated area.

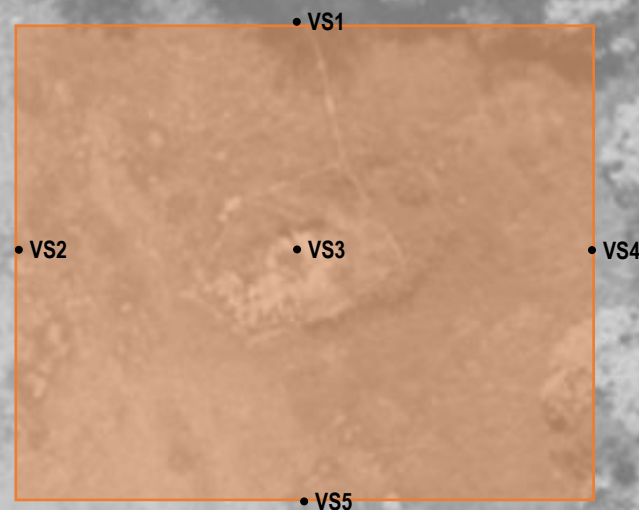
Drawing No: 743/1

- VS1 Validation sample location
-

Approximate extent of
remediated area, excavated
to 0.15-0.2m deep

39 Branthwaite Drive, Rolleston Validation Sample Location Plan
