**Soil Contamination Risk  
Detailed Site Investigation Report**

**586 Weedons Ross Road,  
West Melton, Canterbury**

July 2022

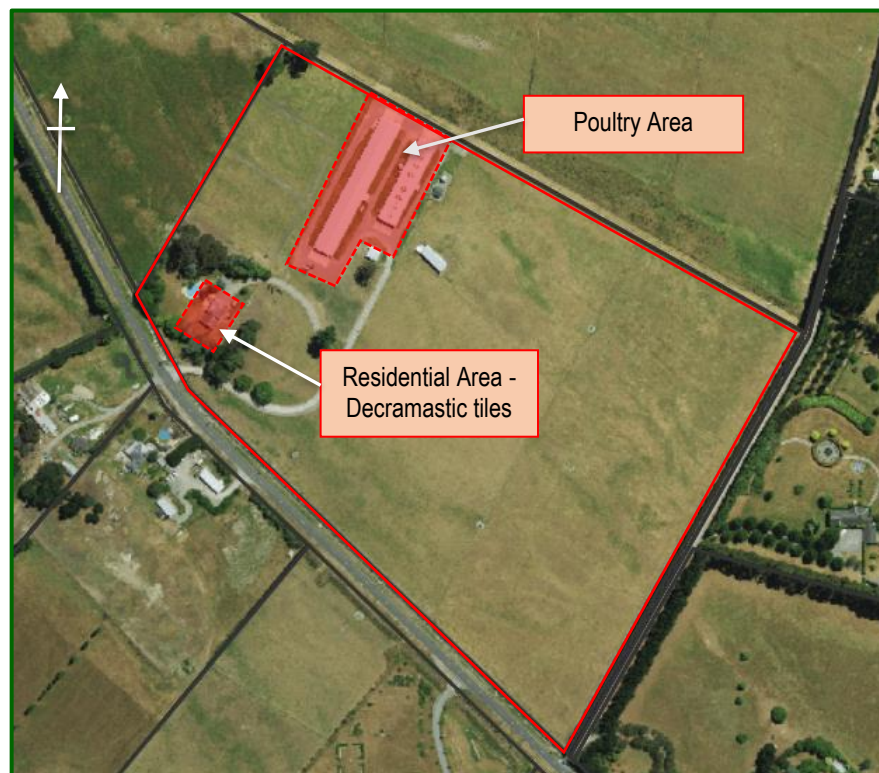
**Figure 2 – Risk Areas Plan**

**Figure 2** below outlines the potential risk areas which will form the basis of the sampling methodology. Each risk area has different historical land uses, with differing modes of contamination and contaminants of concern. Except for the south-eastern corner of the site each identified risk area has the same proposed use, residential. For the purpose of sampling design, the risk areas have been separated into two exposure areas as detailed in **Tables 2-3** below and outlined dashed red on **Figure 2**.

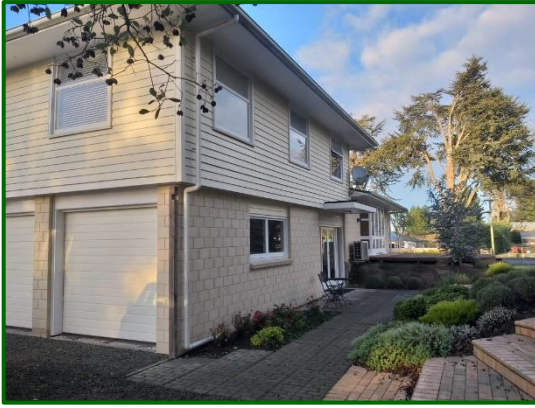
Photo 1 – Western face of the dwelling

The residential dwelling was surrounded by gravel driveway, a patio and decking area, garden beds and a grassed area. Based on the presence of the gravel driveway, patio and decking area, soil samples were collected from three locations directly surrounding the dwelling and an additional three locations approximately 3m from the dwelling. There was no evidence of asbestos contamination within the sampled soils. Soils surrounding the dwelling generally consisted of topsoil and sand.

No asbestos was detected in the soil samples collected from directly surrounding the residential dwelling.

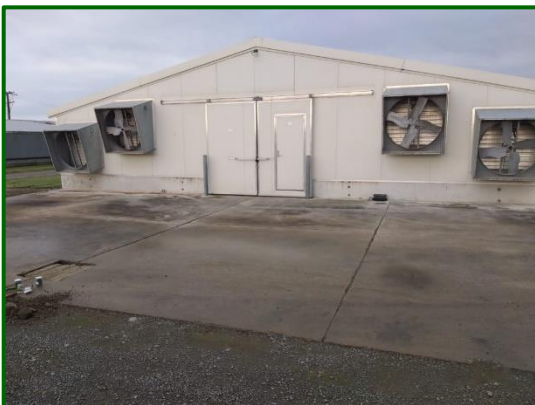
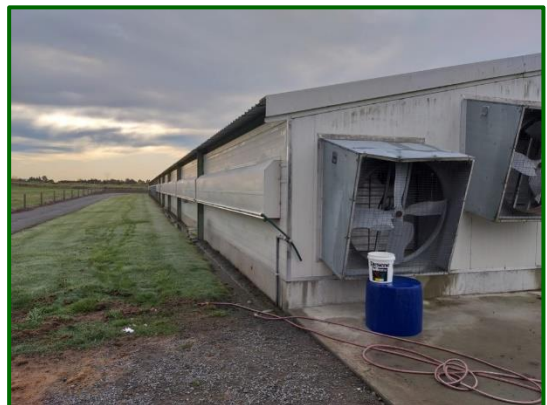
Photo 5 & 6 – Poultry sheds

The two poultry sheds are constructed from iron with concrete floors. There is a concrete pad and a sump at the northern end of each of the poultry sheds. No evidence of asbestos containing materials were seen on the exterior of the sheds. Soil samples were collected from ten sample locations surrounding the outside of the poultry sheds. Soils at the northern and southern ends of the sheds consisted of hardpacked gravel underlain by sand. Soils at the eastern and western sides of the poultry sheds consisted of topsoil underlain by sand.

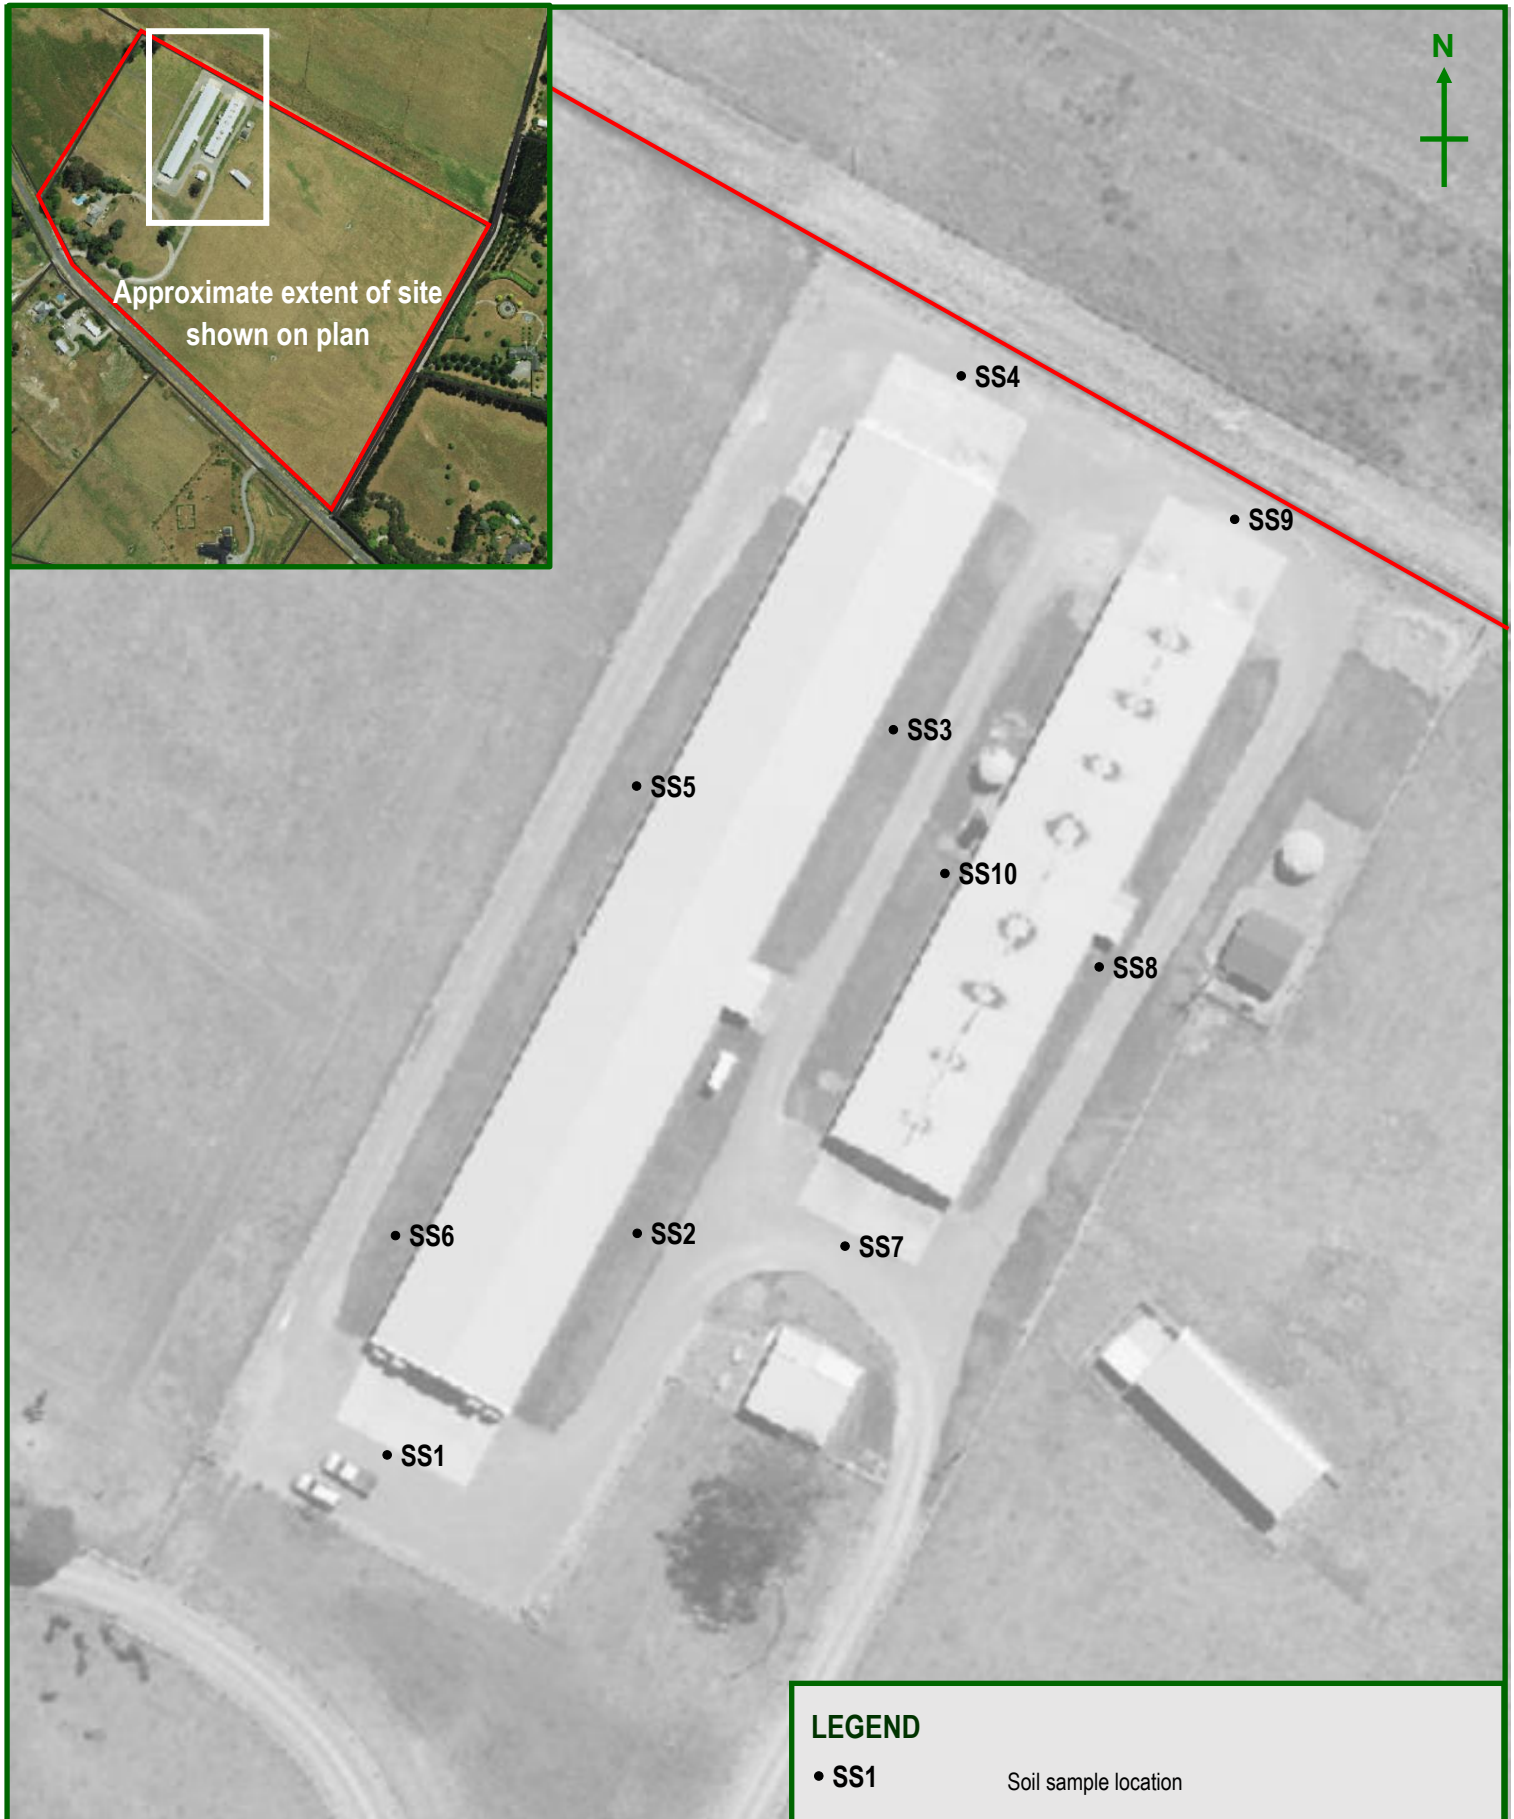
Sample Location Plan – Poultry Sheds  
586 Weedons Ross Road, West Melton

- SS1 Soil sample location

Zinc concentrations marginally exceeded the ecological guideline value (EGV) of 410mg/kg at sample location SS7.1, with a result of 426mg/kg. There were no other exceedances of the EGV.

Zinc concentrations in surface soils at sample locations SS4 and SS7-SS10 were above expected background values. The zinc concentrations at these locations ranged from 118-426mg/kg, compared to a background concentration of 93.94mg/kg. Cadmium concentrations also exceeded above expected background values at sample location SS7. The cadmium concentration at SS7 was 0.22mg/kg, compared to the expected background value of 0.19mg/kg.

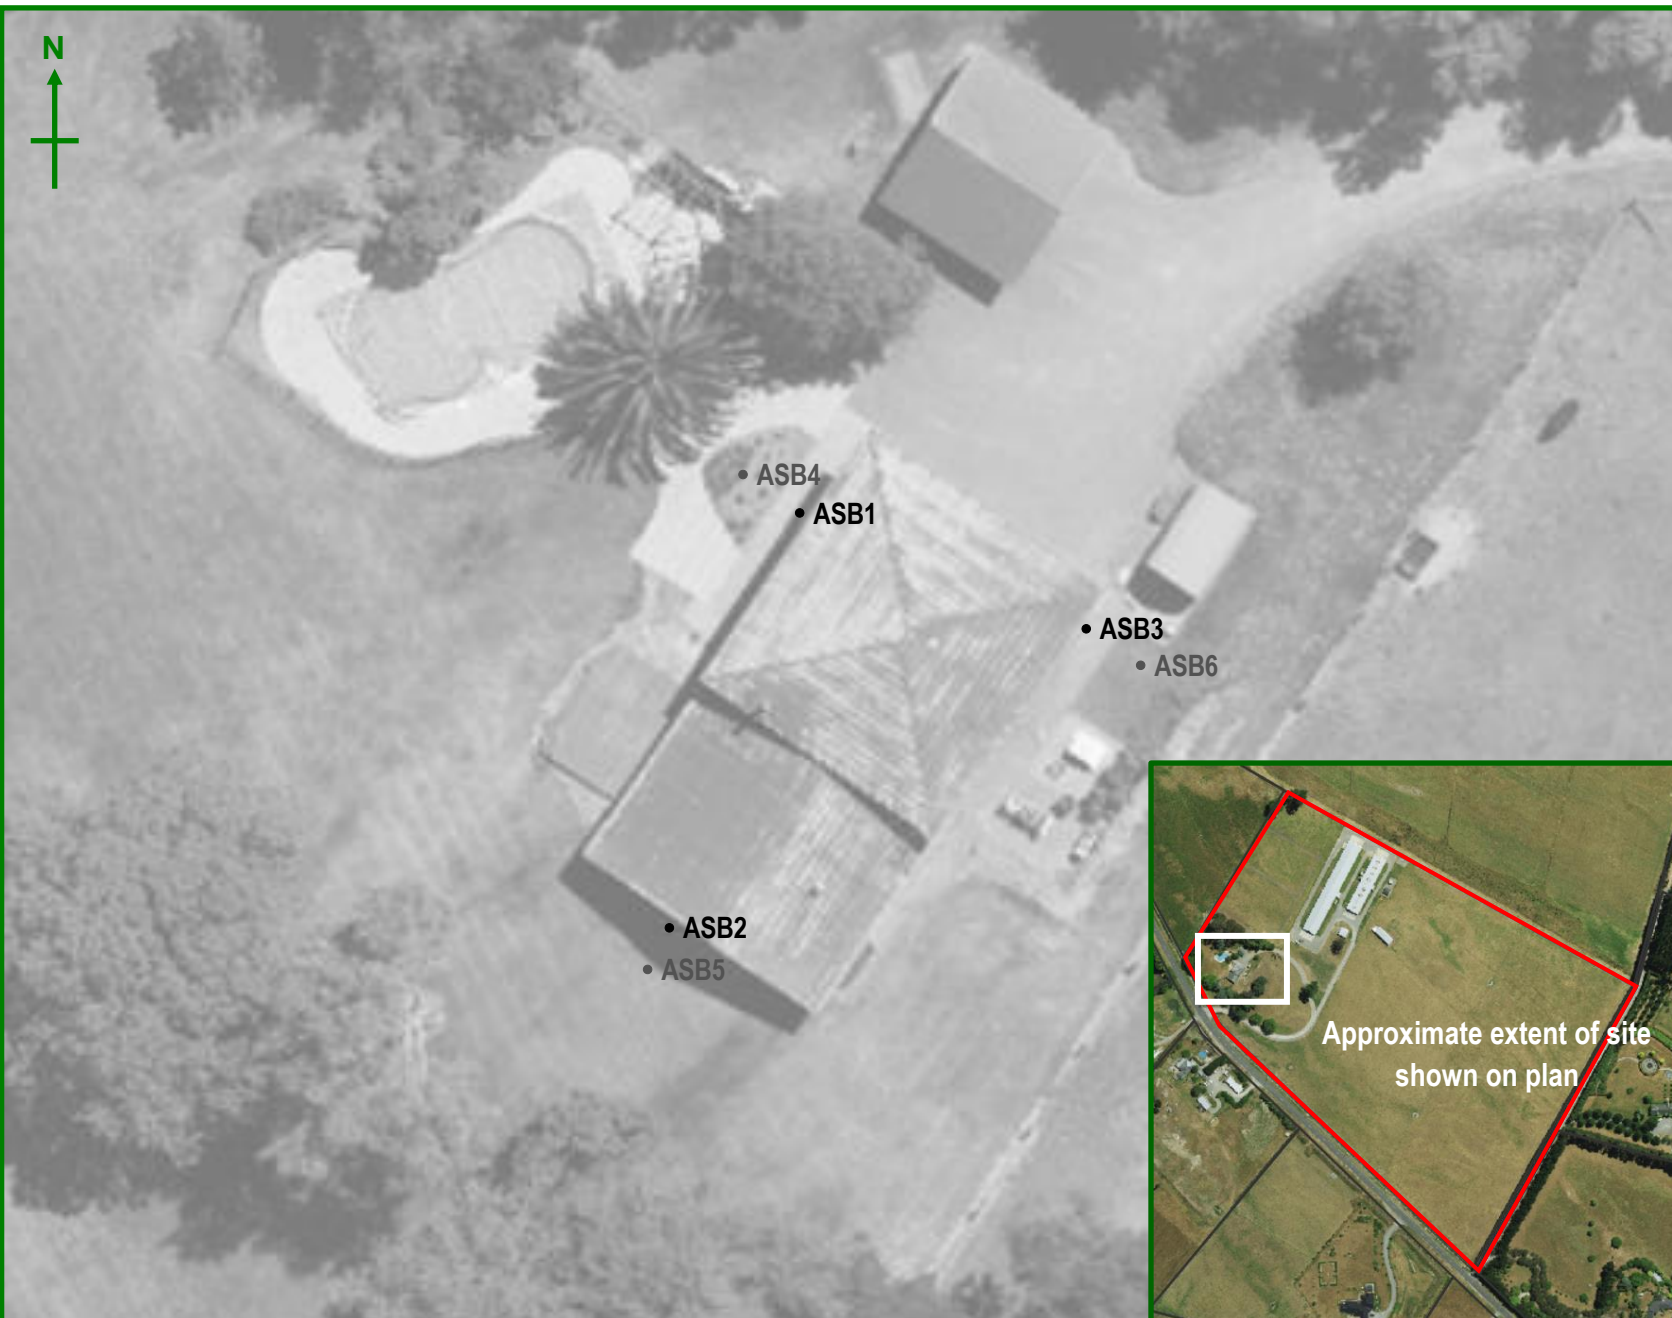
Sample Location Plan – Residential Area  
586 Weedons Ross Road, West Melton

- **ASB1** Soil sample location tested for asbestos
- **ASB1** Soil sample held cold at the laboratory

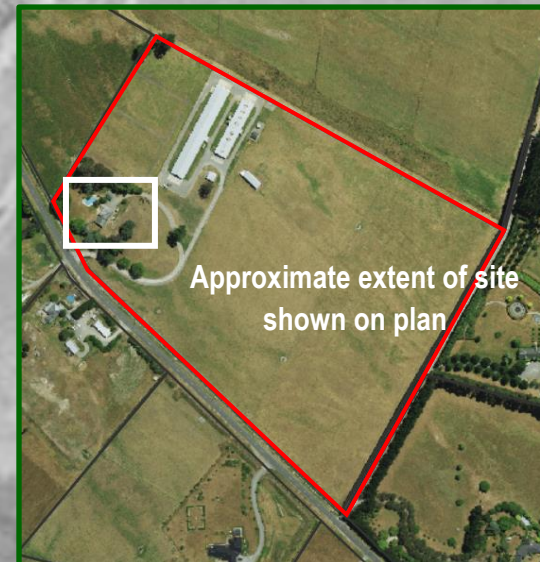
Approximate extent of site  
shown on plan
